U.S. Department of Energy
Office of Environmental Management

Accident Investigation Report

Fall Injury Accident at the Savannah River Site on July 1, 2011

August 8, 2011

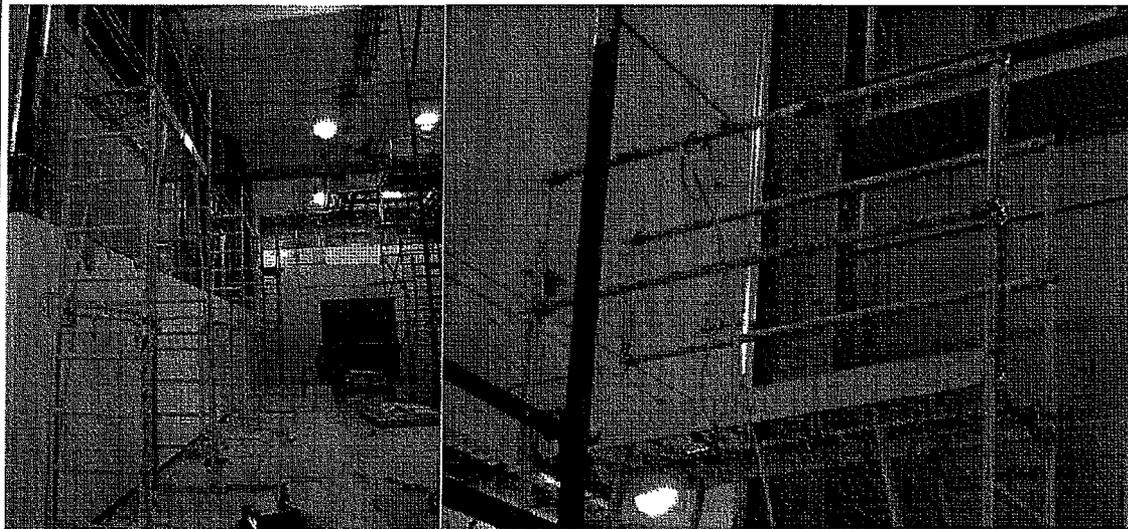
Figure 2-1: Tele-Tower[®]s A, B & C
Left to right

Figure 2-22: Tele-Tower[®] A
Safety Chains unhooked

The worker could have been affected by an overhead cable that was located near the west ladder of the scaffold. All four safety chains at the platform edges were unhooked indicating the IW may have been exiting the scaffold. The overhead cable within 15" of the end of the platform (possible interference to egress) is the item that may have contributed. The cable height was 63" above the working platform. This would have been about chin high to the IW while standing on the platform.

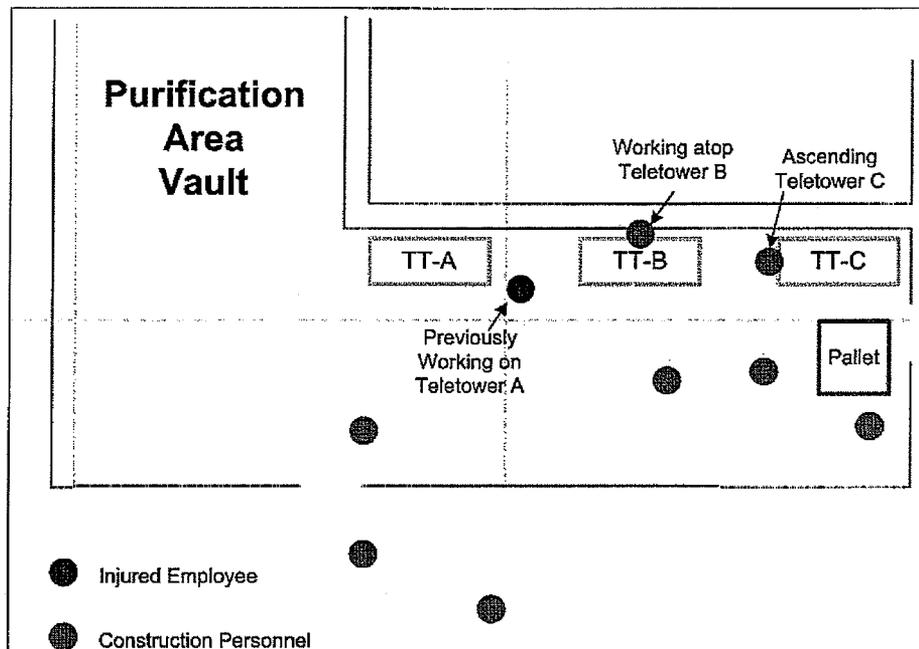
Figure 2-33: PAV Accident Scene Layout

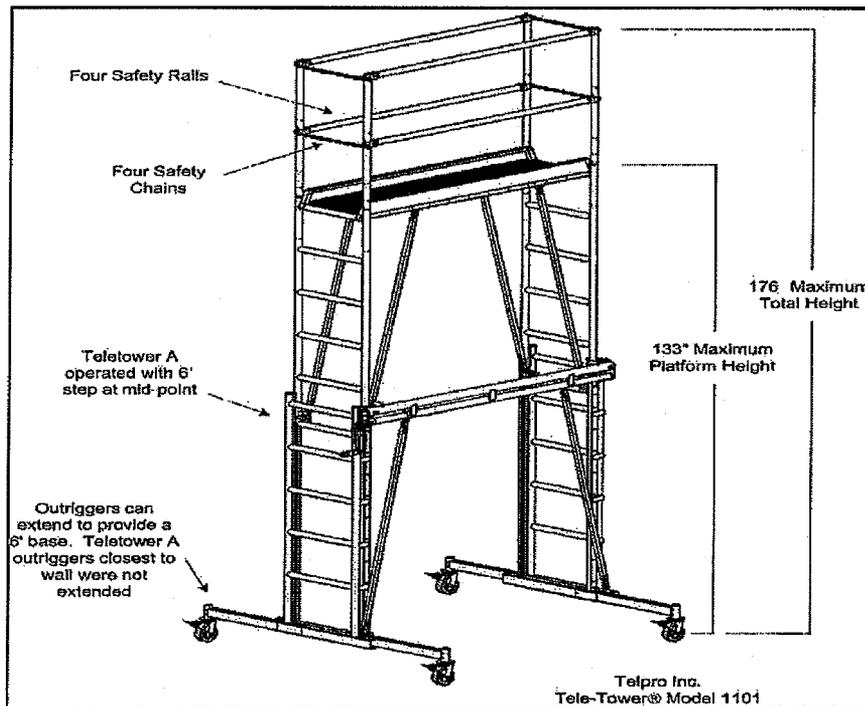
The Board examined Tele-Tower® "A" and noted the following:

Figure 2-44: Tele-Tower® "A"

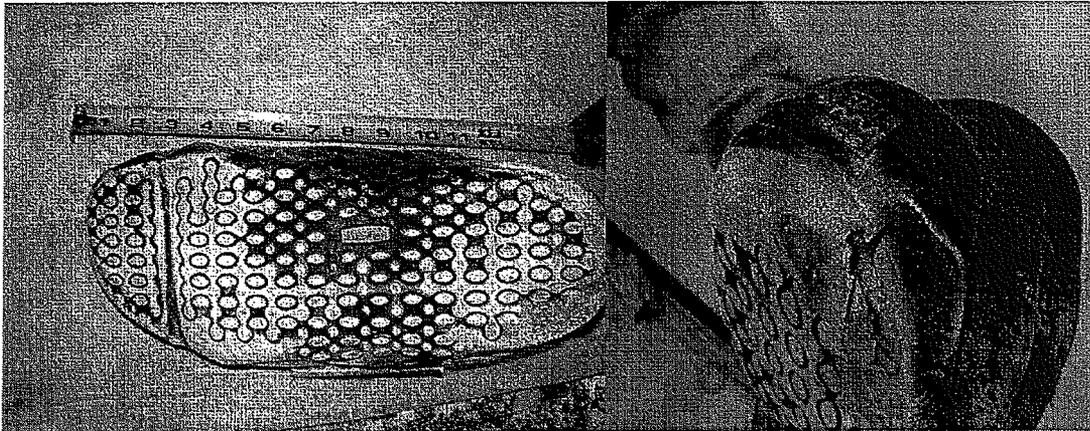
The Board examined the IW’s shoes and noted the following: The work shoes were worn and in questionable condition. Sides of the shoes were broken down. The right shoe had a piece of the heel missing and a slice mark and showed considerably more wear than the left. The uppers were constructed of soft leather and the soles were soft rubber. The shoes had no American Society for Testing and Materials (ASTM) or American National Standards Institute (ANSI) label.

Figure 2-55: Pictures of IW's footwear

The activity of the IW at the time of the injury only required sturdy work shoes/boots as indicated by the Work Package. The shoe has no ANSI or ASTM rating per manufacturer's information or found on the shoe itself. The soles of the shoes are soft rubber. But, most critical was the condition of the soles of these shoes; they showed obvious wear particularly on the right foot at the heel's right side a $\frac{3}{4}$ " split limiting the grabbing ability on that portion of the heel. The shoe does not have a definite heel separate from the sole or a raised heel distinct from the rest of the sole. In addition, previous activities by the majority of the work crew included potential material falling on toes and use of tools that should have required safety shoes, i.e. handling/using a reciprocating saw, handling wallboard pieces of 25 or more pounds at heights, and the need for good slip resistant footing to work in settled wallboard dust.

<p>The company construction management (CMP11-1.1, Rev 5) policy and the AHA failed to identify the appropriate work shoes for the activity</p> <p>The selection and condition of the IW's footwear was not appropriate for the work environment.</p>	<p>SRNS needs to evaluate and modify (with justification) construction management procedures and AHA process for specifying proper footwear for construction activities in consideration of the abrasion, impact hazards of falling objects, slip hazards and sole penetrations encountered during construction activities.</p> <p>SRNS need to ensure workers are complying with the requirements for proper footwear in construction areas</p>

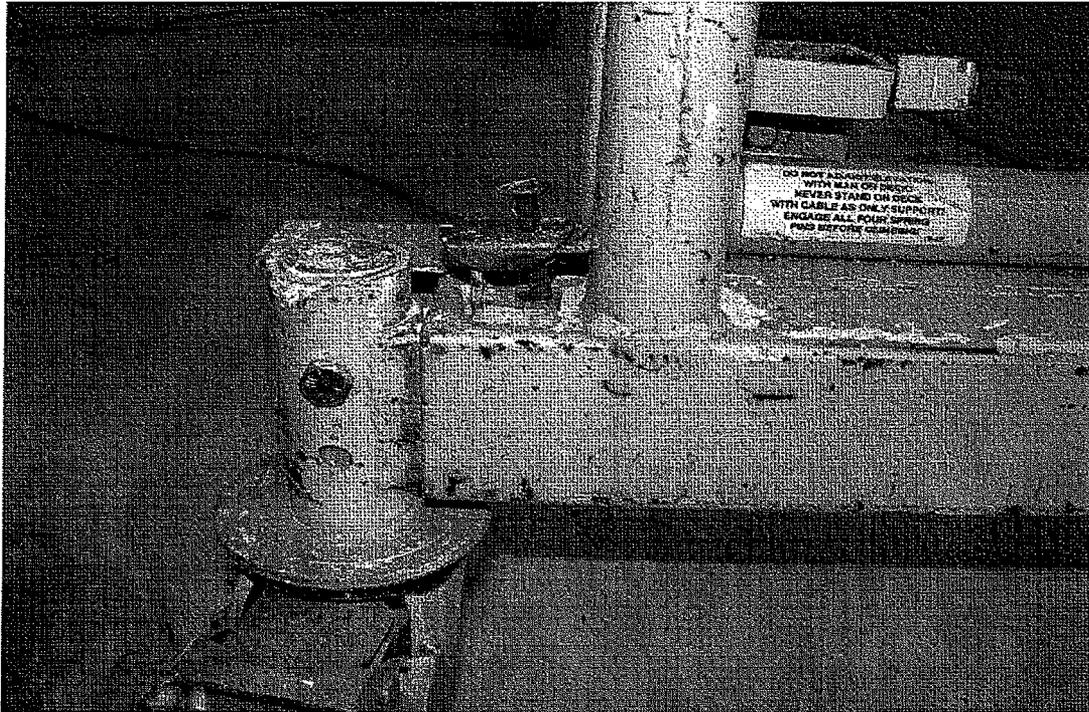
Deficiencies attributed to the Competent Person inspections of scaffold erection and/or modification and User inspections indicate that these were not completed as required at the beginning of shift, subsequent to a modification, or prior to use. The noted deficiencies include the loose wing nuts, non-uniform ladder spacing, locking pins not engaged for wall side outriggers (which were completely in to accommodate work close to the east wall), etc. Each of these issues places the stability of the Tele-Tower® in question. It should be noted that the narrowness of the Tele-Tower® work platform itself and its construction, as erected according to manufacturer's instructions, even when space allows for full outrigger extension, is not as stable as other available options.

Figure 2-66: Example of locking pin not properly engaged on Tele-Tower® B

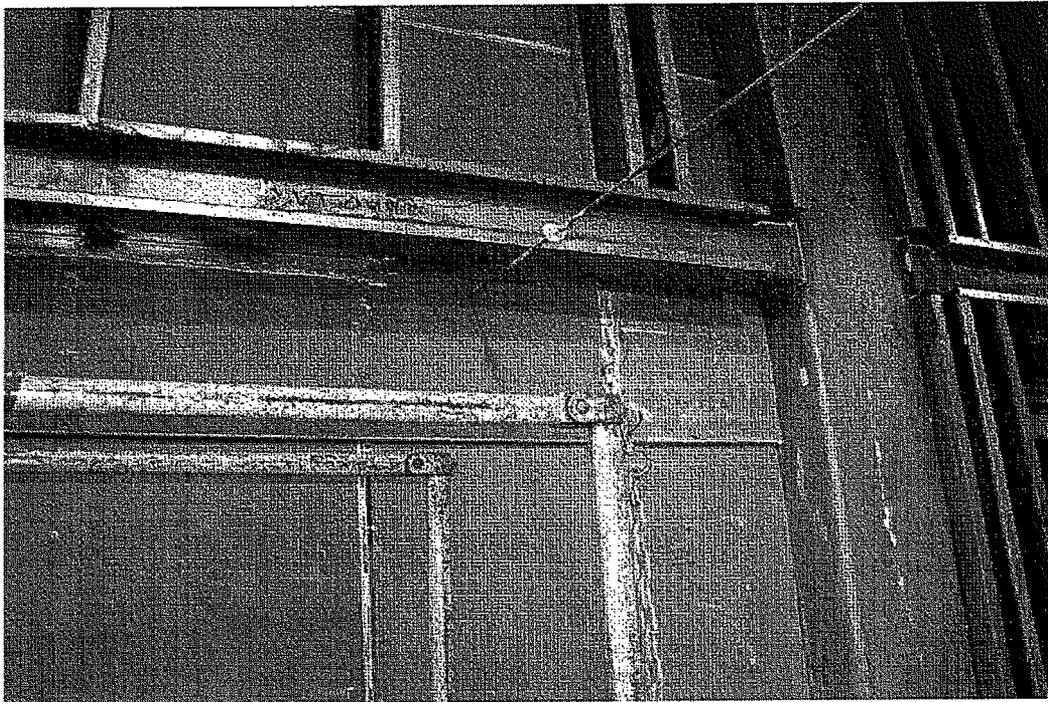
Figure 2-77: Cable near end of scaffold where IW fell
