## Safety Alert

# Radioactive Liquid Release from Drums

June 2011

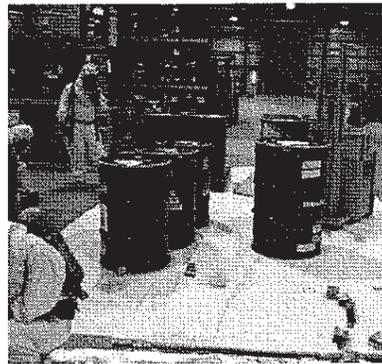
Drum pallet dethatched and leaking drum overpacked.

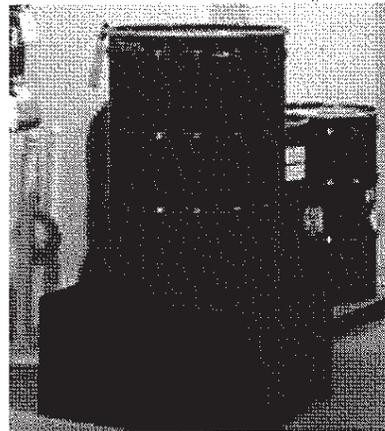
Overpacked drum stored on a spill pallet

1. Sites should develop a process to identify those drums with higher potential for leakage. Drums that may contain free liquids and/or damp materials should have the threat to the integrity of the drum assessed.
2. Each site should develop the capability to mitigate a leak from the drums identified as having higher potential risk. This should include drums in storage and in transit.
