**DOE Contract No. DE-CI0000004: 2014 South Fog Road Bridge Inspection Report**

Re: 2014 Inspection of South Fog Road  
Bridge at Piketon Gaseous  
Diffusion Plant

On May 19, 2014, Burgess & Niple, Inc. (B&N) performed a routine inspection of the South Fog Road Bridge located near the Gaseous Diffusion Plant complex near Piketon, Ohio.

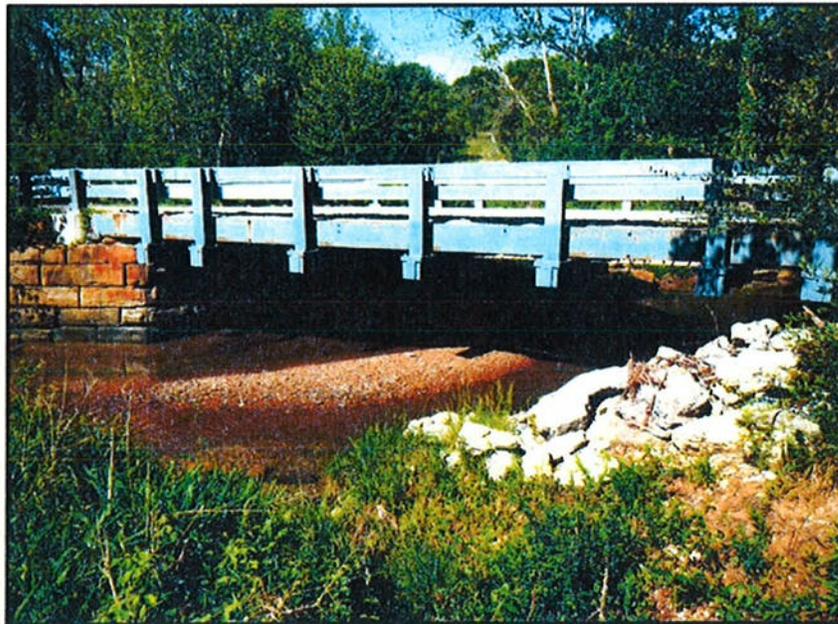
The bridge is rated poor based on the condition of the deck and substructure. The load postings and condition ratings have not changed since the 2013 inspection.

**Photo 1** – Elevation view looking southeast.

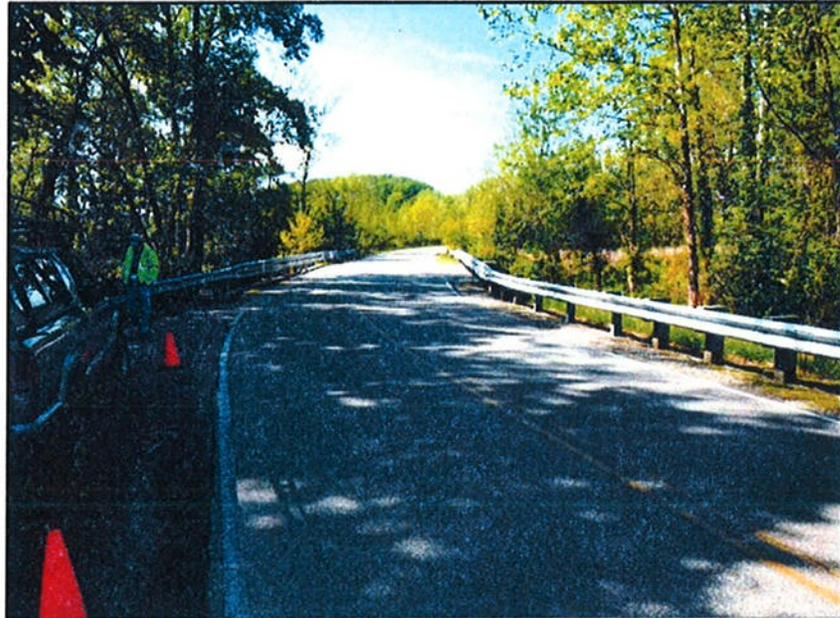
**Photo 2 – End view looking south.**

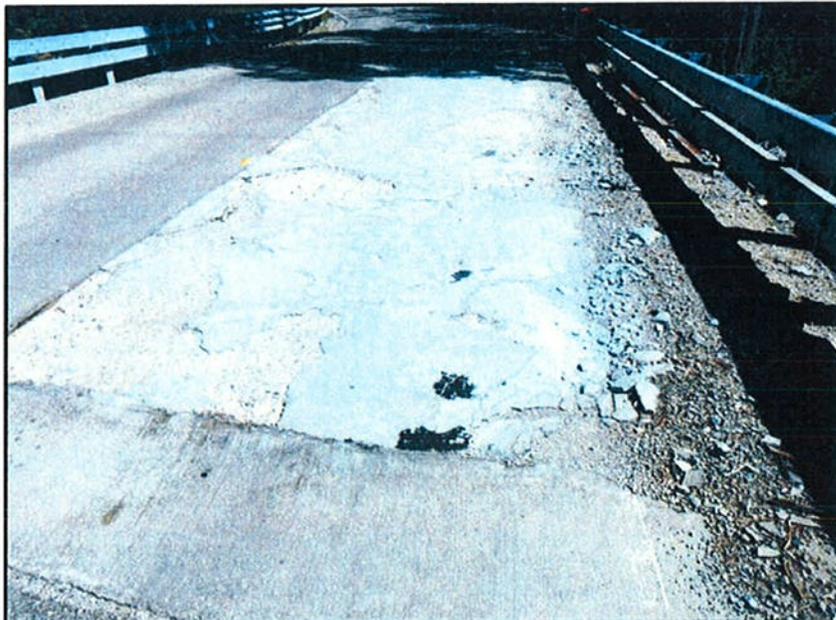
A thin epoxy concrete overlay wearing surface was installed in 2010 on the original portion of the deck to improve the riding surface; however, the new wearing surface has approximately 120 square feet of unsound and spalled epoxy concrete (an increase from 66 square feet in 2013) (Photo 3). The deteriorated wearing surface has exposed 2-inch deep potholes, producing an extremely rough riding surface. This deterioration is possibly the result of chloride contamination of the existing concrete due to application of deicing chemicals over the life of the bridge.

**Photo 3** – Looking north at the original portion of the deck in the northbound lane. Note the concrete wearing surface exhibits scaling and spalling in multiple locations.

- Patch areas of the northbound wearing surface which are spalled or delaminated. Monitor the newly placed and patched concrete wearing surface. When patching, remove all loose or unsound surfaces before placing new epoxy concrete. Due to the high probability of chloride contamination in the existing concrete, it is recommended that a full depth deck replacement be considered in lieu of patching. An alternative could be to replace the original structure with a pre-stressed concrete slab.

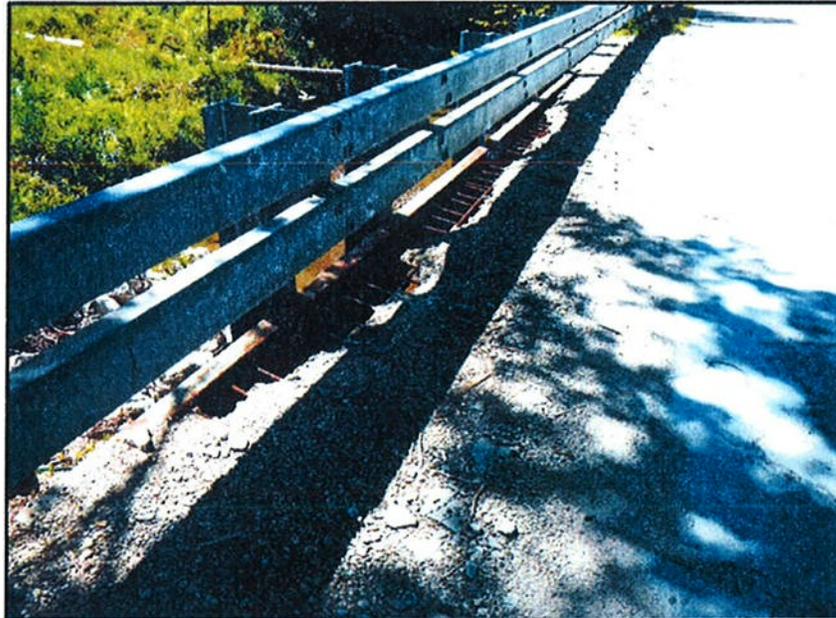
The east exterior 3-1/2 feet of the original deck did not receive the epoxy concrete overlay and still exhibits a full depth hole due to scaling concrete and a large accumulation of deck debris. The full depth hole along the

inside edge of beam 13 measures 26.5-foot long by 17-inch wide (an increase from 23-feet long by 9-inch maximum width in 2011 and 26 feet long by 13-inch maximum width in 2013) (**Photos 4 & 5**). The hole is encroaching into the roadway at this point. This deterioration is common for jack arch decks of this era and is most likely a result of freeze thaw damage from deck drainage penetrating the concrete. The accumulation of debris present along the edge of the roadway will continue to trap water and accelerate the deterioration of the deck. Consideration should be given to replacing the entire original deck. This will not only lengthen the useful life of the structure, but can raise the allowable truck loads, due to the reduction in dead load on the controlling original steel beams. A partial depth deck rehabilitation may result in accelerated deterioration of the existing concrete due to the probable high levels of chlorides in the existing concrete.

**Photo 4** – Looking southeast at the east edge of the deck. Note a 26.5-foot long by 17-inch maximum wide hole exists in the deck edge with exposed and corroding reinforcing steel.

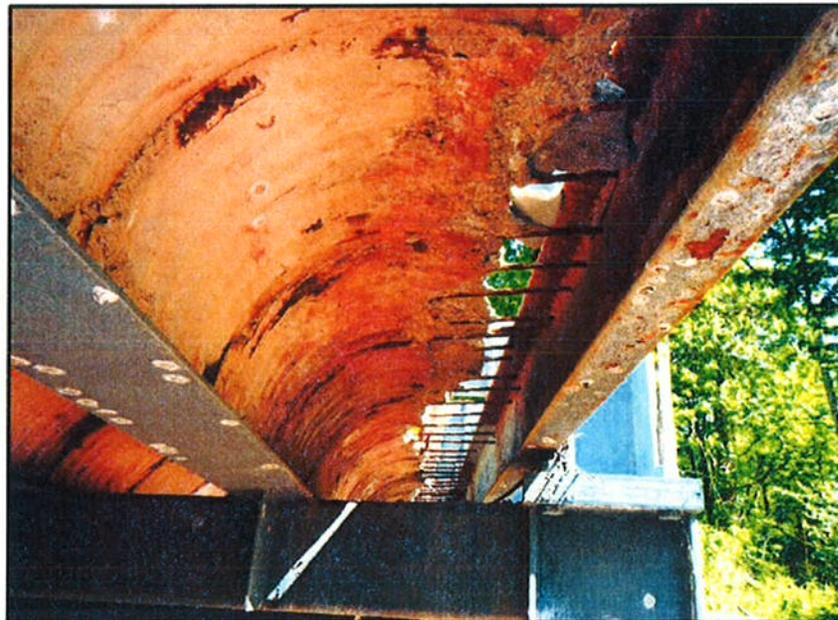
**Photo 5** – Looking up and north at the underside of the deck between beam 12 and the fascia channel beam along the east edge of the bridge. Note a 26-foot long by 13-inch wide hole exists through the deck.

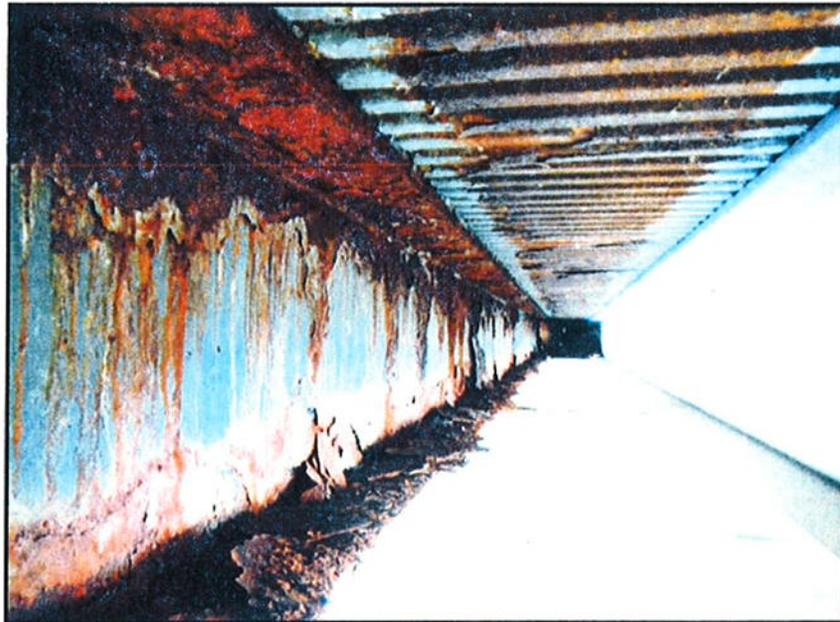
The steel beams in the widened portion of the bridge are in fair condition. Laminating corrosion noted on the west fascia beam has worsened since the 2013 inspection. Corrosion currently exists on both faces of the west fascia beam on the underside of the top flange, top of the bottom flange, and web. Section loss up to 1/8-inch deep was observed at several locations in the west fascia girder (**Photo 6**). The beam end at the north abutment for beam 1 also exhibits considerable laminating corrosion with up to 1/8-inch section loss to the beam web (**Photo 7**). The corrosion of the exterior beam is promoted by deck drainage passing over the edge of the bridge deck. A drip strip is absent from the edge of the deck allowing the drainage to run back to the beam, and the corrugated deck which is placed on top of the top flange allows the drainage to reach the inboard face of the beam.

**Photo 6** – Looking south along the exterior face of beam 1. Note the active laminating corrosion with section loss up to 1/8-inch deep on the flanges and web.

- Abrasively clean and paint the west fascia beam (beam 1).
- Repair the beam 13 bearing area at the south abutment. Remove all loose concrete, abrasively clean and paint the beam 13 channel, and place concrete up to the bottom flange of the channel. Dowel the new concrete into the existing masonry block.

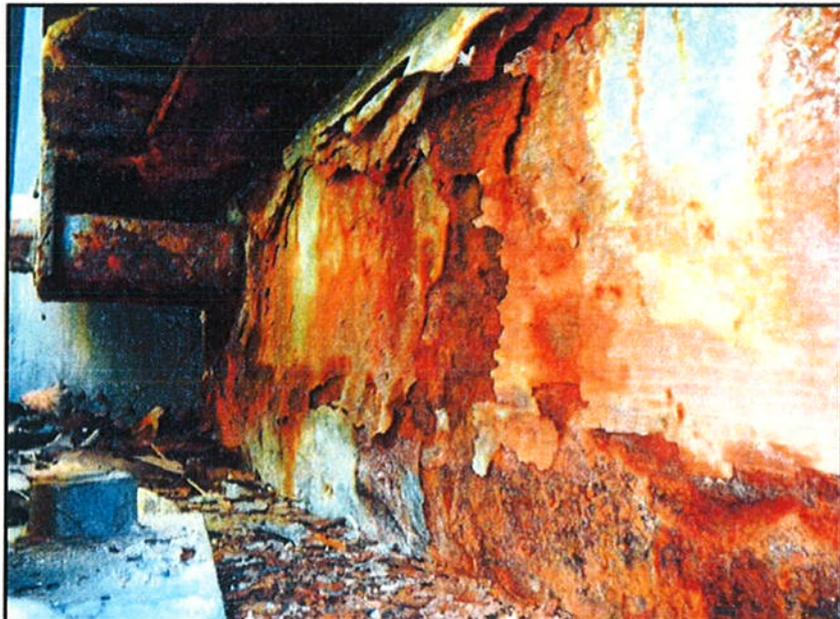
**Photo 7** – Looking north along the end of beam 1 at the north abutment. Note heavy laminating corrosion on the beam web with up to 1/8-inch section loss.

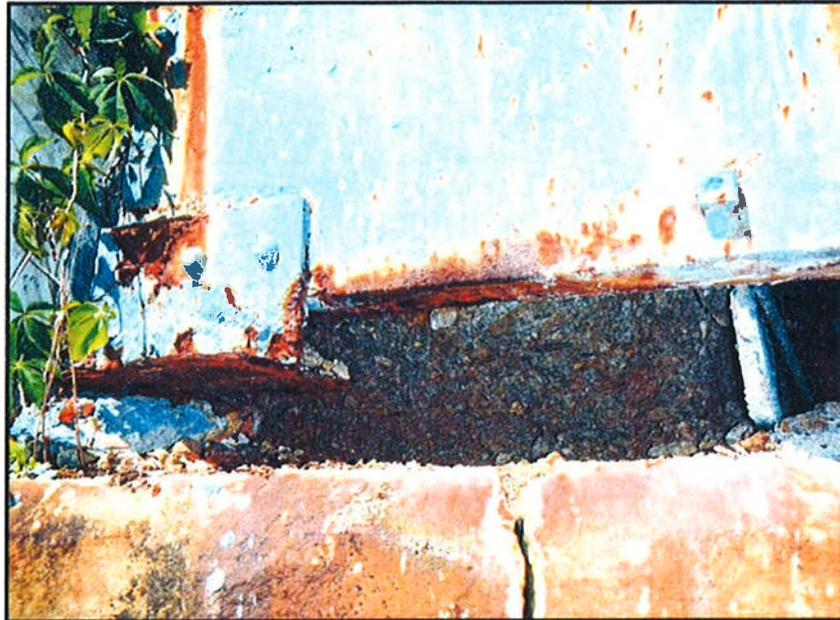
The east fascia beam bearing is severely undermined due to heavy spalling of the south abutment bearing seat (**Photo 8**). Approximately 10% of the bearing area still exists at this location. Due to high water events at this structure, moderate amounts of debris exist around many of the bearings for the widened portion of the structure at the north abutment.

**Photo 8** – Looking southwest at the east fascia beam at the south abutment. Note severe undermining of the bearing due to heavy spalling of bearing seat. The structural tee bearing assembly is also heavily deteriorated with active section loss.

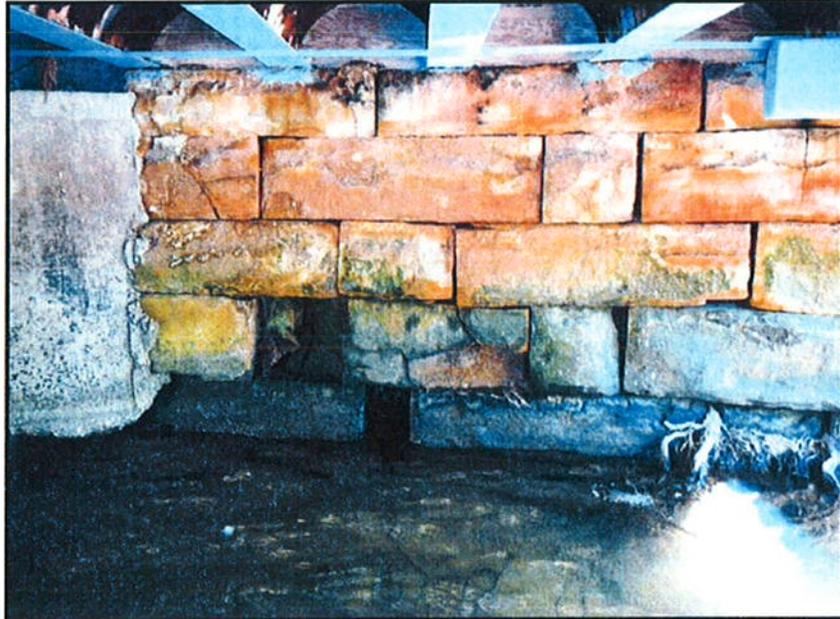
In the original portion of the substructure, many of the masonry blocks exhibit cracks and or missing stones. At the south abutment, 3/16-inch wide cracks exist under beams 8, 11, and 13 in the top course of masonry block. At the north abutment, one missing and one heavily cracked masonry block exists under beams 7 and 8 (**Photo 9**). Also at the north abutment, 1 1/8-inch maximum wide cracks exist in the second course of masonry blocks under beams 11 and 13 (**Photo 10**). The overall condition of the masonry blocks have not significantly changed since the 2012 inspection. No signs of rotation or settlement were noted within the masonry block substructure units.

**Photo 9** – Looking north at the masonry block abutment under beam 8 at the north abutment. Note small missing block and heavily cracked and deteriorated block above.

- Continue to monitor the cracked and missing masonry blocks at the abutments, especially under beams 7 and 8 at the north abutment. Consider doweling into the existing bedrock and masonry and pour concrete to encompass the area of distressed masonry.

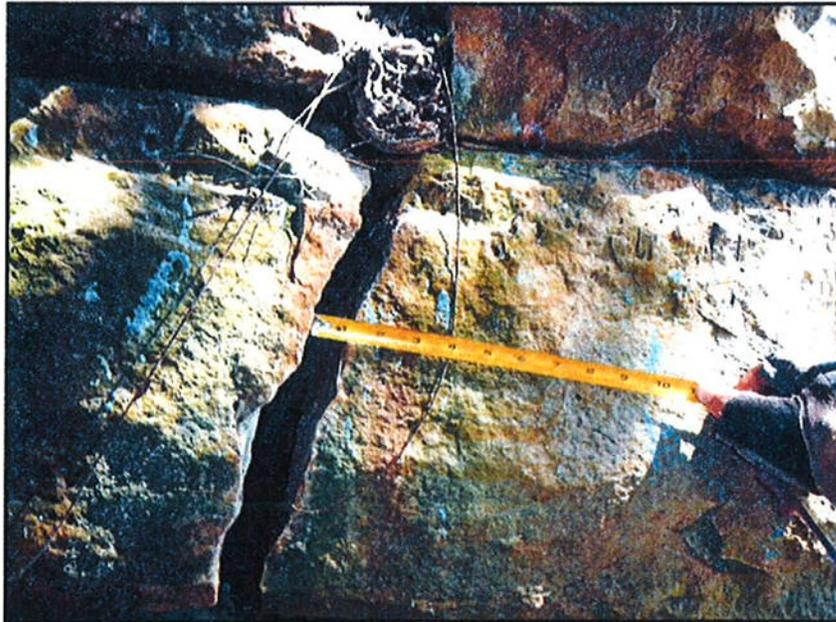
**Photo 10** – Looking north at the second course of masonry block under beam 13. Note 1 1/8-inch wide crack in masonry block.

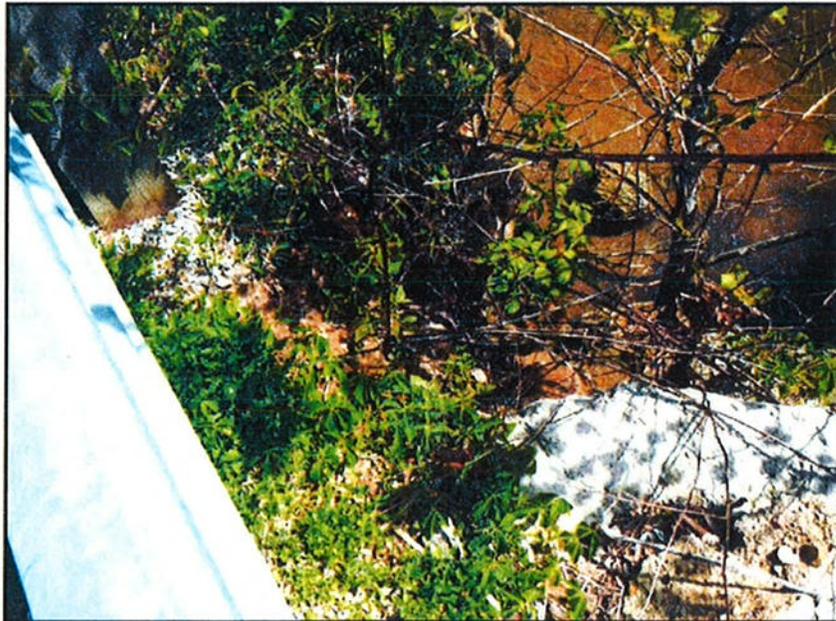
Erosion was noted behind both the southeast and northwest wingwalls. The erosion to the embankment behind the northwest wingwall exposes the top five feet of the rear face of the wingwall. The erosion behind the southeast wingwall creates a steep slope which is 4-feet wide by 6-feet deep by 6-feet long (**Photo 11**). These conditions do not appear to have changed significantly since the 2013 inspection.

**Photo 11** – Looking down and northeast at the embankment behind the southeast wingwall. Note steep erosion to embankment.

- Fill the eroded areas behind the southeast and northwest wingwalls with crushed aggregate and protect the aggregate with riprap.
- Remove debris from the north abutment beam seats.

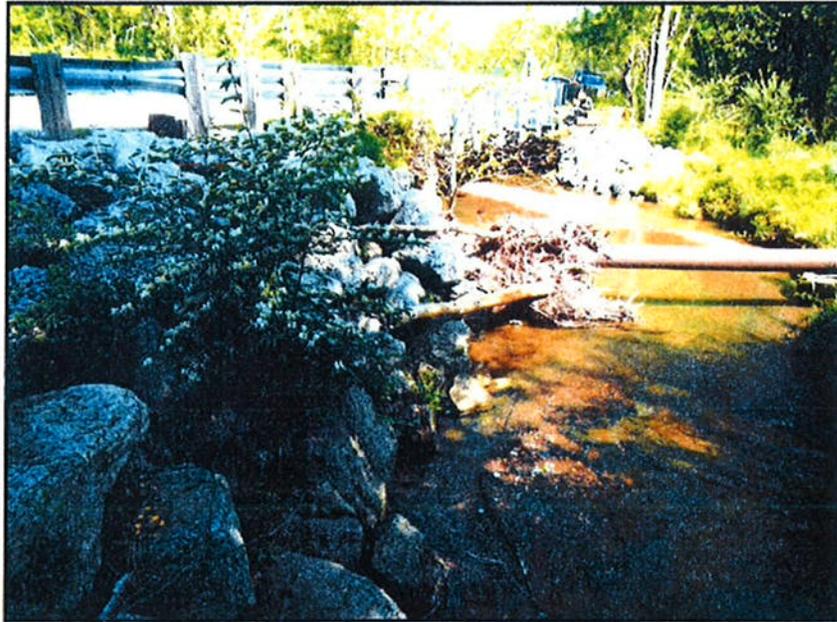
since the 2012 inspection. A pipe exists across the channel just upstream of the bridge. Large debris has become trapped against the pipe directing the flow further east (**Photo 12**).

**Photo 12** – Looking southeast at the upstream channel. Note pipe crosses channel. Also note debris build up along east end of pipe crossing.

- Remove the pipe crossing the channel upstream of the bridge and the ensnared drift.
- Add Z-board or chevron type bridge end markers at all four corners of the bridge.

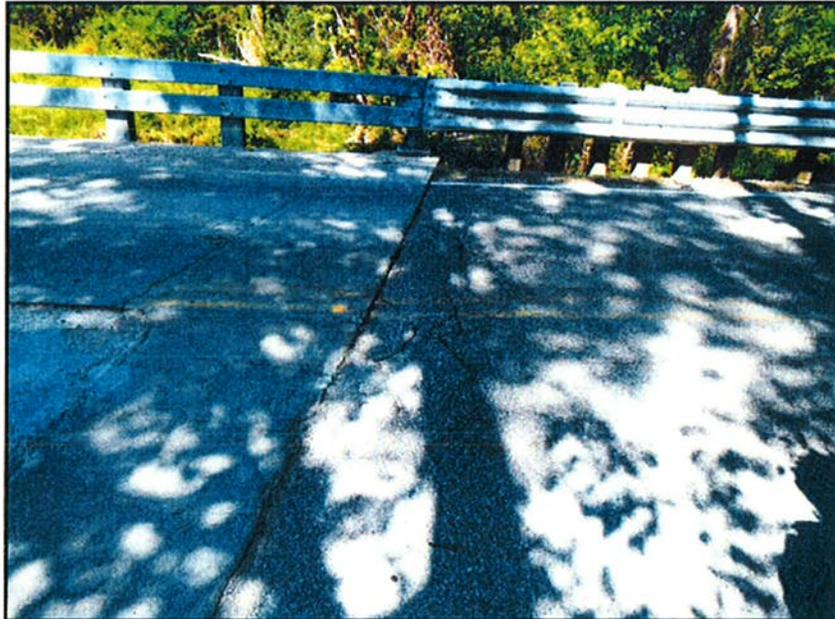
The approaches are paved with asphalt and are in poor condition. Approach pavement settlement exists in the north and south approach pavements adjacent to the abutments with significantly larger settlement noted in the north approach. A 1 1/2-inch maximum vertical offset with unsealed cracks were noted in the north approach pavement. This condition appears to have worsened by 1/4 inch in depth since the 2013 inspection (**Photo 13**). The settlement most likely is due to the excavation and installation of concrete pavement added at both ends of the bridge during the railing installation. This condition causes an extremely rough transition onto the bridge and increases the impact loads on the bridge. The unsealed cracks allow deck drainage to infiltrate the approach embankment, promoting further settlement of the pavement. Unsealed cracks are typical along the centerline in both asphalt pavements.

**Photo 13** – Looking west at approach pavement adjacent to the north abutment. Note: cracking and settlement of approach pavement.
