# **Petrographic Analysis of Concrete Core Samples from Saltstone Disposal Unit #6 at the Savannah River Site, Aiken, SC**

Robert D. Moser, E. Rae Gore, and Kyle L. Klaus

March 2016

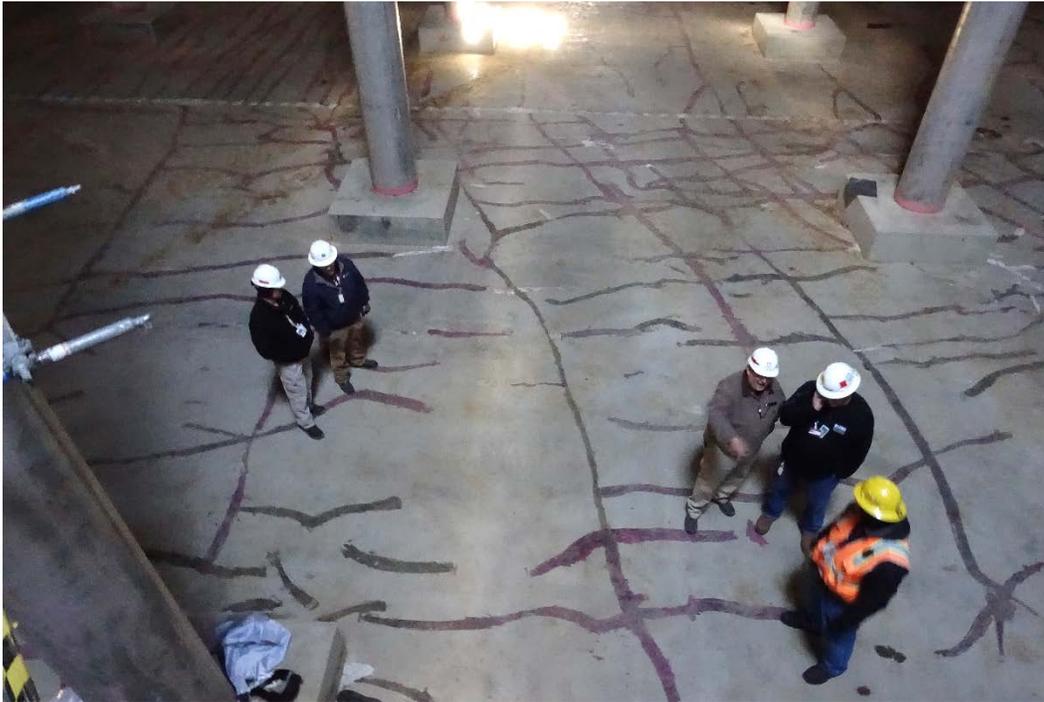
observed is shown in Figure 2. Map cracking was observed throughout the slabs but appeared to be more severe in locations with additional restraint. This was especially true for slabs placed later during construction such as Floor 8 which was the final placement which was restrained on two edges (location of Core #5).

Figure 2. Photograph taken from scaffolding above floor showing locations of cracks. Map cracking observed throughout the slabs highlighted here in purple due to epoxy which was gravity fed into cracks. Two columns can be observed at the top of the picture as well as a construction joint line which has been pressure injected with epoxy.

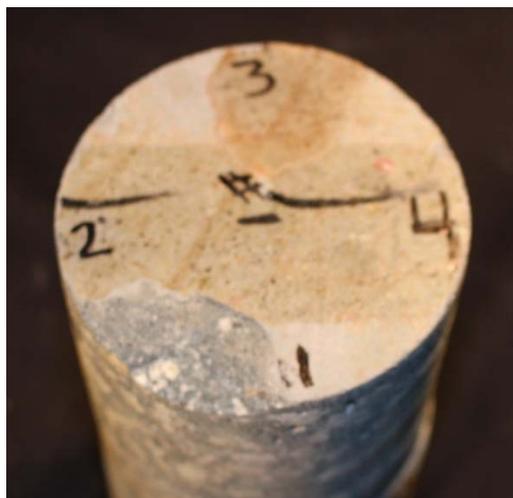
The typical as-received core from location #1 is shown in Figure 3. A small crack was observed on the top surface of the core (see Figure 4). This crack had been coated by the gravity fed epoxy (see Figure 5). The core was 9.5 cm diameter and 21.6 cm long. One piece of reinforcing steel was included in the core at a depth of approximately 10 cm. The reinforcing steel was located at the edge of the core and was not examined further due to potential degradation in bond during coring. No segregation was observed on the surface of the core and the aggregates and voids appeared to be uniformly distributed. No honeycombs or entrapped air voids were noted.

Figure 4. Top of Core Sample #1.

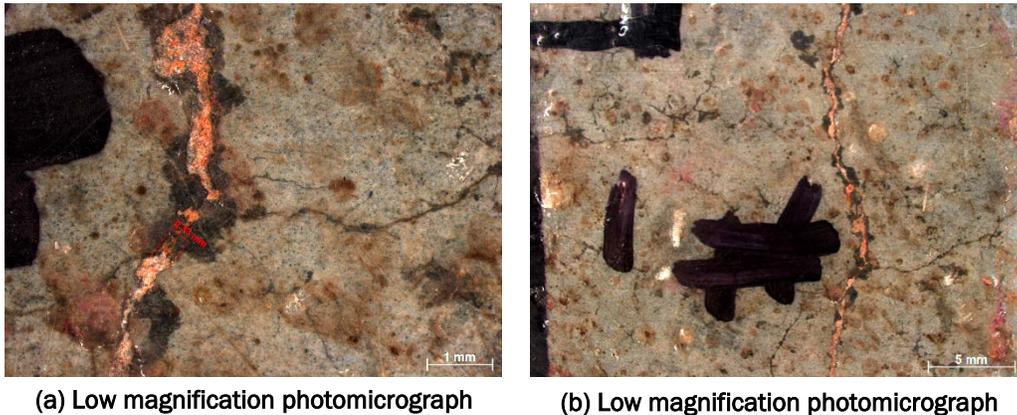
Figure 5. Micrographs of crack observed on top of Core Sample #1

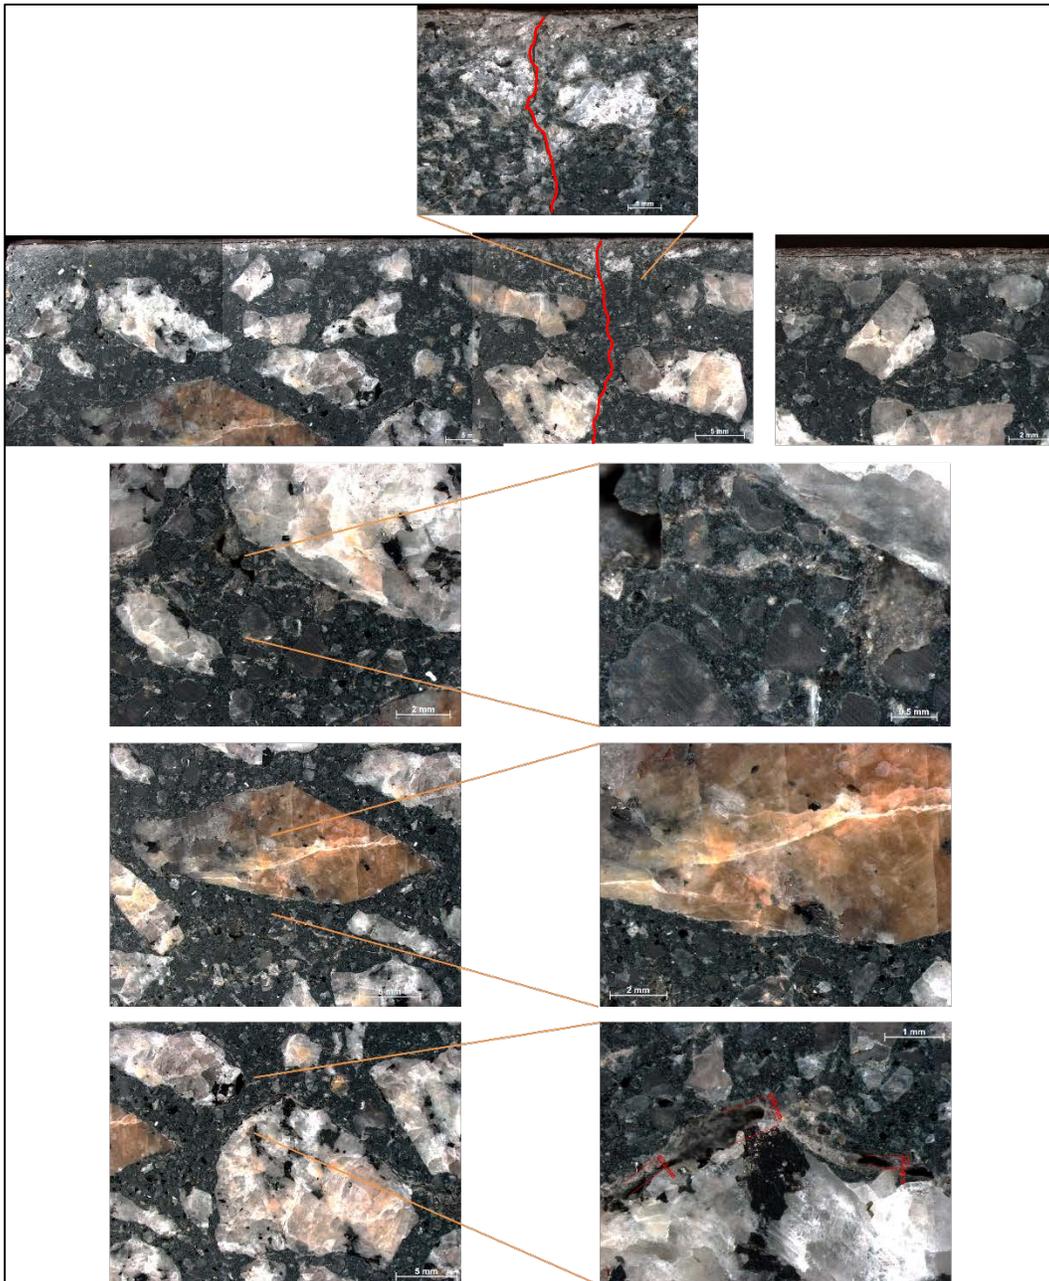
A low magnification montage of images of the sectioned surface of the concrete and the crack observed in Core Sample #1 is shown in Figures 6 and 7. This crack extended to approximately 5 cm in depth into the concrete with a width of approximately 100  $\mu\text{m}$  near the top surface of the crack (see Figure 8). At depths greater than 5 cm, the crack width reduced significantly and appeared to have largely healed itself. Smaller microcracks observed in the paste fraction of the concrete with widths of single to tens of  $\mu\text{m}$  appeared to be self-healed. Examples of these self-healed cracks are shown in Figure 9 and 10. These cracks exhibited white colored mineral deposits likely formed by additional hydration of unhydrated cement grains, precipitation of calcite, or supplementary pozzolanic reactions from unreacted supplementary cementitious materials (e.g., slag, fly ash). Examples of cracks intersecting coarse aggregates were observed (see Figure 7). This suggests that cracking occurred at later ages when concrete had gained sufficient tensile strength to cause cracking of the aggregate rather than debonding around aggregate interfaces and in the paste fraction of the concrete. No vertical displacement was observed between the faces of the crack. The paste appeared as anticipated, with a greenish color in interior portions of the concrete associated with the high slag content of the concrete. Although it was difficult to identify with optical microscopy, epoxy was observed within the crack to depths in excess of 5 cm from the top surface of the concrete (see Figure 11). Overall, the concrete appeared to be of competent quality with no additional defects other than the crack running vertically through the slab. Smaller microcracks in the near surface concrete and

throughout the paste appear to have largely self healed. Discoloration of the concrete was observed to a depth of approximately 1 mm although it was unclear whether this was caused by oxidation of slag in the paste, carbonation of the concrete, or exposure to acidic water.

Figure 6. Montage of optical micrographs of top six inches of concrete from Core Sample #1. Crack in top approximately 5 cm of concrete appears to thin and self heal at greater depths.

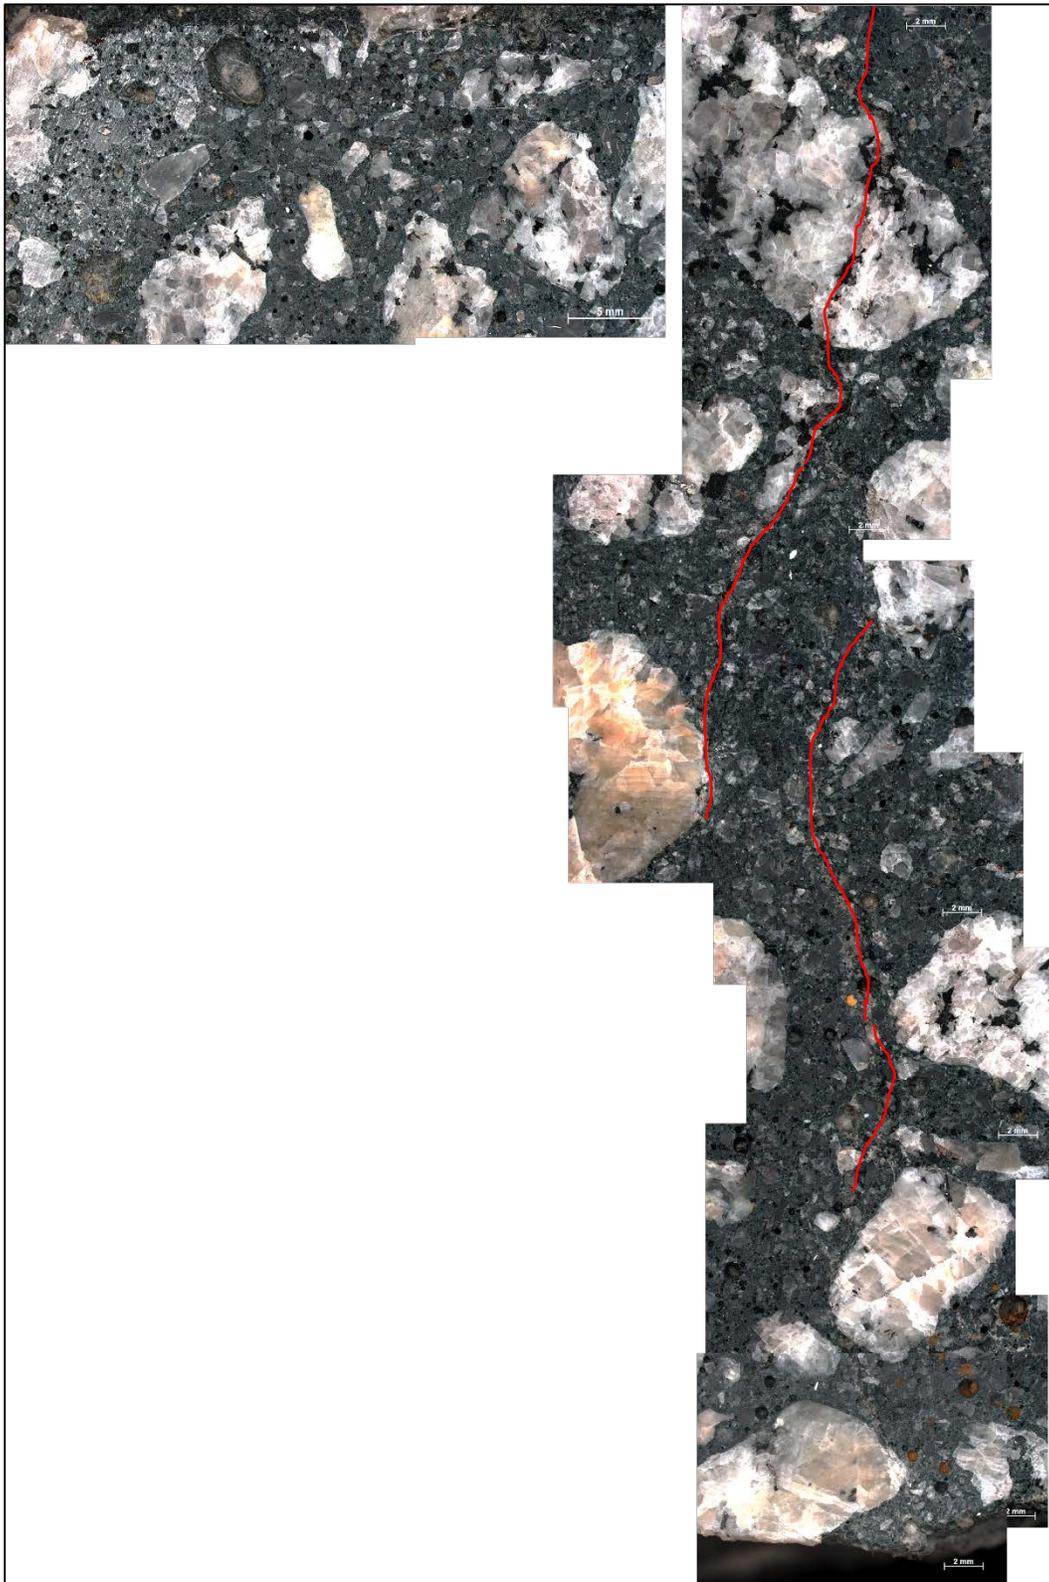
Figure 7. Montage of optical micrographs of bottom 15 cm of concrete from Core Sample #1. Crack observed but faint and appears to be self healed.

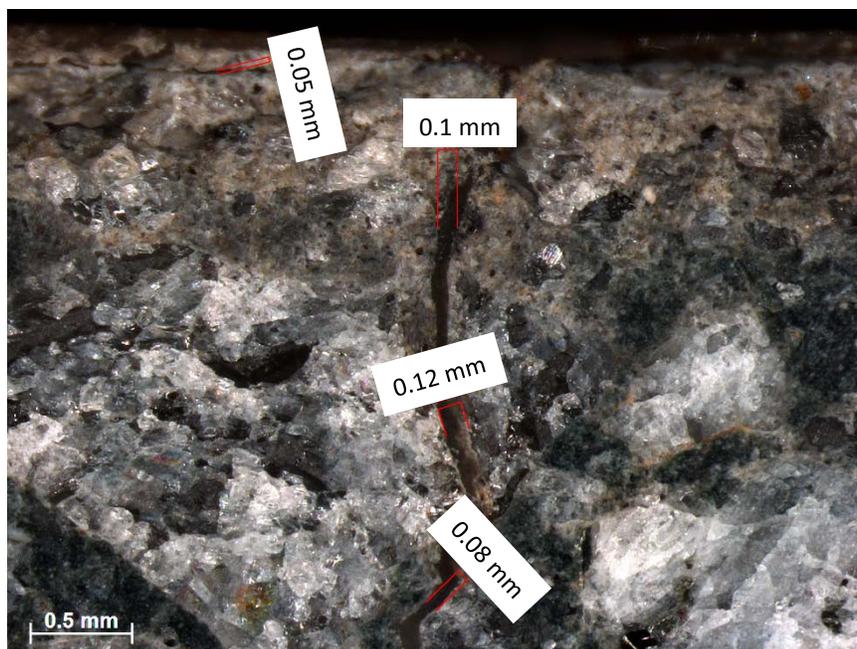
Figure 8. Crack adjacent to top surface of concrete with crack widths of approximately 0.1 mm.

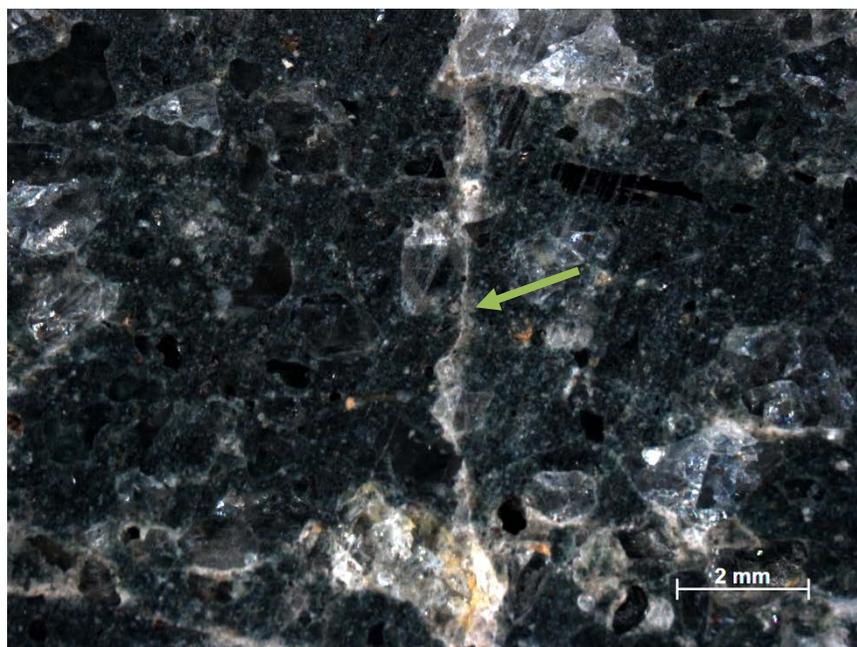
Figure 9. Self healed crack in paste fraction of concrete.

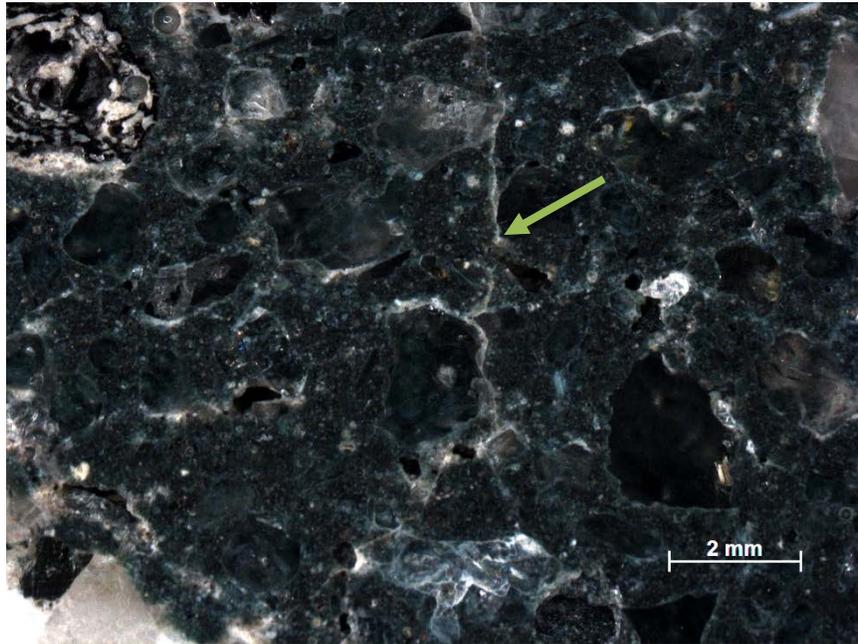
Figure 10. Self healed crack in paste fraction of concrete.

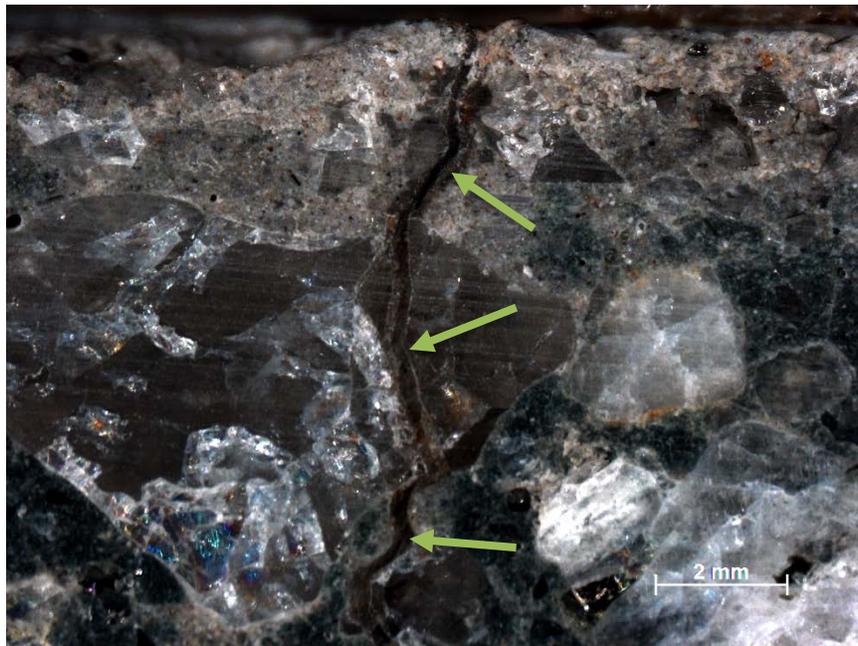
Figure 11. Brown colored epoxy observed to impregnate crack adjacent to concrete surface.

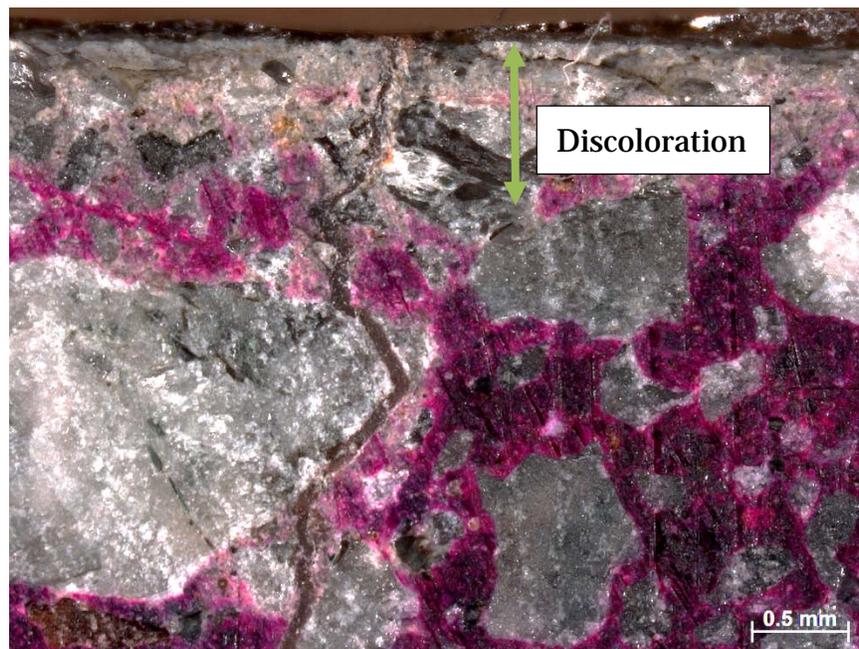
Figures 12 and 13 show examples of pink staining observed following the application of the pH indicator solution. No staining was observed in the top approximately 1 mm of concrete. Within the concrete, staining was observed adjacent to the crack face and epoxy impregnating the crack. Discoloration of the paste in the near surface of the concrete was associated with some reduction in pH and this is likely due to carbonation and anticipated based on the age of the concrete and its low buffering capacity. Discoloration on the faces of the crack does not appear to be associated with a pH reduction and therefore is likely associated with oxidation of the slag-rich paste rather than carbonation and or acid attack of the concrete.

Figure 12. Staining of paste with pH indicator solution evidencing low pH of near surface concrete but no effect on inner concrete with staining observed adjacent to crack and epoxy in the crack.

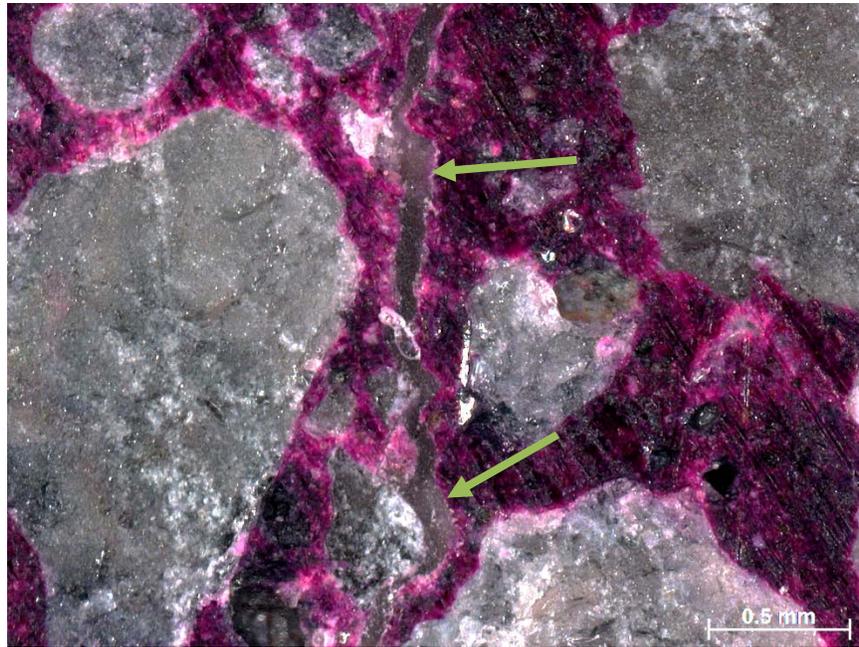
Figure 13. Staining of paste indicating high pH adjacent to crack and epoxy within the crack.

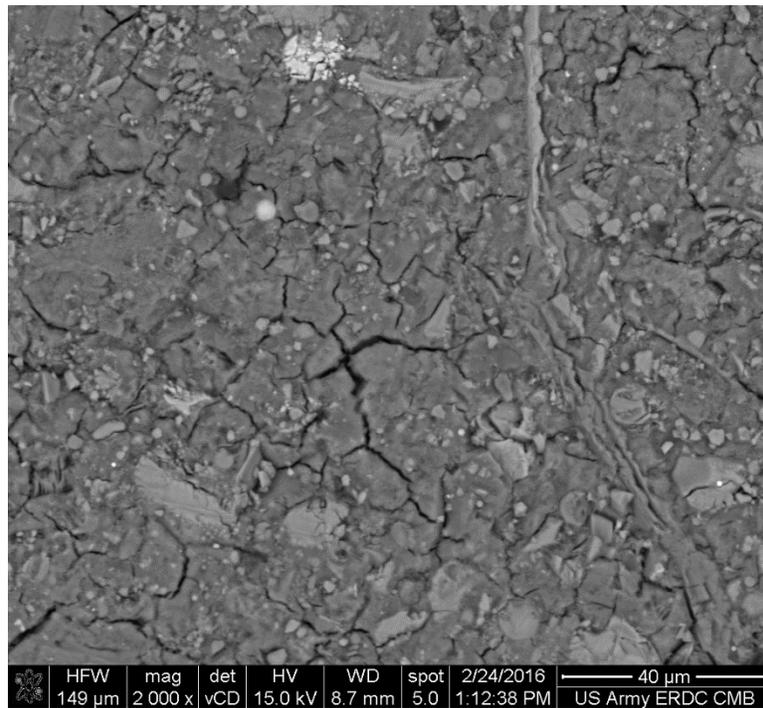
Figure 16. Distributed microcracking observed in paste.

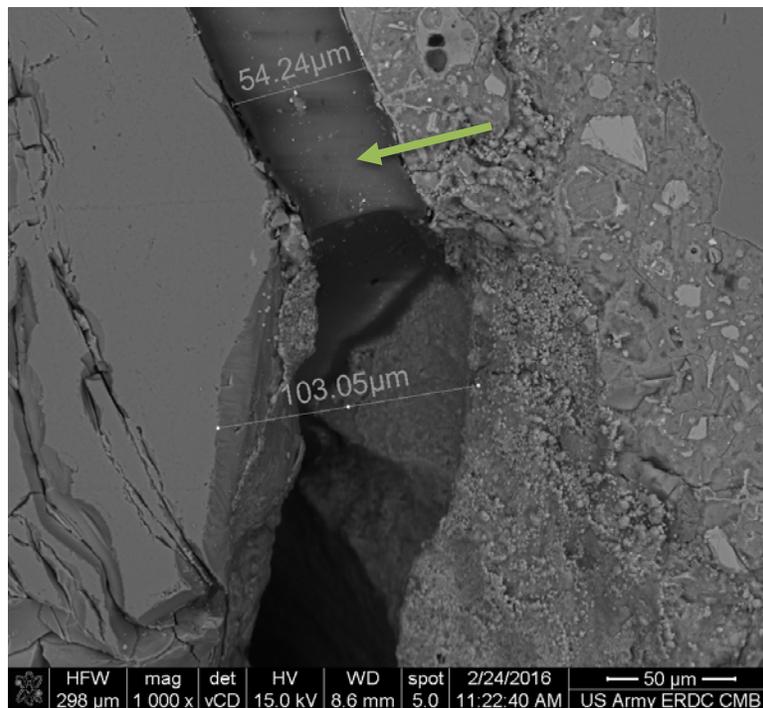
Figure 17. Crack at interface with coarse aggregate with epoxy infilling top portion of crack with 54  $\mu$ m width but with the crack voided in the larger 103  $\mu$ m wide cracked area. Epoxy noted by green arrow.

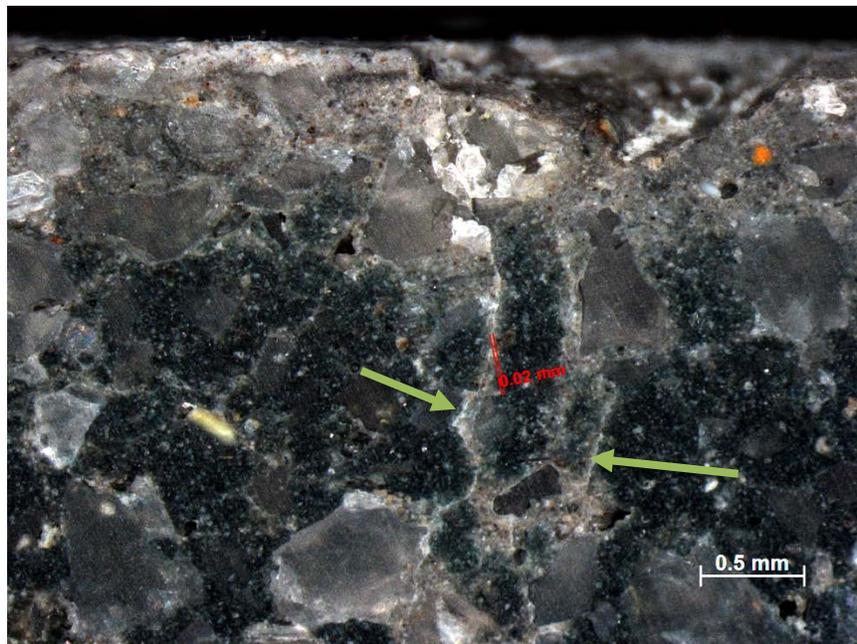
Figure 21. Microcracking in near-surface concrete with white colored infilling from mineral self healing of cracks.

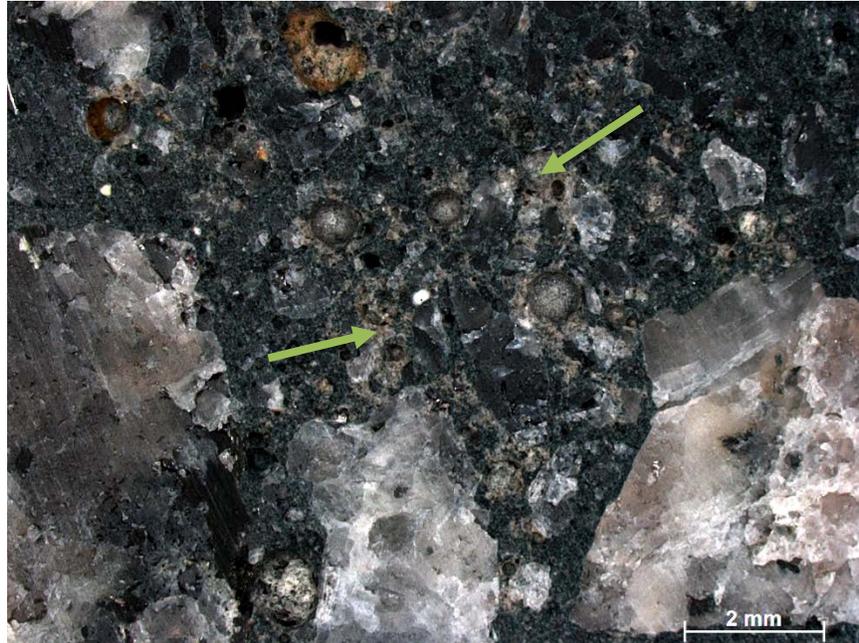
Figure 22. Typical paste microstructure. Spherical air voids observed throughout the paste. Sparse regions of gray / taupe colored poorly reacted paste noted by green arrow.

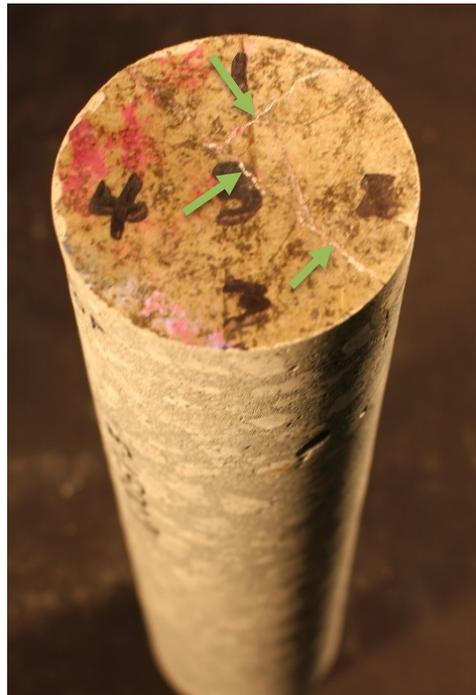
The typical as-received core from location #3 is shown in Figure 23. A small crack was observed on the top surface of the core (see Figure 24). This crack had been coated by the gravity fed epoxy. The core was 7 cm in diameter and 30.5 cm long. No segregation was observed on the surface of the core and the aggregates and voids appeared to be uniformly distributed. No large honeycombs or entrapped air voids were noted.

Figure 24. Top surface of Core Sample #3 with crack location noted.

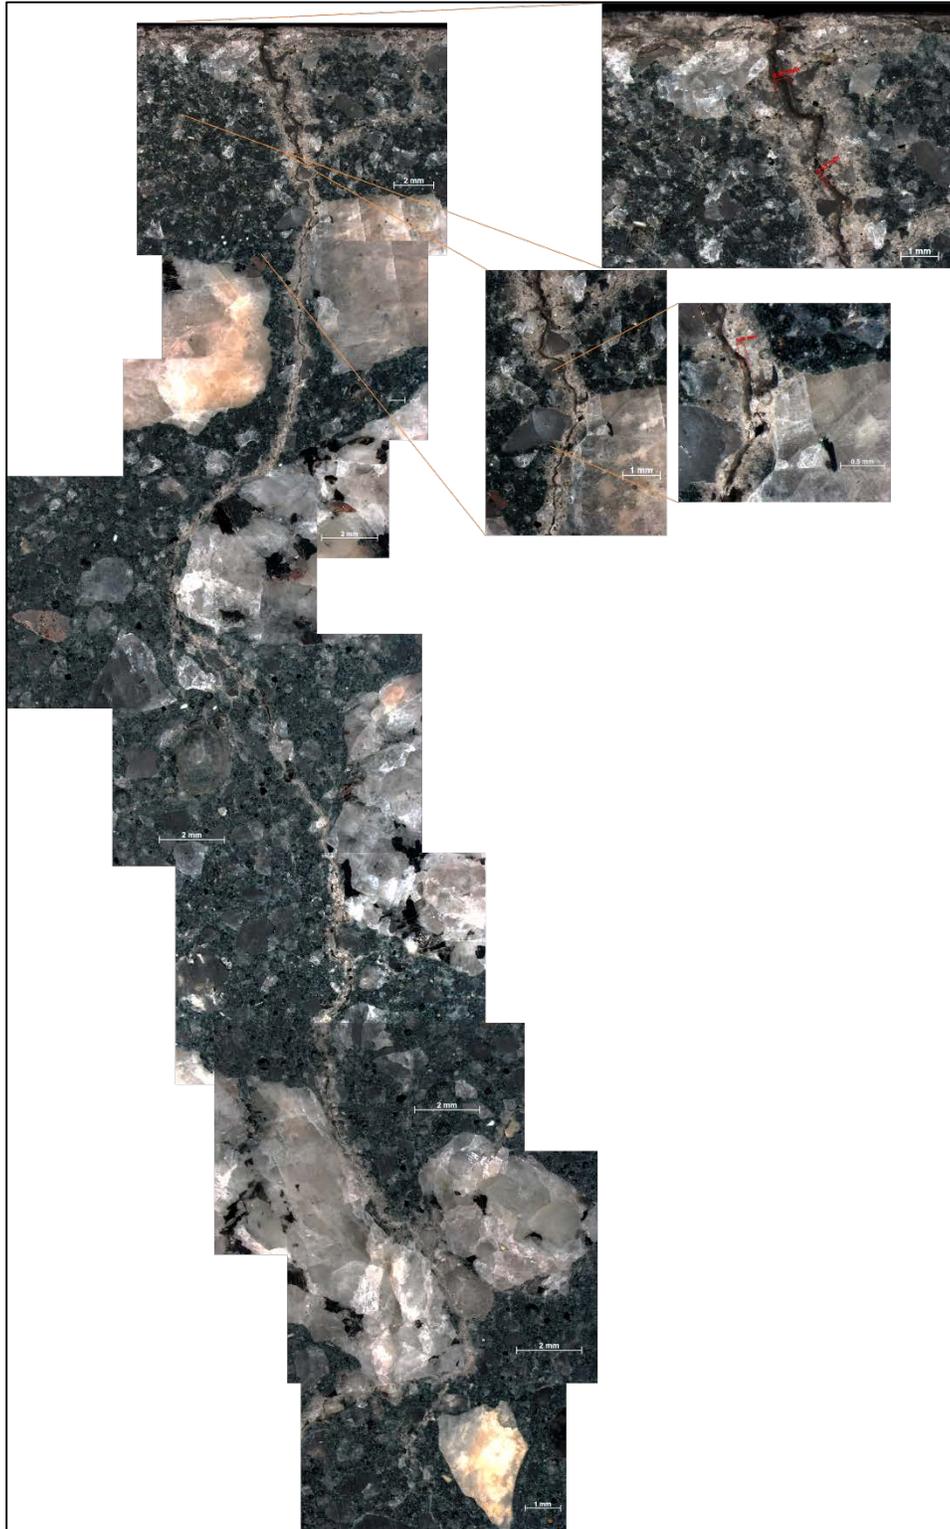
A low magnification montage of images of the sectioned surface of the concrete and the crack observed in Core Sample #3 is shown in Figures 25 and 26. Crack widths in the first two inches of concrete ranged from 0.1 to 0.2 mm in width (see Figure 27). Smaller microcracks observed in the paste appeared to be self healed with mineral infilling of cracks (see Figure 28). Cracks were noted to sparsely intersect with coarse aggregates (see Figure 26). This suggests that cracking occurred at later ages when concrete had gained sufficient tensile strength to cause cracking of the aggregate rather than debonding around aggregate interfaces and in the paste fraction of the concrete. Higher magnification imaging of the primary crack observed in the core indicated successful infilling of the crack with full infilling of the crack itself and coloring of the faces of the crack likely associated with epoxy impregnation of the paste. An example of this successful infilling is shown in Figure 29. No vertical displacement was observed between the faces of the crack. The paste appeared as anticipated, with a greenish color in interior portions of the concrete associated with the high slag content of the concrete. Overall, the concrete appeared to be of competent quality with no additional defects other than the crack running vertically through the slab.

Figure 25. Low magnification montage of the crack observed in the top 15 cm of concrete from Core Sample #3. The crack extended the full length of the core with discoloration observed at the top surface and inner faces of the crack. Infilling of epoxy observed in the crack.

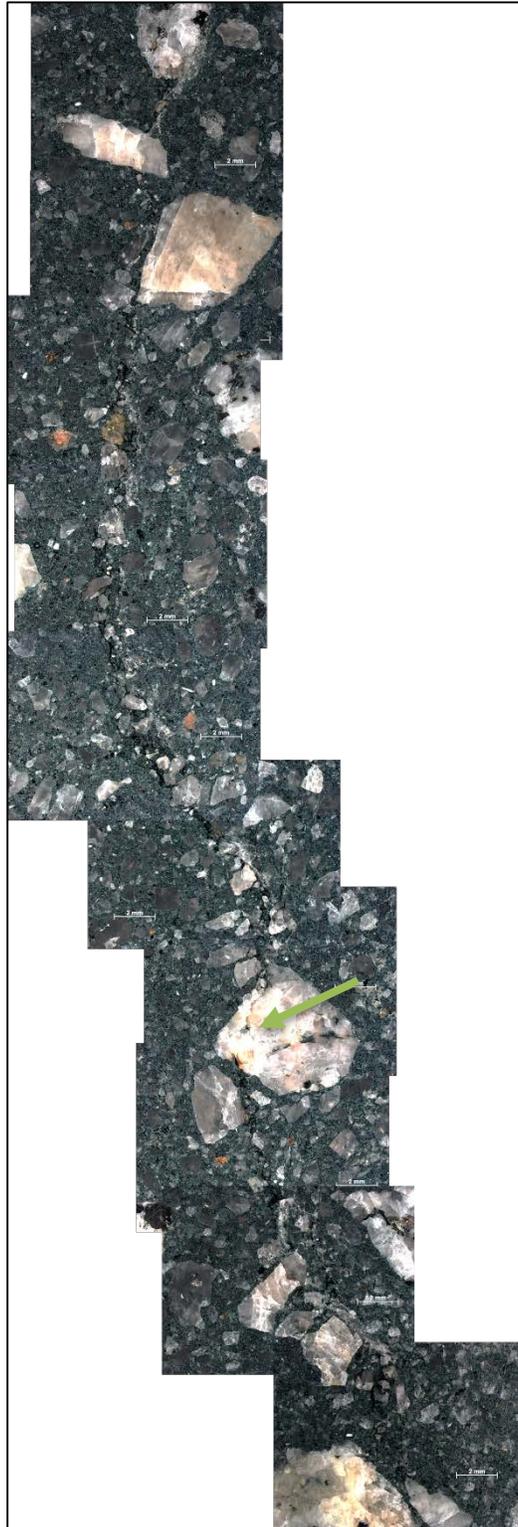
Figure 26. Low magnification montage of crack through the bottom portion of Core Sample #3. Crack intersecting coarse aggregate noted with green arrow.

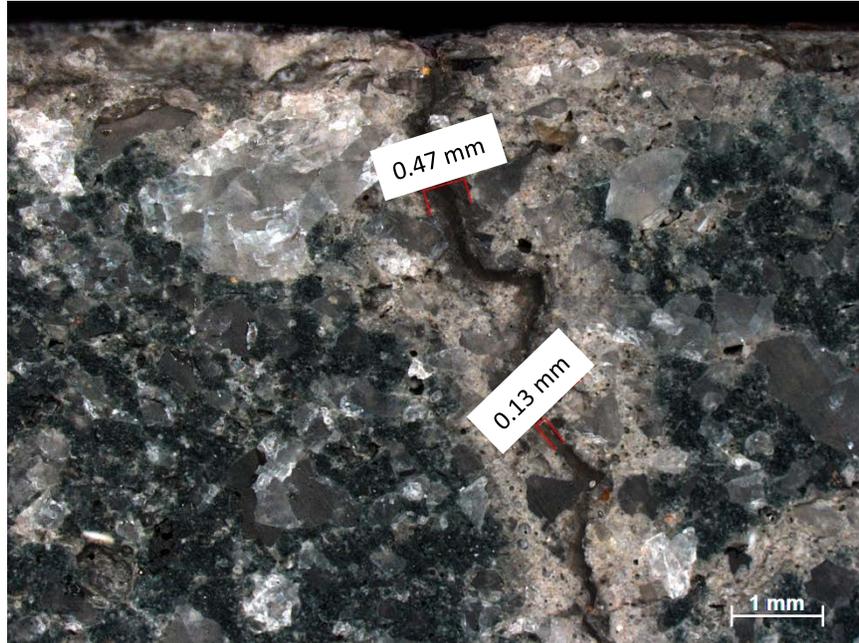
Figure 27. Low magnification image of crack adjacent to surface. Discoloration of concrete observed in top approximately 2 mm of concrete as well as down the length of the crack. Crack widths range from 0.1 to 0.2 mm.

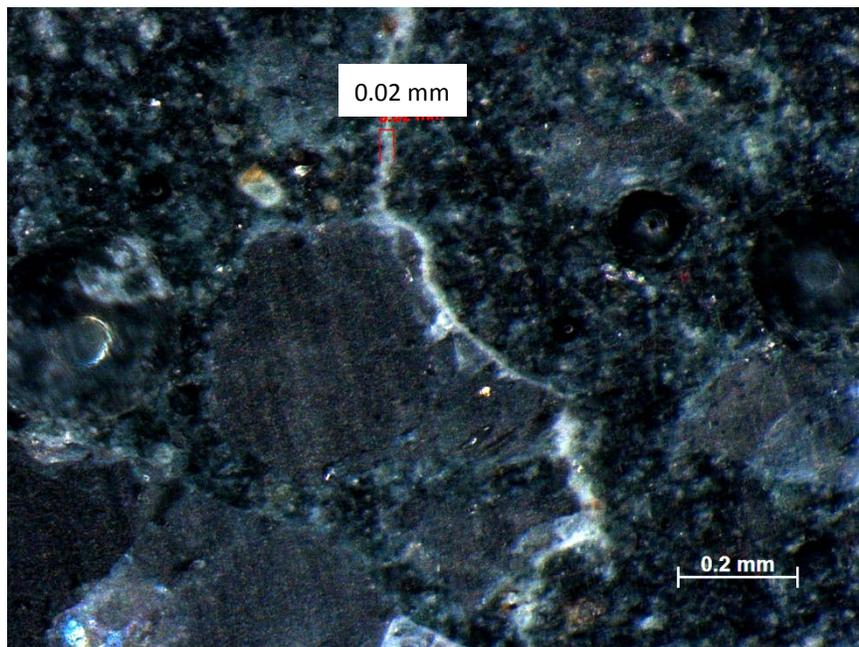
Figure 28. Microcracks in paste fraction of concrete with mineral infilling of crack and self healing.

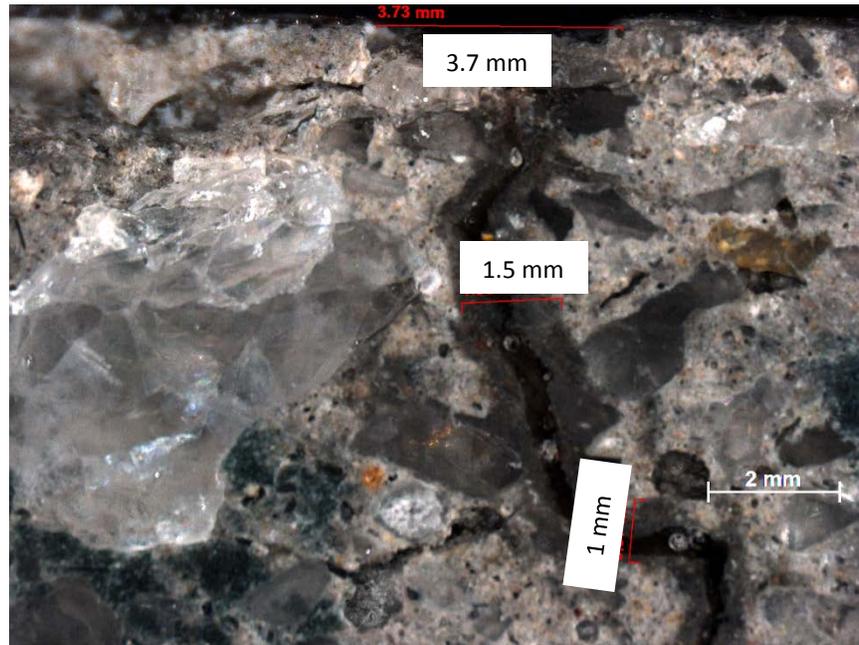
Figure 29. High magnification image of epoxy infilling of crack. Epoxy appears to successfully infill the crack to multiple inches in depth. Discoloration of the faces of the crack was also observed resulting from impregnation of the adjacent paste with epoxy. Discoloration of the paste was also observed at the concrete surface and down the length of the crack.

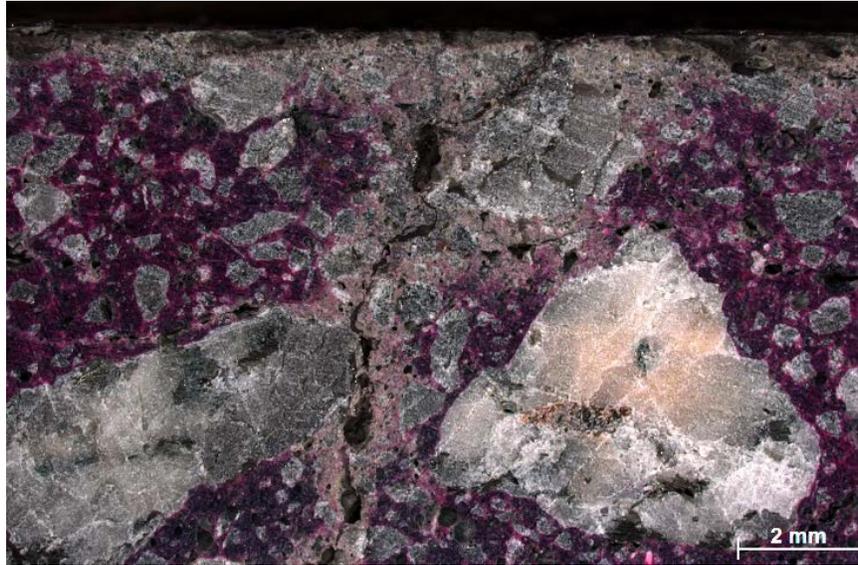
Figures 30 and 31 show examples of pink staining observed following the application of the pH indicator solution. No staining was observed in the top approximately 1.5-2 mm of concrete. Within the concrete, staining was observed adjacent to the crack face and epoxy impregnating the crack. Discoloration of the paste in the near surface of the concrete was associated with some reduction in pH and this is likely due to carbonation and anticipated based on the age of the concrete and its low buffering capacity. Discoloration on the faces of the crack does not appear to be associated with a pH reduction and therefore is likely associated with oxidation of the slag-rich paste rather than carbonation and or acid attack of the concrete.

Figure 30. Photomicrograph of concrete following application of pH indicator solution. No staining observed in near surface concrete. Minor staining observed on faces of crack. Strong staining observed in paste fraction.

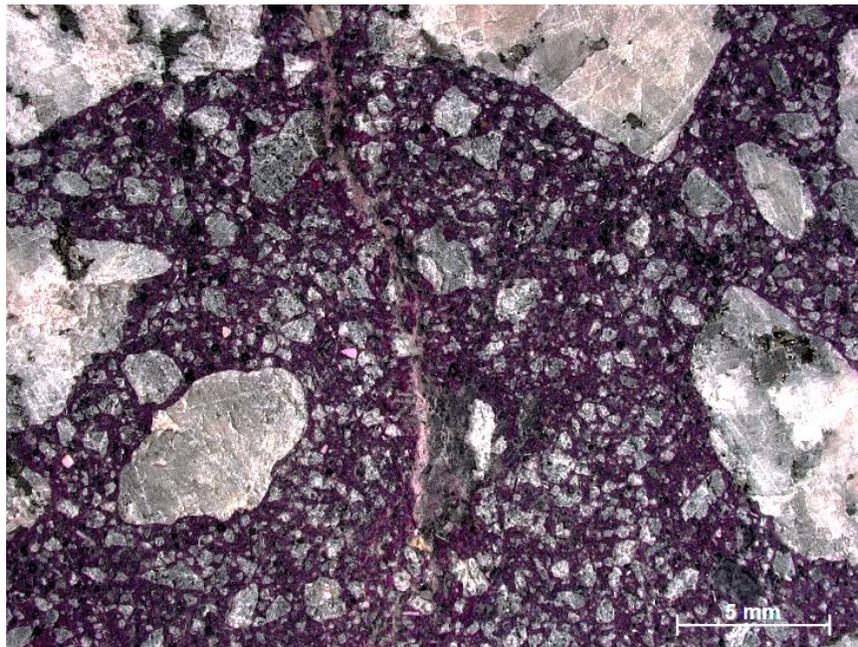
Figure 31. Strong staining of concrete with pH indicator solution completely to faces of crack, indicating that discoloration at face of crack is not associated with a reduction in pH.

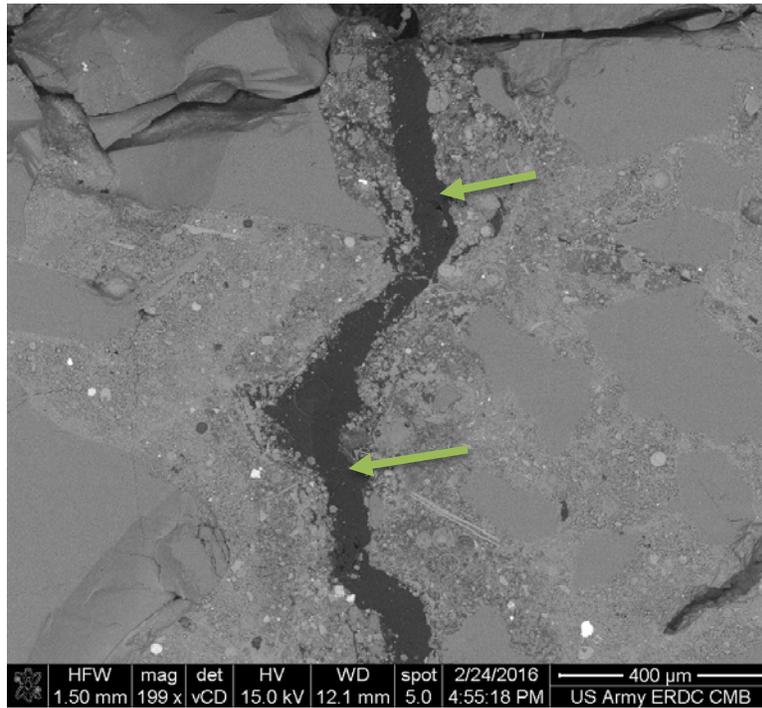
Low magnification montage images of the concrete microstructure including the crack adjacent to the surface and at a depth of approximately 7.5 cm are shown in Figures 32 and 33, respectively. Epoxy infilling within the crack in Core Sample #3 was very successful, with full infilling of the crack, no voids observed, and strong adherence to the faces of the crack, likely imparting water tightness to this crack. Higher magnification imaging of the polished paste microstructure indicated anticipated phases similar to those observed in Core Sample #1 when examined using SEM. An example of the microstructure observed at higher magnification is shown in Figure 34. Unreacted fly ash, slag, and cement particles were observed with the fly ash particles being spherical in shape and unreacted cement and slag particles being angular. Smaller silica fume particles were observed as sub-micron sized spheres distributed throughout the paste. The paste appeared to be dense and near full reaction, with minimal porosity. The water-to-cementitious materials ratio appeared to be less than 0.40 based on the minimal porosity observed. At higher magnification, distributed microcracking was observed which is likely due to shrinkage (drying or autogenous).

Figure 32. Vertical crack through Core Sample #3 with infilling of the crack with epoxy.

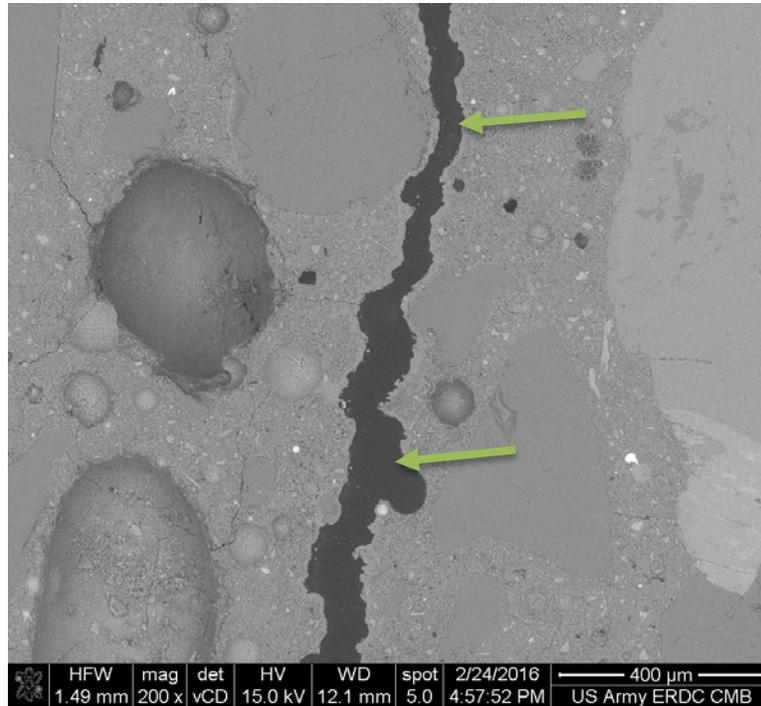
Figure 33. Vertical crack through Core Sample #3 at depth of approximately 7.5 cm with full infilling of crack with epoxy.

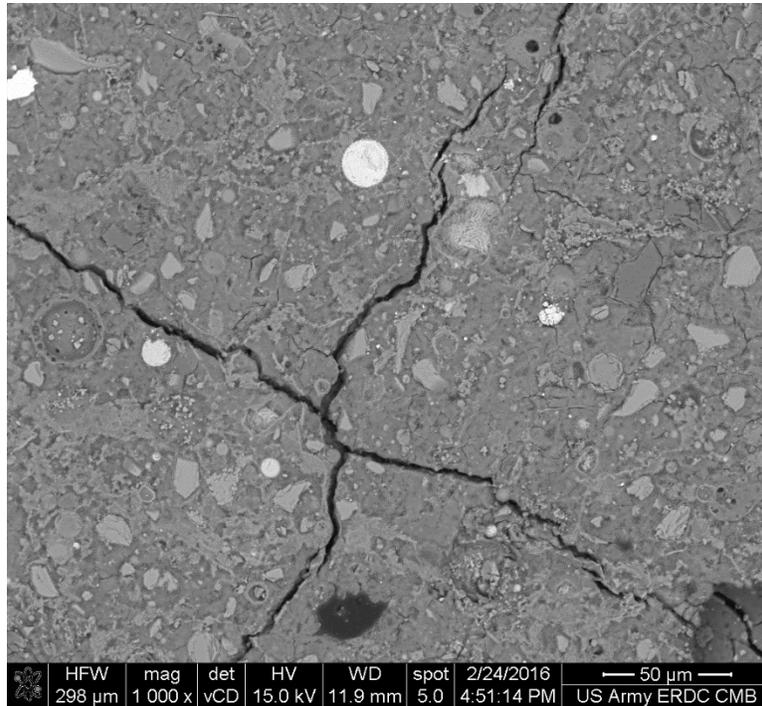
Figure 34. Typical paste microstructure with microcracking observed. Larger spherical particles associated with unreacted fly ash. Larger angular particles

associated with untreated cement and slag. Very dense hydrated cement paste microstructure with minimal porosity.

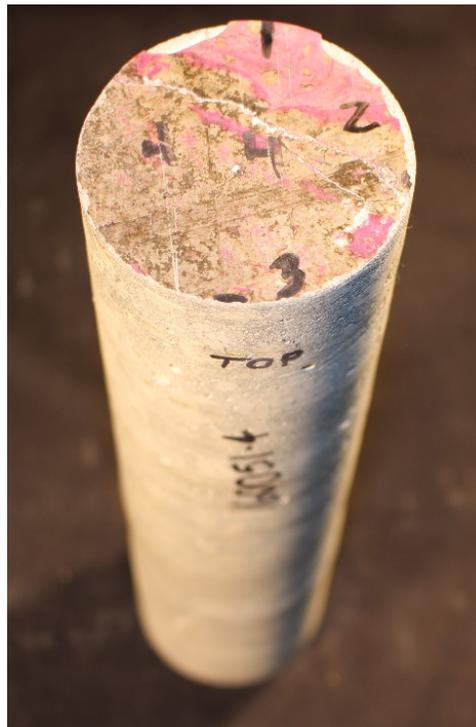
The typical as-received core from location #4 is shown in Figure 36. A small crack was observed on the top surface of the core (see Figure 37). This crack had been coated by the gravity fed epoxy. The core was 7 cm in diameter and 30.5 cm long. No segregation was observed on the surface of the core and the aggregates and voids appeared to be uniformly distributed. No large honeycombs or entrapped air voids were noted.

Figure 37. Top surface of core sample #4.

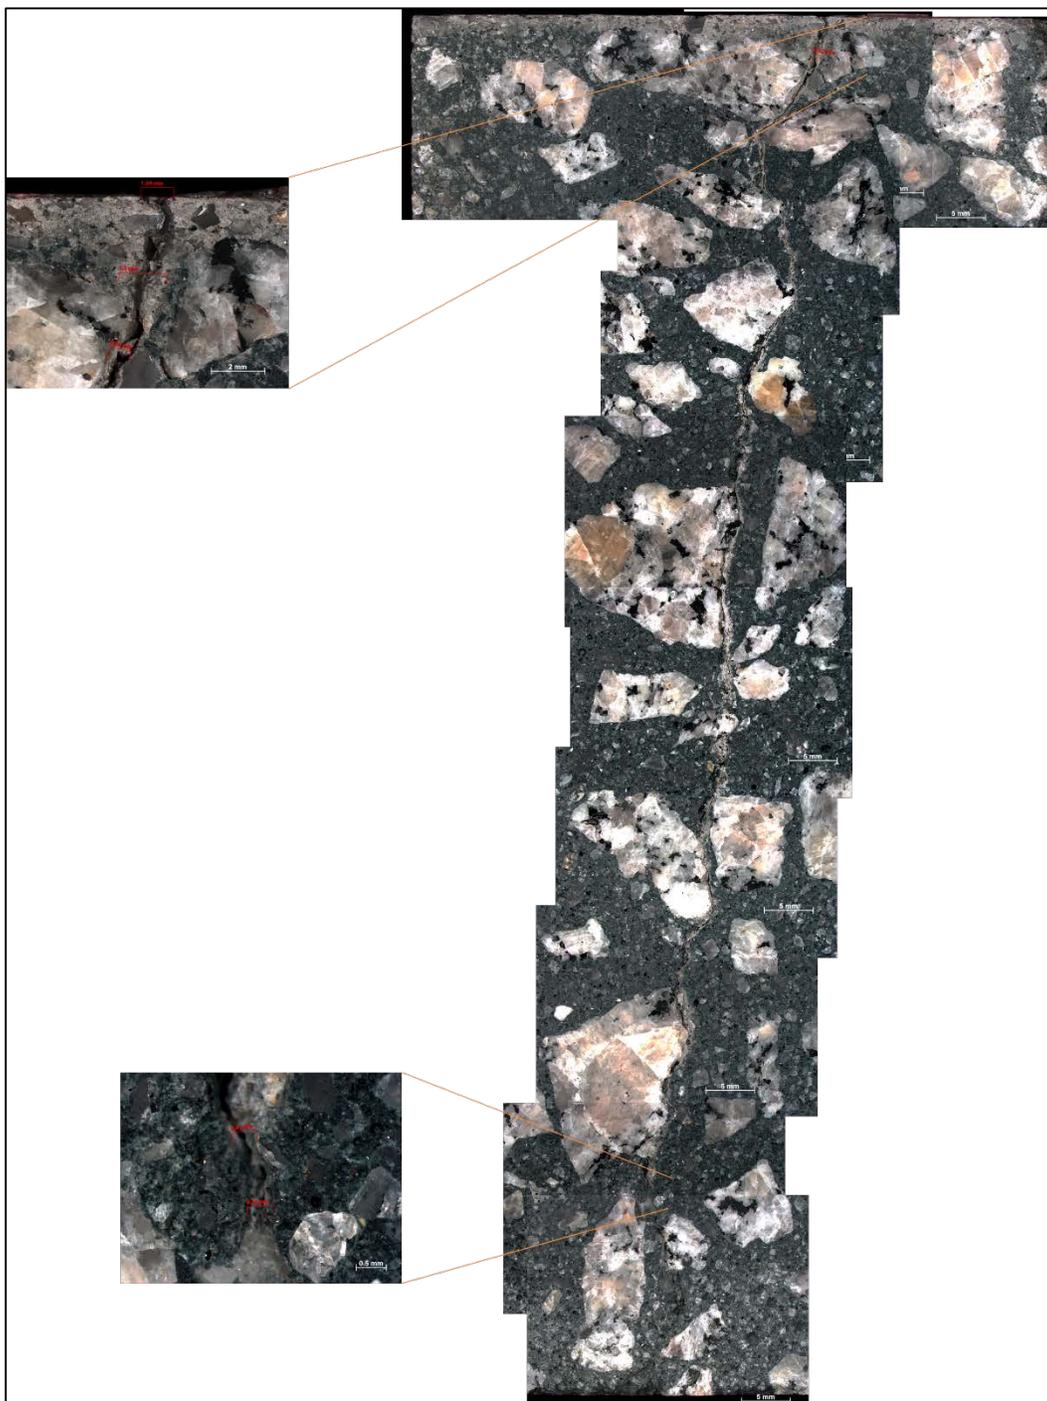
A low magnification montage of images of the sectioned surface of the concrete and the crack observed in Core Sample #4 is shown in Figures 38 and 39. Crack widths ranged from 0.2 to 0.5 mm in width (see Figure 40). Cracks were noted to sparsely intersect with coarse aggregates (see Figure 41). This suggests that cracking occurred at later ages when concrete had gained sufficient tensile strength to cause cracking of the aggregate rather than debonding around aggregate interfaces and in the paste fraction of the concrete. No vertical displacement was observed between the faces of the crack. The paste appeared as anticipated, with a greenish color in interior portions of the concrete associated with the high slag content of the concrete. Overall, the concrete appeared to be of competent quality with no additional defects other than the crack running vertically through the slab.

Figure 38. Low magnification montage of upper portion of Core Sample #4 through-depth cracking.
