# **Petrographic Analysis of Concrete Core Samples from Saltstone Disposal Unit #6 at the Savannah River Site, Aiken, SC**

Robert D. Moser, E. Rae Gore, and Kyle L. Klaus

March 2016

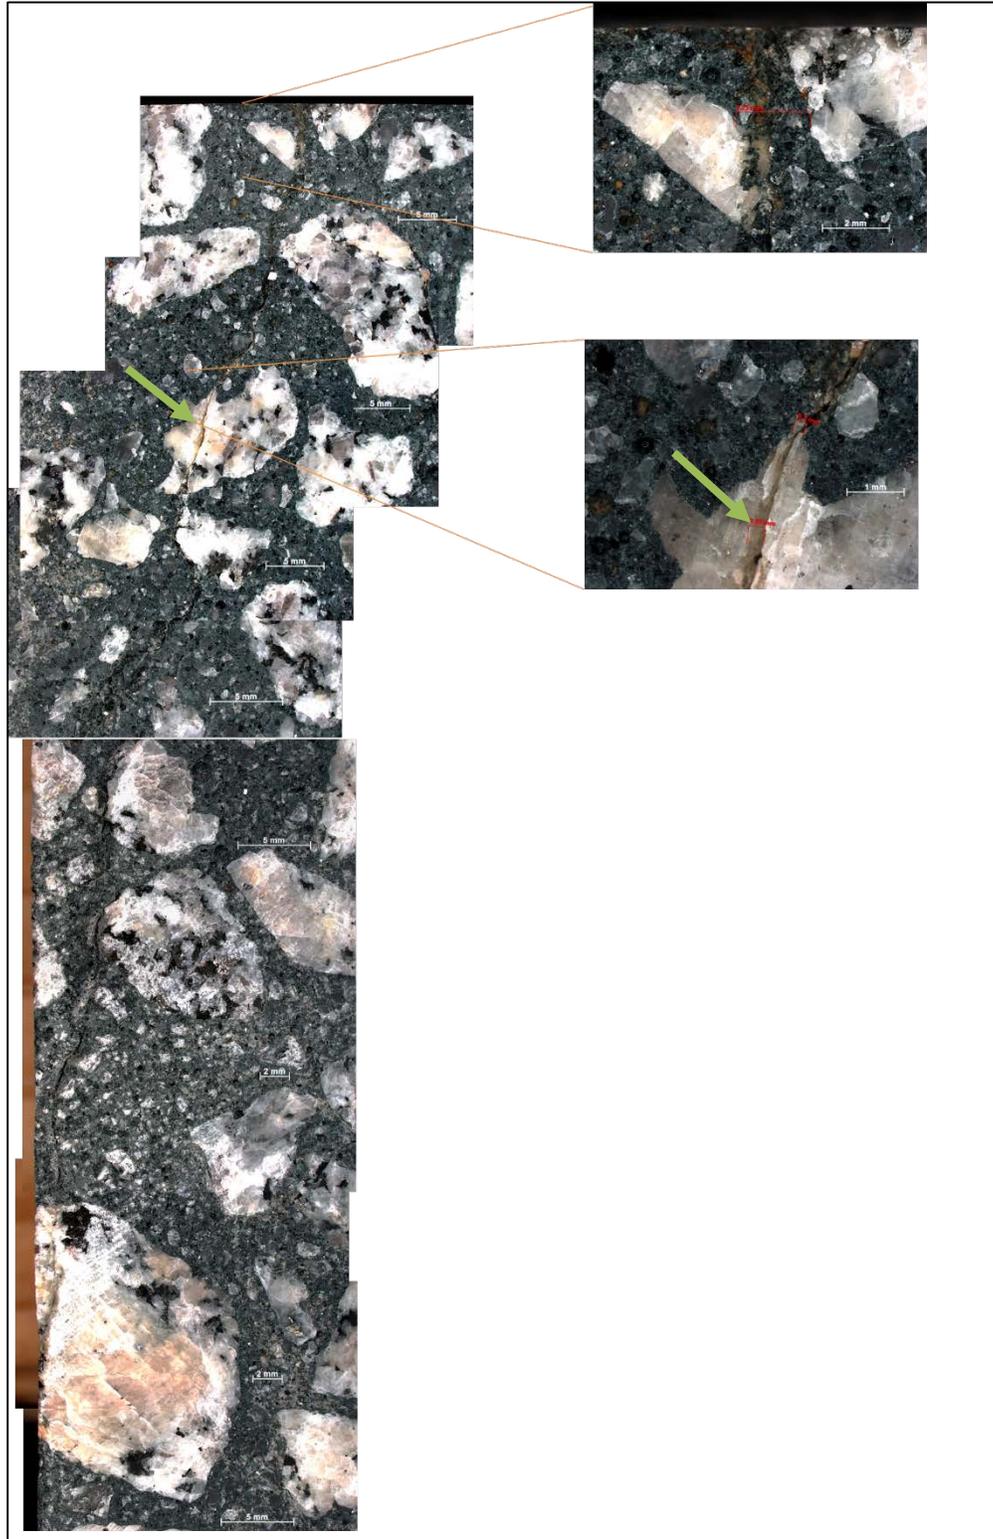
Figure 39. Low magnification montage of cracking in bottom portion of Core Sample #4. Crack extends through full depth of core and through coarse aggregates as noted by green arrows.

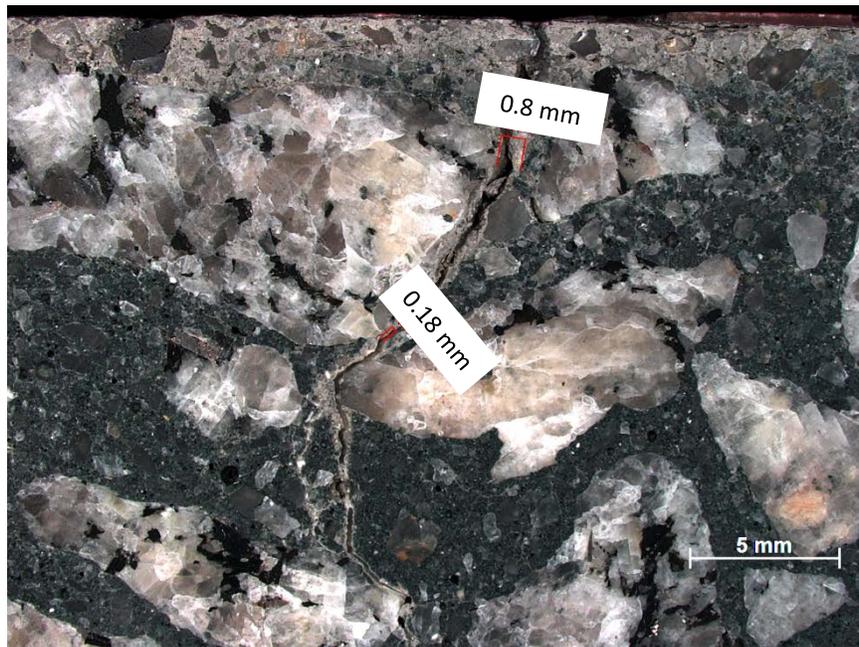
Figure 40. Measurements of crack at concrete surface.

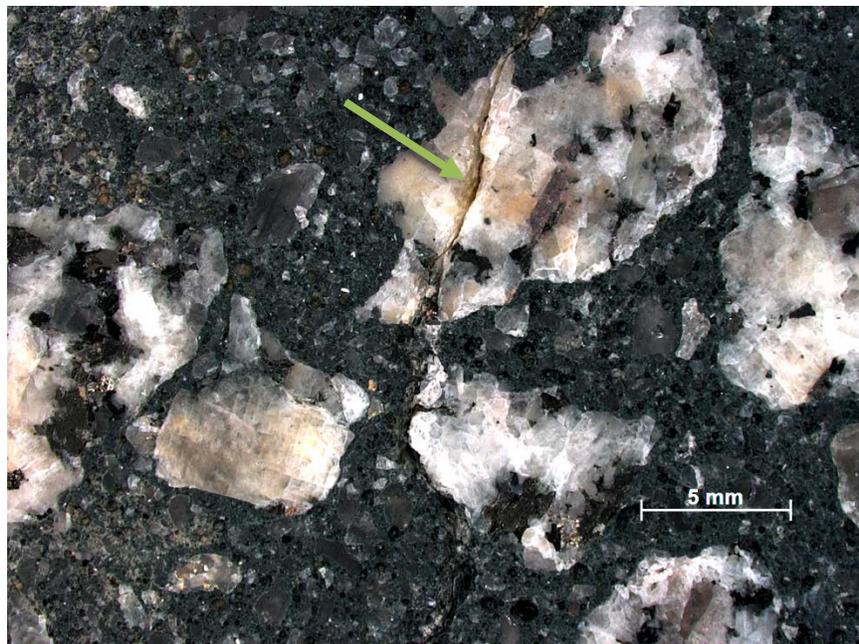
Figure 41. Crack observed through coarse aggregate noted with green arrow.

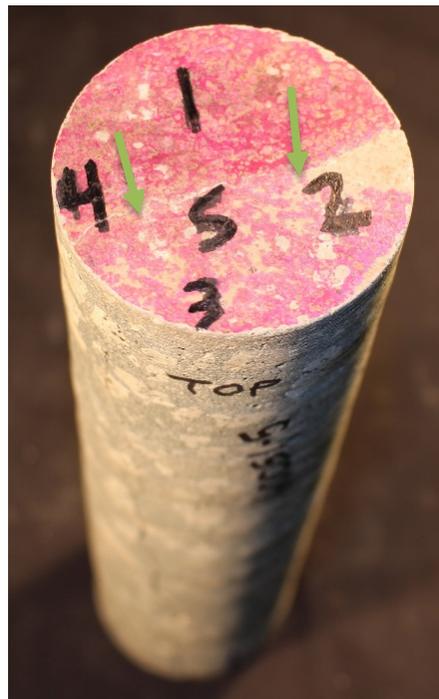
The typical as-received core from location #5 is shown in Figure 42. A large crack was observed on the top surface of the core (see Figure 43). This crack had been coated by the gravity fed epoxy. The core was 7 cm in diameter and 30.5 cm long. No segregation was observed on the surface of the core and the aggregates and voids appeared to be uniformly distributed. No large honeycombs or entrapped air voids were noted.

Figure 43. Top surface of core sample #5 with crack noted with green arrows.

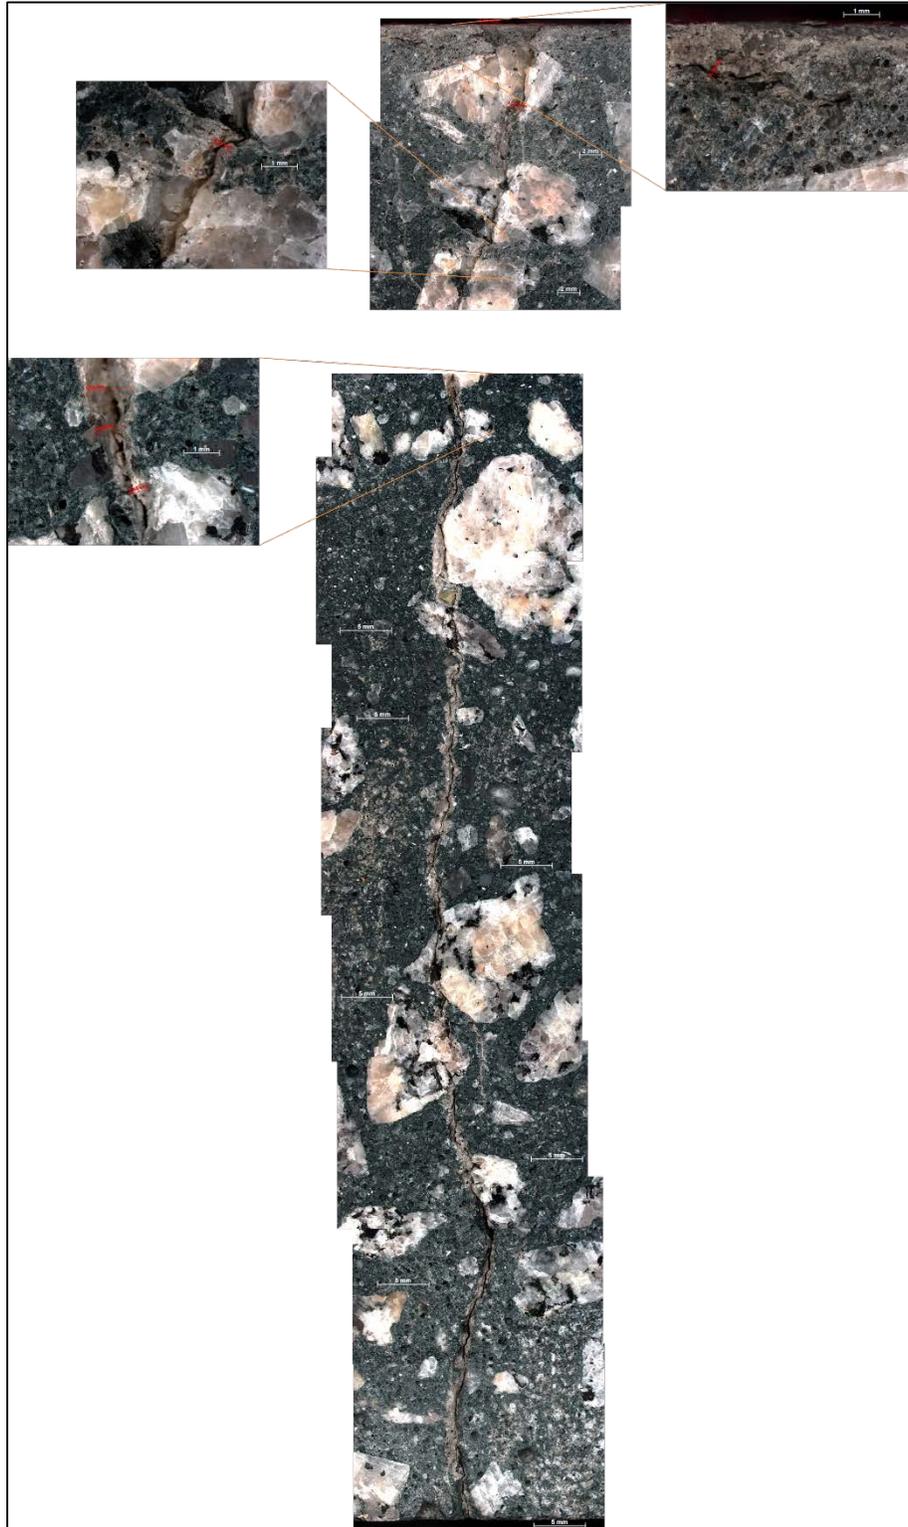
A low magnification montage of images of the sectioned surface of the concrete and the crack observed in Core Sample #5 is shown in Figures 44 and 45. Core #5 was removed from floor placement 8 which had a high degree of restraint and severe cracking. The crack in Core Sample #5 ran the full depth of the slab, with crack with ranging from 0.5 to 1 mm in the near surface concrete to 0.2 to 0.5 mm in inner portions of the concrete. At higher magnification, cracks were observed to be 0.4 to over 1 mm in width (see Figures 46 and 47). Although epoxy was observed on the top surface of the core, the crack appeared to be void of epoxy. The crack also was observed to intersect 10 coarse aggregates through the depth of the slab. This suggests that cracking occurred at later ages when concrete had gained sufficient tensile strength to cause cracking of the aggregate rather than debonding around aggregate interfaces and in the paste fraction of the concrete. Examples of this cracking are shown in Figures 47 and 48. No vertical displacement was observed between the faces of the crack. The paste appeared as anticipated, with a greenish color in interior portions of the concrete associated with the high slag content of the concrete. Overall, the concrete appeared to be of competent quality with no additional defects other than the crack running vertically through the slab.

Figure 44. Low magnification montage of through depth crack in top portion of Core Sample #5. Crack of 0.5 to 1 mm in width extending to a depth of 7-10 cm with the crack thinning to 0.2-0.5 mm in width at greater depths.

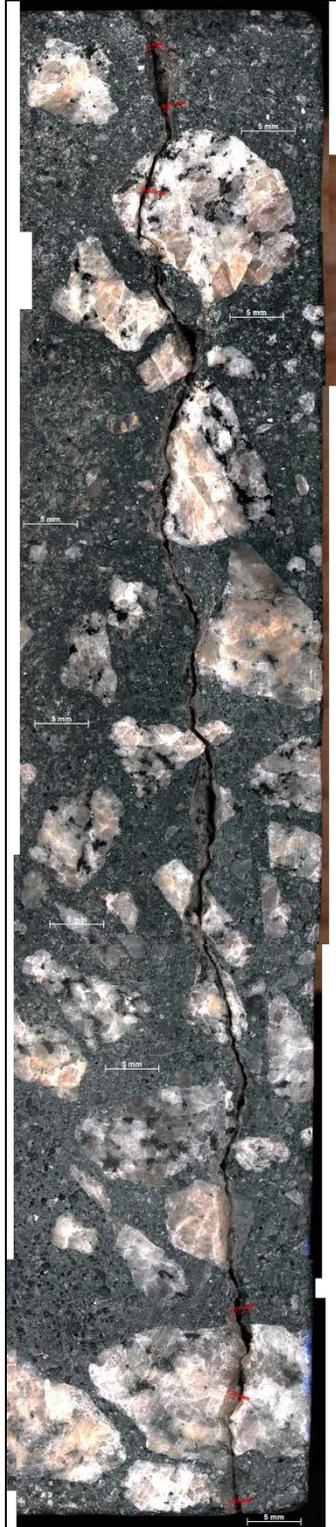
Figure 45. Low magnification montage of crack through the bottom portion of Core Sample #5. Multiple instances of the crack intersecting coarse aggregates.

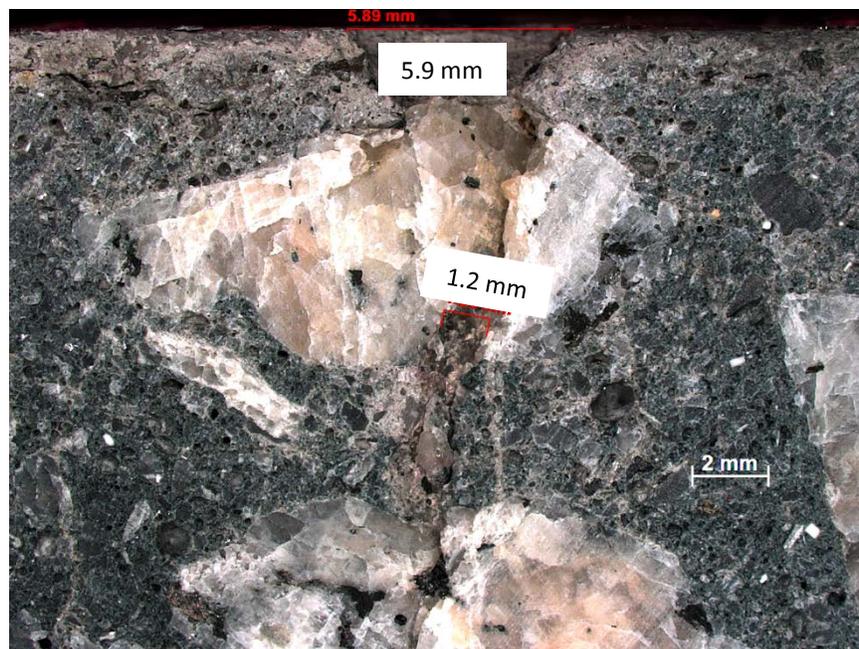
Figure 46. Imaging of crack near concrete surface with measurements of crack with noted on image.

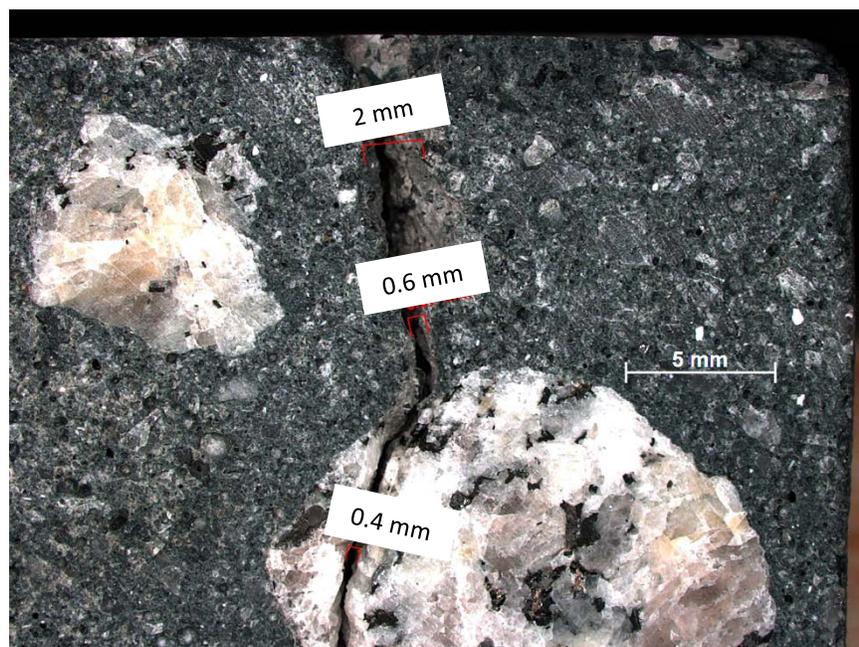
Figure 47. Crack width measurements in bottom portion of core and location of crack intersecting coarse aggregate.

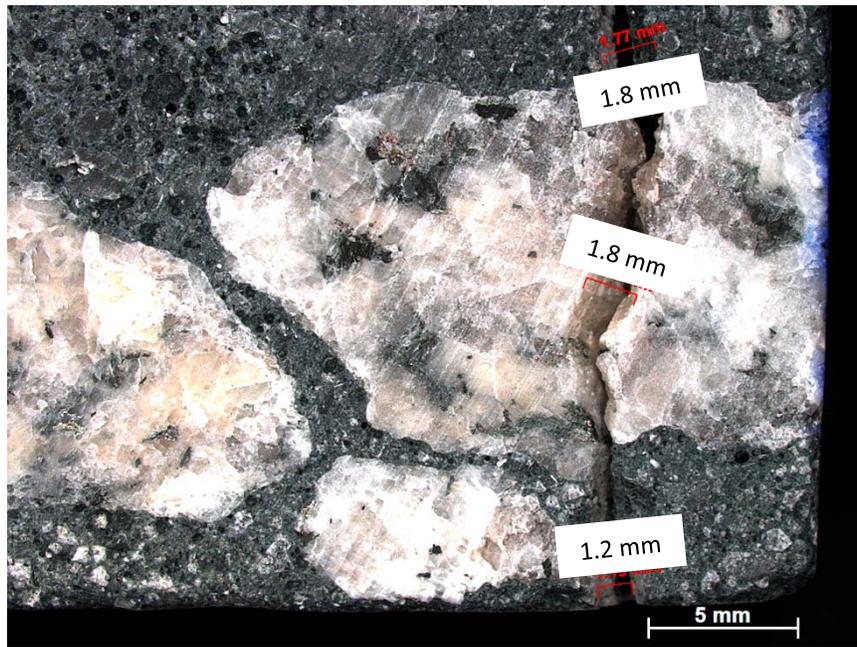
Figure 48. Crack intersecting coarse aggregate.

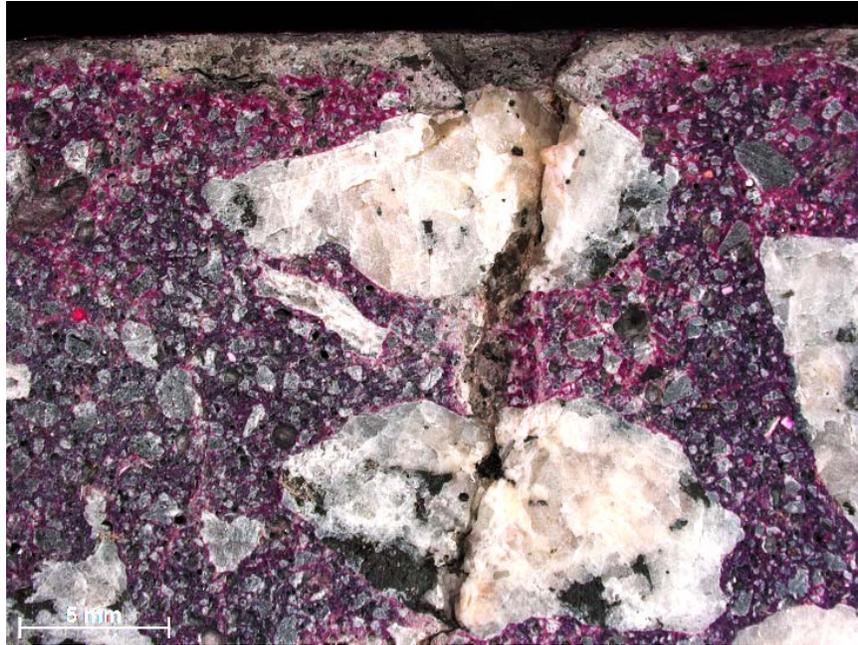
Figures 49 and 50 show examples of pink staining observed following the application of the pH indicator solution. No staining was observed in the top approximately 1.5-2 mm of concrete. Within the concrete, staining was observed adjacent to the crack face. Discoloration of the paste in the near surface of the concrete was associated with some reduction in pH and this is likely due to carbonation and anticipated based on the age of the concrete and its low buffering capacity. Discoloration on the faces of the crack does not appear to be associated with a pH reduction and therefore is likely associated with oxidation of the slag-rich paste rather than carbonation and or acid attack of the concrete.

Figure 49. Micrograph of result of pH staining test showing no staining at near surface of concrete.

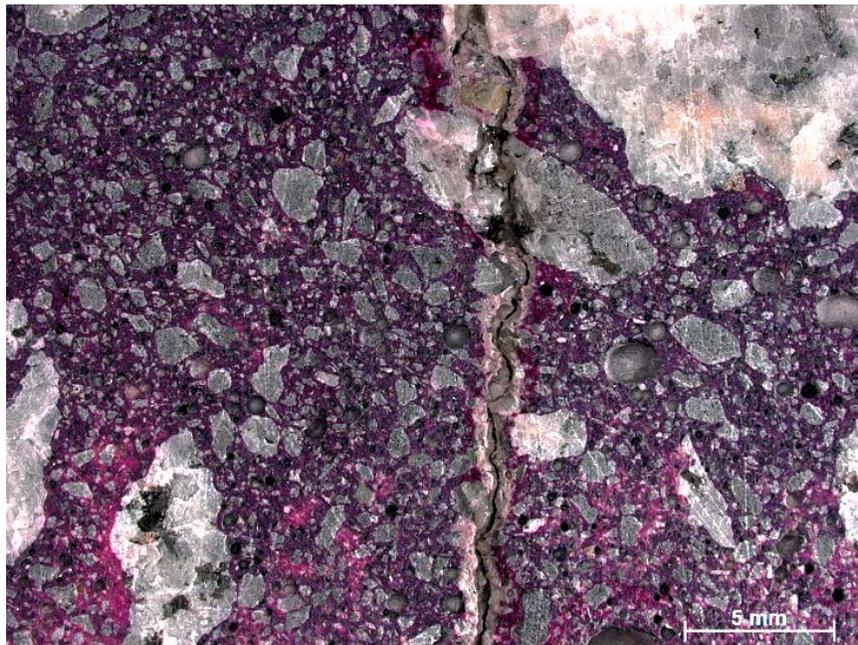
Figure 50. Result of pH indicator solution staining showing strong staining of paste and minor staining of discolored region adjacent to crack face.

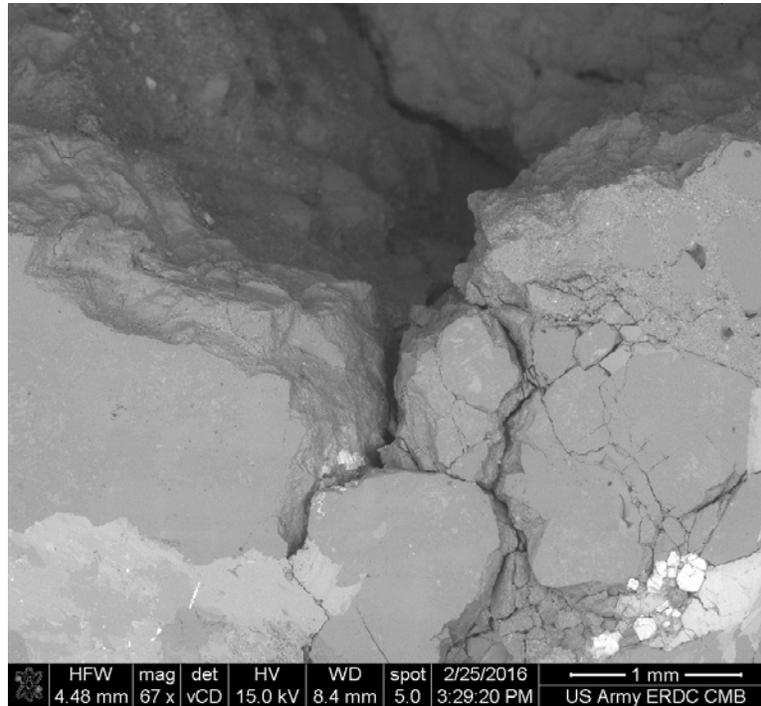
A low magnification montage image of the concrete microstructure including the crack adjacent to the surface is shown in Figure 51. No epoxy was observed to infill the crack in Core Sample #5 even after in depth analysis of the full length of the crack. No epoxy was observed on the walls of the crack. Higher magnification imaging of the polished paste microstructure indicated anticipated phases similar to those observed in Core Sample #1 when examined using SEM. An example of the microstructure observed at higher magnification is shown in Figure 52. Unreacted fly ash, slag, and cement particles were observed with the fly ash particles being spherical in shape and unreacted cement and slag particles being angular. Smaller silica fume particles were observed as sub-micron sized spheres distributed throughout the paste. The paste appeared to be dense and near full reaction, with minimal porosity. The water-to-cementitious materials ratio appeared to be less than 0.40 based on the minimal porosity observed. At higher magnification, distributed microcracking was observed which is likely due to shrinkage (drying or autogenous).

Figure 51. Low magnification montage of crack through coarse aggregate near the concrete surface.
