## Paducah Railroad Culvert Evaluation

There were a total of 13 railroad culvert locations walked down outside the Limited Area (LA) fence and 9 inside the LA fence. One culvert on Warren Road was also included because of its potential impact to the railroads and access to public warning sirens.

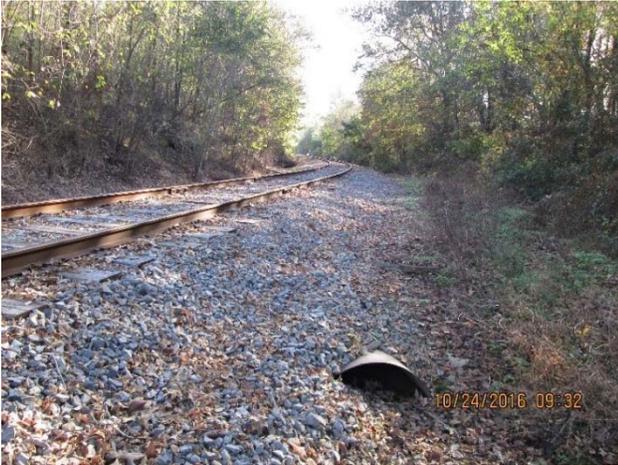
**Track #1, one 36" steel pipe culvert approximately 100 feet west of Mile Marker 10**, at approximate GPS coordinates 37.08443° N, 88.84167° W. This culvert extends diagonally beneath the railroad and is approximately 90% silted. There is no washing or significant signs of deterioration but the silted material should be removed. See photographs 2419 and 2425 below:

*2419 Metal Pipe Culvert (36") Outlet, West End, Looking East*

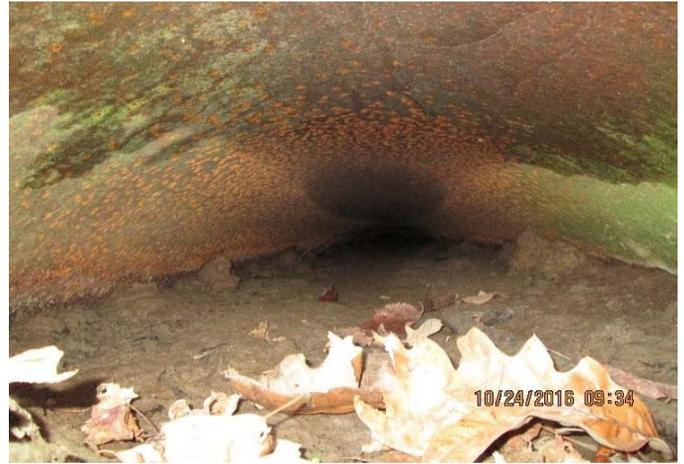
*2425 Metal Pipe Culvert (36"), West End Inlet Interior of Culvert, 90% Silted*

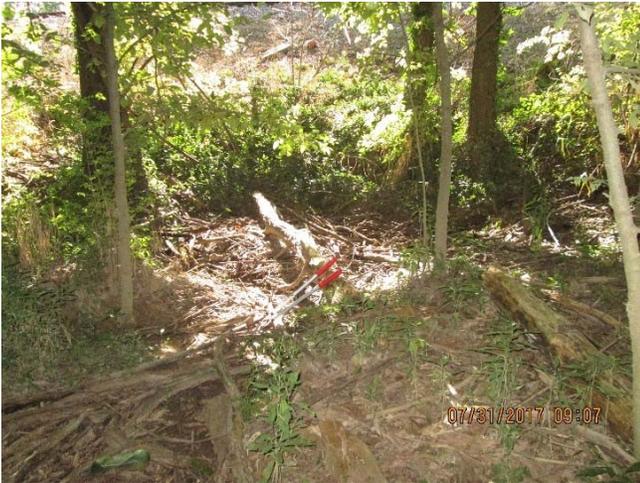
**Track #1, two 30" RCP culverts, approximately 75 yards south of Woodville Road**, at approximate GPS coordinates 37.08823° N, 88.84338° W. On the west side, both culverts were covered with debris (see photographs 7424 and 7437) and it was only through significant excavation that one opening was found. Due to silting, it was not possible to determine the full condition of the concrete. However, the roof of the concrete appeared to be in acceptable condition. The south culvert is two thirds plugged on the east end and covered in debris on the west end. The north culvert is nearly completely plugged on the east end (see photo 7454) and covered with debris on the west end. Very little water flows through the north culvert. The embankments are not eroded and there is no sign of sinkholes.

7424 Two RCP Culverts (30") Covered in Debris West End (Inlet)

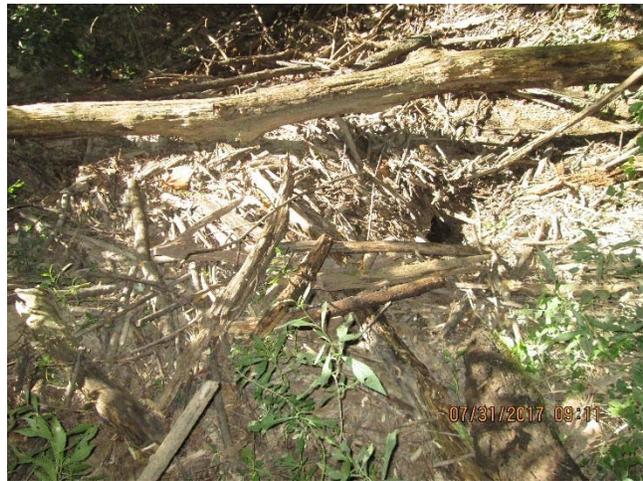
7437 RCP Culverts (30") After Partially Uncovering Debris,

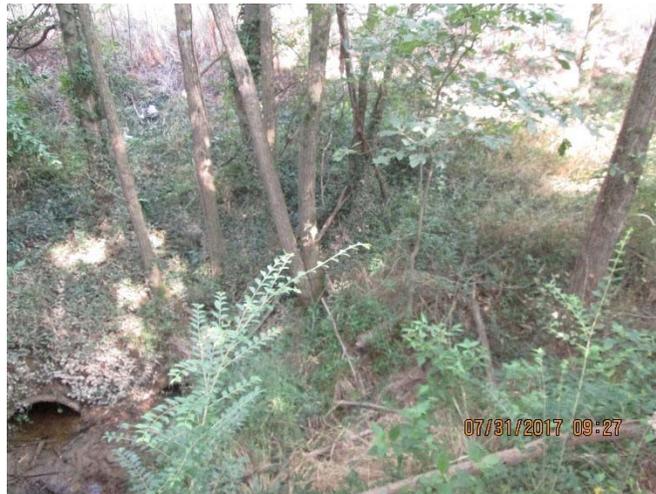
7454 Two RCP Culverts, (30"), East End, 90% Silted

An old road bed extends for a significant distance east of and parallel to the railroad embankment. As such, a depression exists between the road bed and the railroad embankment and the two culverts (mentioned above) drain into this depression. This depression is approximately 20 to 25 feet deep and approximately 60 to 80 feet east of the railroad. The drain pipe(s) exiting this depression beneath the old road bed could not be seen (due to plugging and vegetation) on the west side of the road bed. The east side had stagnant water standing and the culvert(s) were under water 4 to 6 inches. The entire area needs to have vegetation control performed and culverts cleaned.

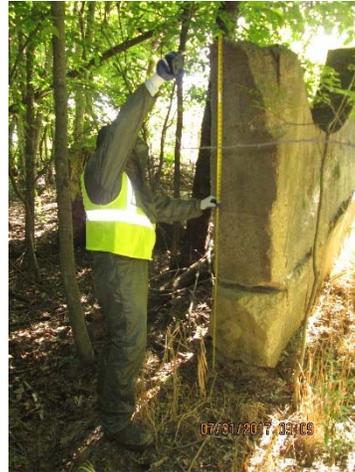
7432 Concrete Tank Support, 7' Tall

These present a hazard if railcars should derail at this location. The concrete structures and/or metal pipe could easily puncture a loaded tank car.

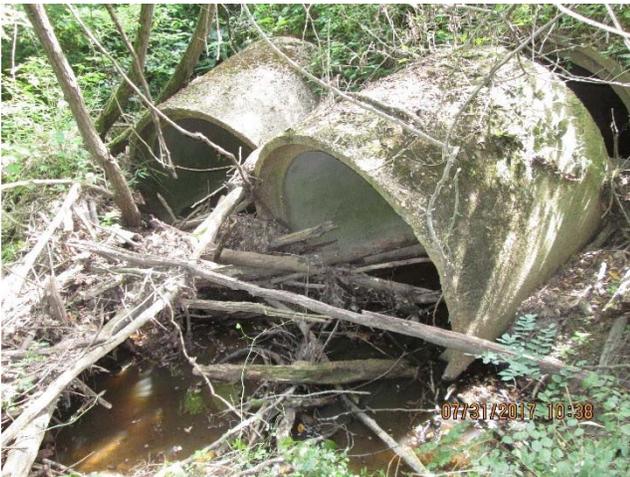
**Track #1, two 60" RCP culverts, approximately 285 yards north of Woodville Road at approximate GPS coordinates 37.09137° N, 88.84135° W.** On the west end, two five foot segments (one on each culvert) have dislodged downward (approximately one foot). In addition, the second concrete segment, inside the south culvert (west end), has signs of separation from the third segment (slumping down slightly) and may need attention. See photographs 7541 and 7517 below:

7541 West Side of 60" RCP Culverts

The westernmost segments of both culverts should be temporarily removed, the ground stabilized and the segments placed back into position. Debris has piled against the inlet of both culverts on the west end. However, further inside the culverts, the concrete does not appear to be deteriorated and other than the segments mentioned above, the interior segments are not separated and the bottom of the pipe is intact. Flow is completely open through both culverts. Slight erosion has occurred around the

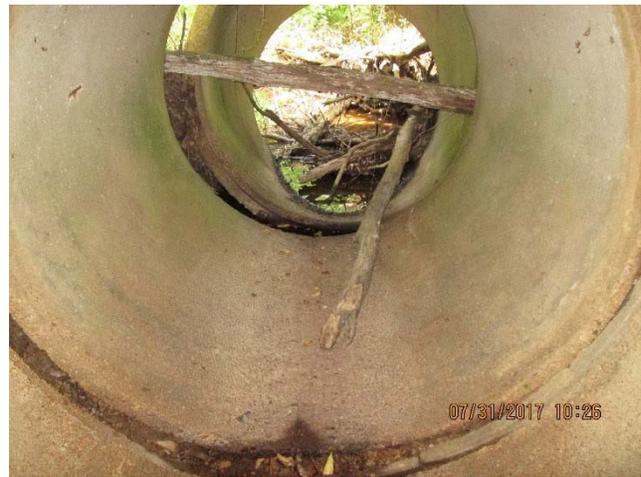
7517 South RCP Culvert, West End

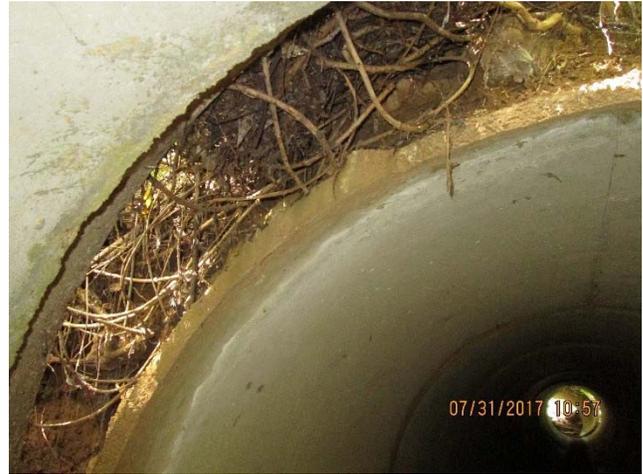
On the east side of the track, both culverts have begun to slump on the outer segments, see photo 7560. The north culvert, outer segment, has slumped approximately 6 inches and separated from the main culvert, see photo 7583. The outer segment of the south culvert has slumped approximately 3 inches, see photo 7575, but has not separated completely from the main culvert.

7583 North RCP Culvert (60"), Separated Segment

Water appears to be clearing the ditch well and the high-water marks (indicating stream stage) are very slight. However, the earth is beginning to give way on both sides, and above, the east end of the culverts. Slight washing has occurred between the two culverts. A small amount of concrete spalling was observed on the sides of the north culvert. Spalling is approximately 1/4" deep. Both culverts have grouted segment joints but, in many cases, the grouting has fallen out. It is recommended that both the inlet and outlet sides of these culverts be stabilized, erosion control be performed, and new grouting

installed. There appears to be no immediate danger (in terms of sinkholes or subsidence) but repairs and cleanup work should be completed within the next year.

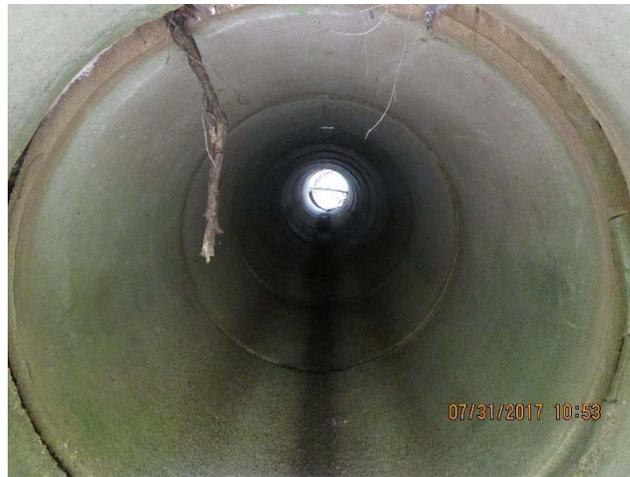
7575 South RCP Culvert (60"), Separated Segment

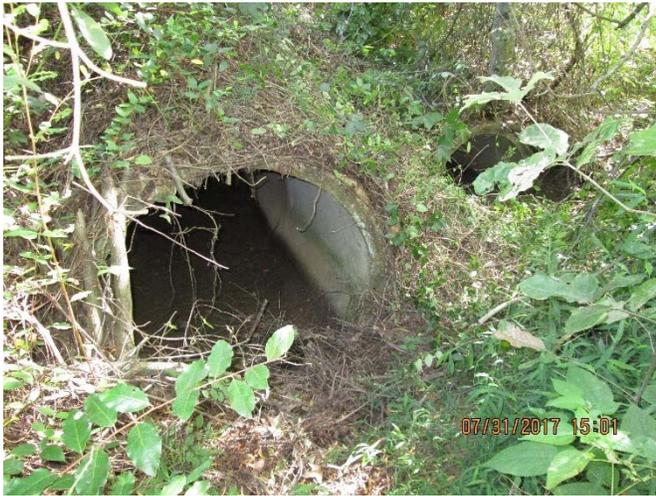
**Track #1, two RCP culverts, the north culvert is 48” and the south culvert is 36”, approximately 130 yards south of the 1-1Ws switch, at approximate GPS coordinates 37.09294° N, 88.84021° W.** Both culverts are approximately half silted in, see photo 7673. No segments appear to be substantially dislodged and there is no sign of subsidence or washing. However, there is significant woody growth around both culverts. Near the west end (culvert inlet) a 6” tree is growing atop the south culvert and the outer concrete segment is beginning to displace (possibly due to the tree growth), see photograph 7669.

7673 RCP Culverts (48” on North and 36” on South), West End

The leading edges of both culverts (west end) have their lip broken but this is of little concern. It is recommended that vegetation control be performed, the tree (atop the south culvert) be removed, and the silt, rocks, and debris inside the culvert be removed.

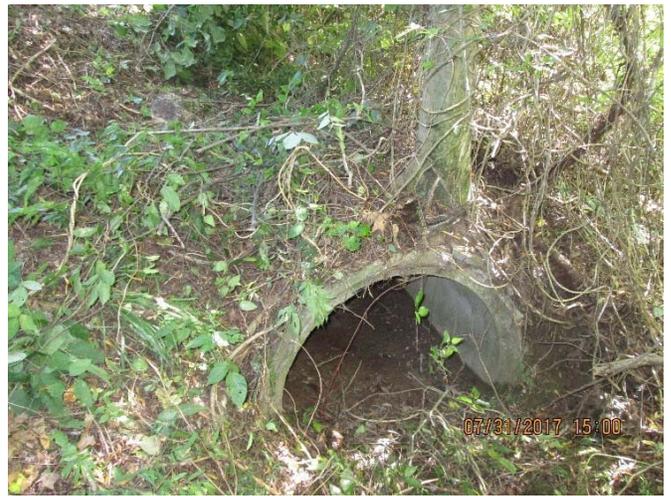
7669 South RCP Culvert, West End, with 6” Tree on Top

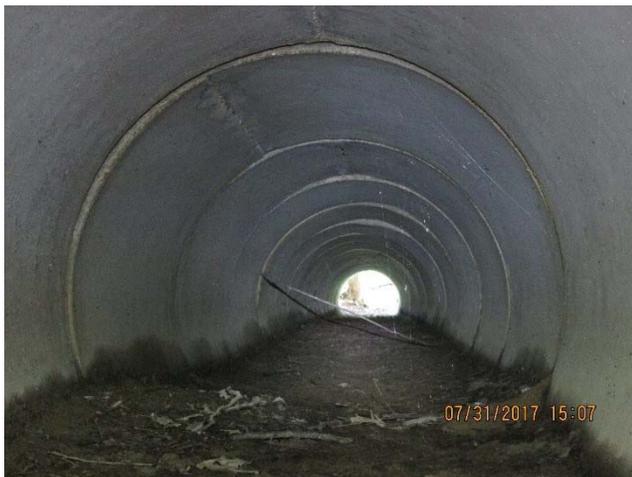
The bottoms of the culverts could not be seen but the sides appear to be in good and acceptable condition with the segments intact under the rail bed. See photographs 7684 and 7697.

7684 North RCP Culvert (48”) Interior, Looking East

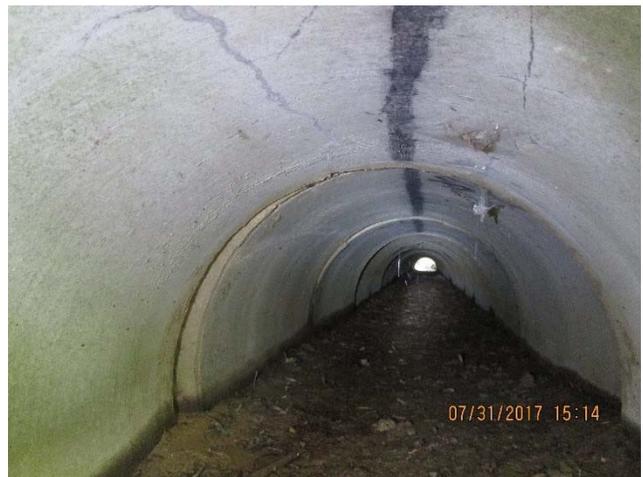
7697 South RCP Culvert (36”) Interior, Looking East

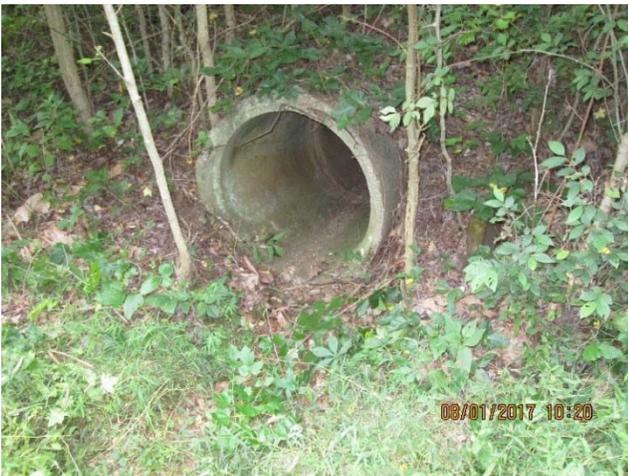
**Track #1, a 36" (primarily) RCP culvert located approximately 100 yards north of the sinkhole culvert,** at approximate GPS coordinates 37.09983° N, 88.83549° W. This culvert is unusual in that the primary culvert (beneath the tracks) is concrete, however, the east end of the culvert has an approximate 14 foot metal pipe extension. The culvert is clear and has no sign of erosion or subsidence on the west side. Water appears to be clearing the ditch well and there are no high-water marks on the surrounding vegetation. The grout has begun to fall away from the concrete segments and the bottom has a slight deterioration. See photographs 7797 and 7810.

*7797 RCP Culvert (36") West Side*

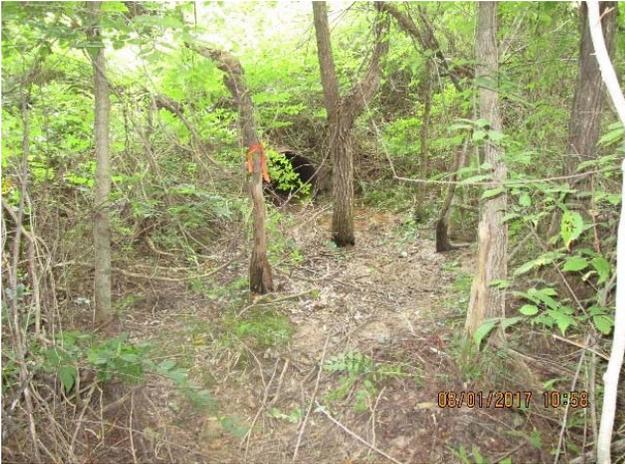
downward at least 6 inches. This creates a significant disturbance in water flow through the culvert and into the pipe. In addition, the concrete culvert appears to have a significant hump, and downward slope, approximately 20 feet further inside the culvert. This places the hump location approximately beneath the east rail and it may indicate erosion below the culvert or below the connection to the metal pipe. The metal pipe was observed to have a bent roof (possibly due to heavy loads having traversed the roadway at some time in the past). See photographs 7874, 7835, 7848, and 7867.

7874 Culvert (36") North of Sinkhole Repair Location, East End

Though it does not appear to be an immediate hazard, it is recommended further inspections be performed of this culvert and a determination as to the need for repairs (if any) or replacement. Consideration should be given to making repairs to this location in conjunction with the repair to the sinkhole culvert issue identified in May, 2017. Without some level of repair, within the next several years, this culvert may become a major issue.

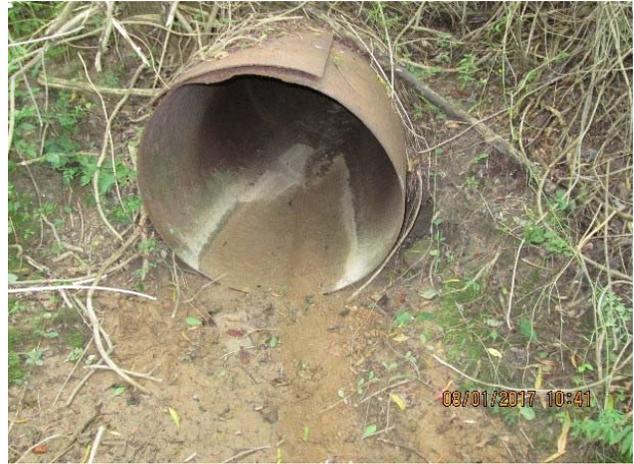
The 36" culvert on the east side of the track is a section of metal pipe that appears to have been placed into position to provide a culvert beneath an old road bed that, at one time, ran parallel to the east side of the railroad embankment. The metal pipe (approximately 14 to 16 feet in length) is butted against, and appears to be attached to, the concrete culvert (discussed above). However, at this joint the metal pipe has separated from the concrete culvert, become egg shaped, skewed to the side, and deflected

7835 Culvert (36") Metal Pipe, Extension on East Side of Concrete Culvert

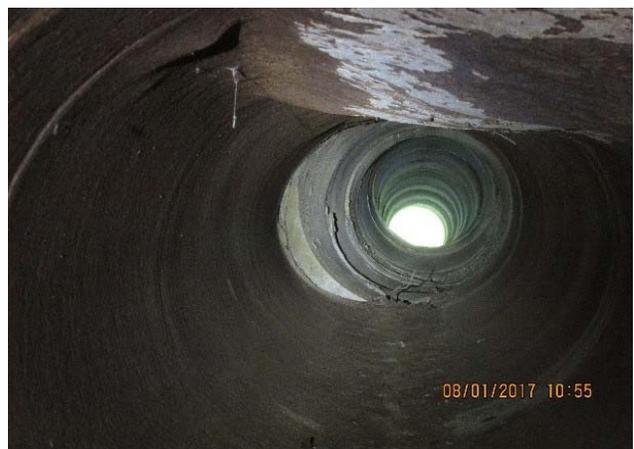
7867 Culvert (36"), East End, Metal Pipe Showing Egg Shape, Skewed From the Connecting Point to the Concrete Culvert and the Hump in the Concrete Culvert

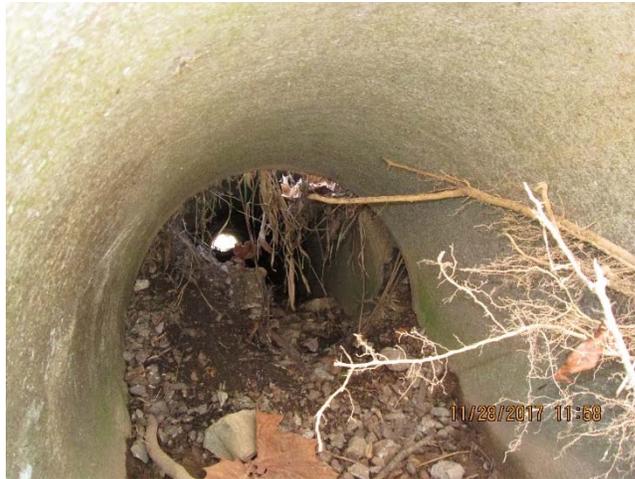
*8313, Inlet (west side) segment dislodged and filling with rocks, soil, debris, and vegetation. Outlet visible in background.*

The inlet segment needs to be reset and the silt, rocks, and debris cleaned out. The vegetation debris needs to be removed from both ends of the culvert, and controlled going forward. (This culvert was

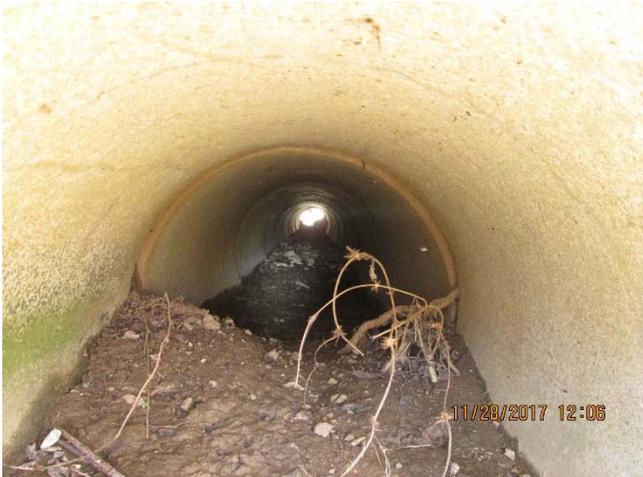
*8333, Outlet (east side) of culvert about half filled with rocks, soil, debris, and vegetation.*

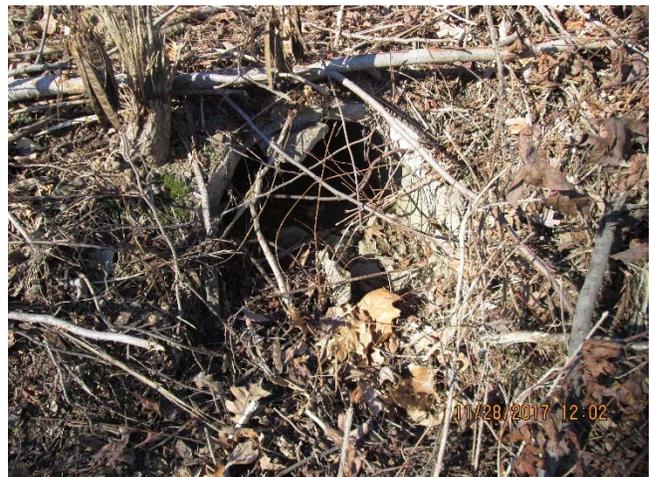
*8328, Outlet (west) side segment with damaged top and some vegetation debris still covering the culvert outlet.*

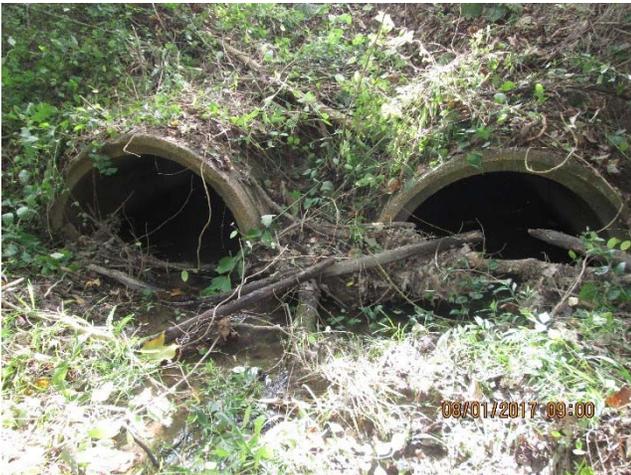
**Track #1, two 48" RCP culverts, north of South Acid Road, approximately 200 yards south of the 2-DUF<sub>6</sub> switch and 90 feet south of the Danger High Voltage Sign,** at approximate GPS coordinates 37.10466° N, 88.82938° W. These two culverts extend at a sharp (south to north) angle beneath the railroad tracks and serve to drain an active stream on the west side of the tracks. On the west side, approximately one third of the inlet (on both culverts) is silted and there is minor erosion (between the culverts) for a distance of 5 to 6 feet eastward toward the railroad embankment (see photographs 7711, 7722, and 7730).

*7711 RCP Culverts (48") South of 2-DUF<sub>6</sub> Switch*

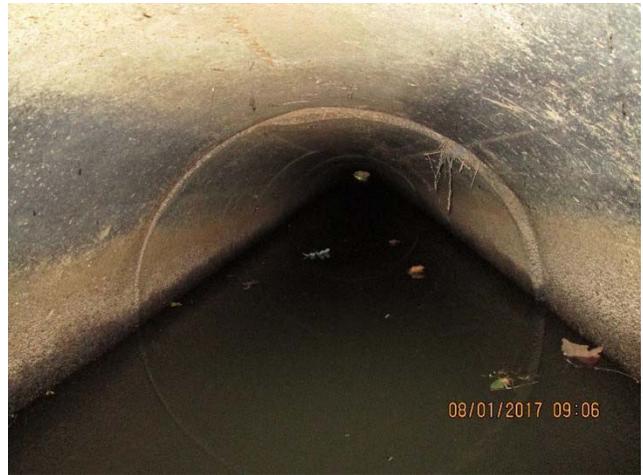
*7722 RCP Culvert (48") South of 2-DUF<sub>6</sub> Switch, North Culvert Interior*

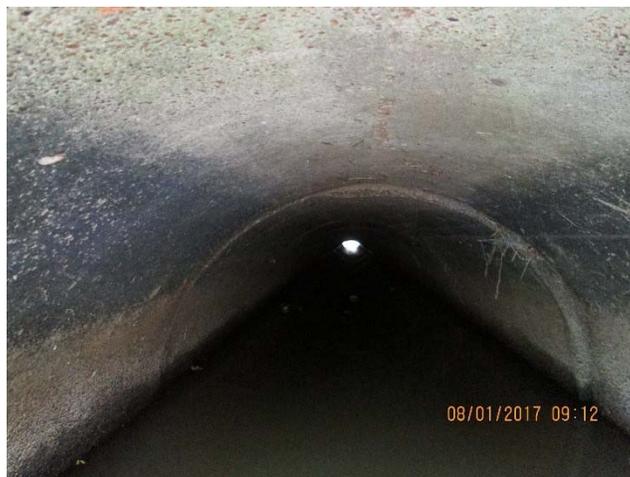
*7730 RCP Culvert (48") South of 2-DUF<sub>6</sub> Switch, South Culvert Interior*

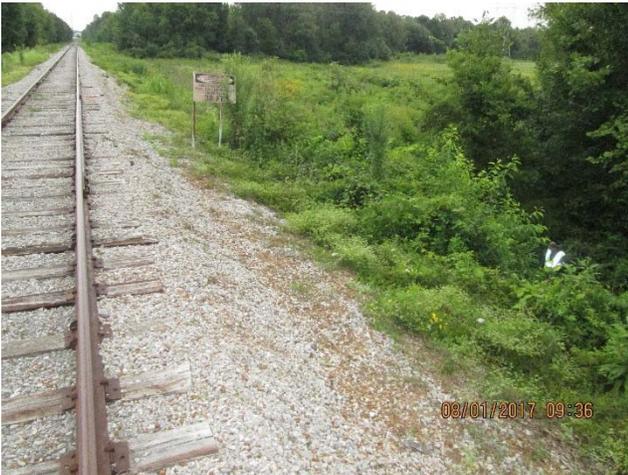
On the east side of the railroad embankment, rip rap is located above the two 48 inch culverts for a distance of approximately 40 feet. This rip rap has become heavily overgrown with low growing vegetation and access to the stream bed must be made on the east side of the track, approximately 30 feet north of the Danger High Voltage Sign. No subsidence or potholes were observed above or to the sides of the culverts. There is slight erosion between the culverts. Water is standing in the stream bed at the culvert outlet. This stream appears to be effectively draining, however, vegetation is heavily overgrown downstream of the culvert outlets. See photographs 7783, 7786, and 7793. It is recommended to remove the sediment, repair the erosion, and perform vegetation control to facilitate inspection access.

*7783 RCP Culverts, Two (48"), South of 2-DUF<sub>6</sub> Switch, East Outlet Heavily Overgrown (Water Standing Near Culverts)*

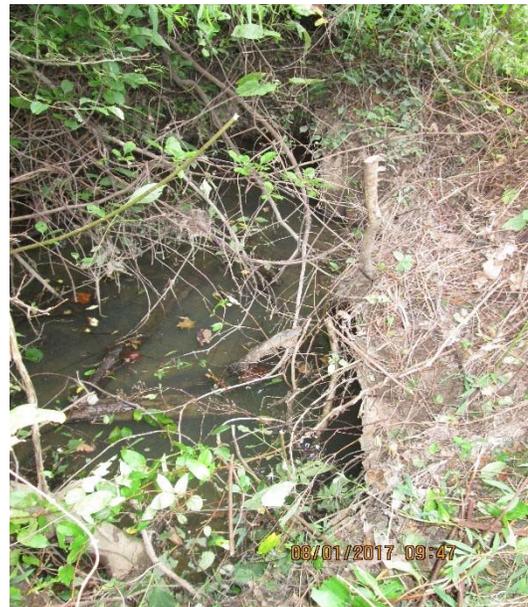
*7786 RCP Culverts, Two (48"), South of 2-DUF<sub>6</sub> Switch, East Side Outlet*

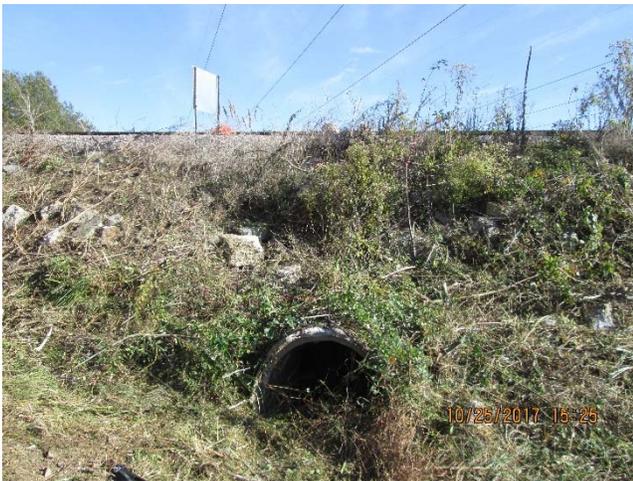
5403, Inlet (west side) segment dislodged and crevice filling with rocks, soil, debris, and vegetation.

Recommend resetting the inlet segment, remove the sediment, rocks and vegetation along with the reinforcing wire on the outlet segment. (This culvert was missed by Pro2Serve personnel during the initial walkdown due to extensive vegetation surrounding both the inlet and outlet.)

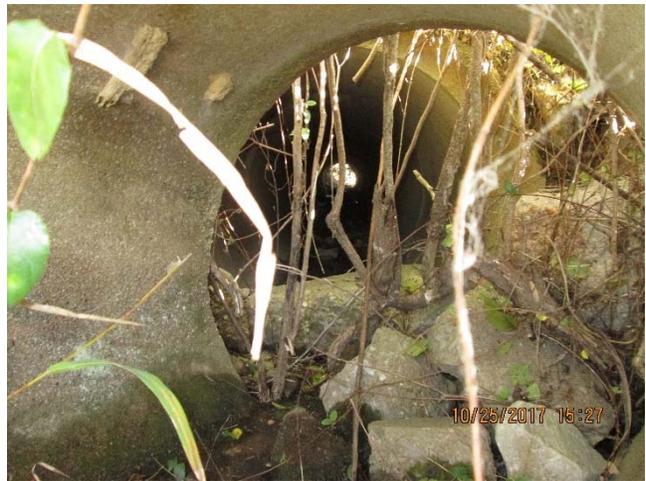
5410, Inlet (west side) segment dislodged and filling with rocks, soil, debris, and vegetation. Outlet visible in background.

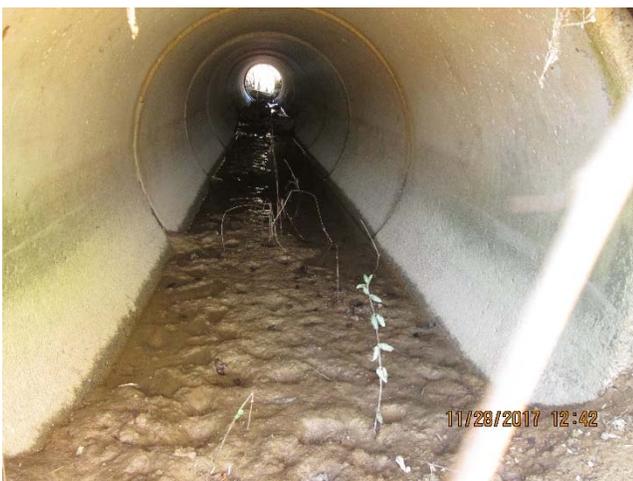
8369, Main culvert under Track 1 is 90% unobstructed. .

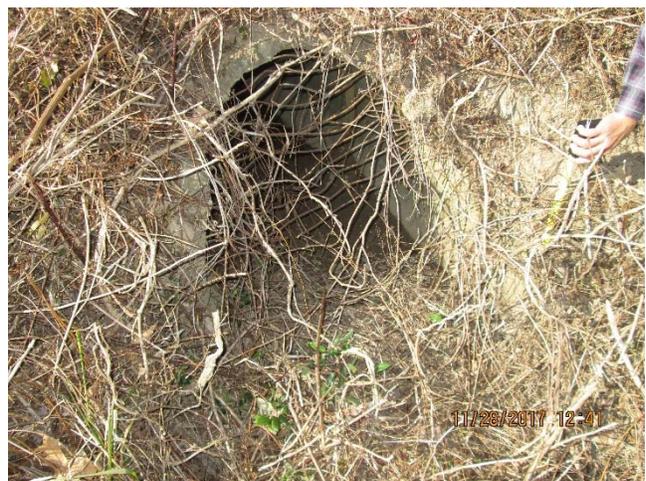
8364, Outlet (east side) segment, Top damaged, wire reinforcing partially blocking culvert exit.

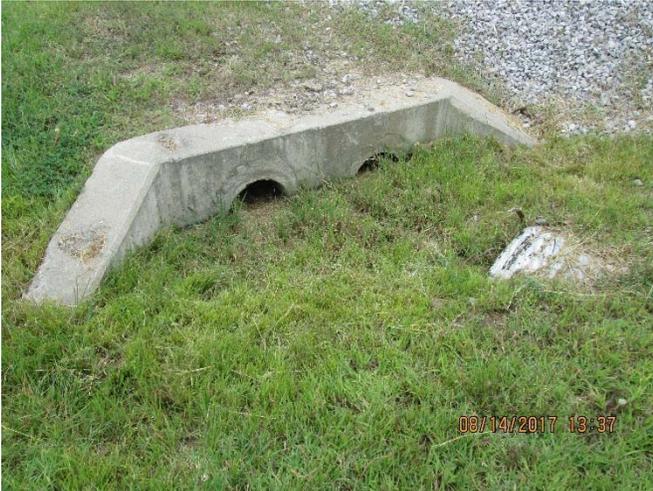
**DUF<sub>6</sub>, two 15" CMP culverts, approximately 60 feet west of Hobbs Road on the DUF<sub>6</sub>-B spur, at approximate GPS coordinates 37.104566° N, 88.818231° W. The north culvert is approximately 75% silted and the south culvert is approximately 50% silted. The culvert metal appears to be in good condition and there are no erosion or vegetation control issues. Recommend removing the sediment. See photographs 8090, 8104, 8105, and 8114.**

*8090 CMP Culvert (15"), DUF<sub>6</sub>-B, 60' West Of Hobbs Road, East End*

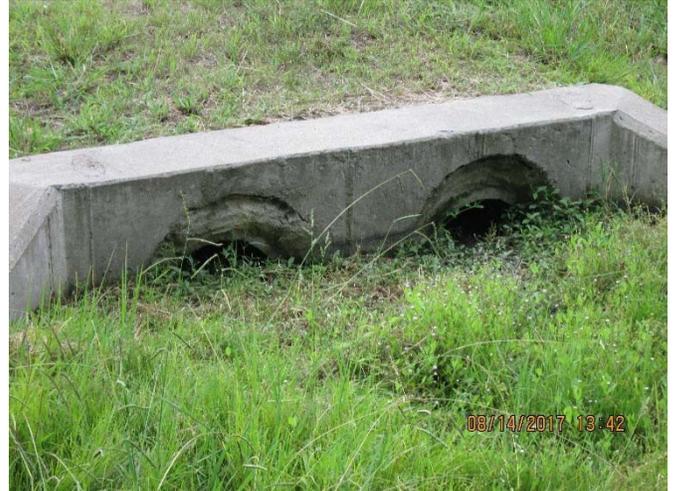
*8104 CMP Culvert (15"), DUF<sub>6</sub>-B, 60' West Of Hobbs Road, West End*

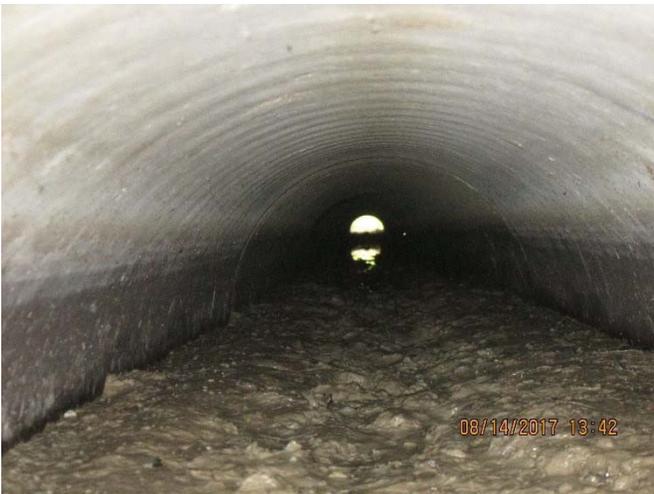
*8105 CMP Culvert (15"), DUF<sub>6</sub>-B, 60' West Of Hobbs Road, South Culvert Looking East*

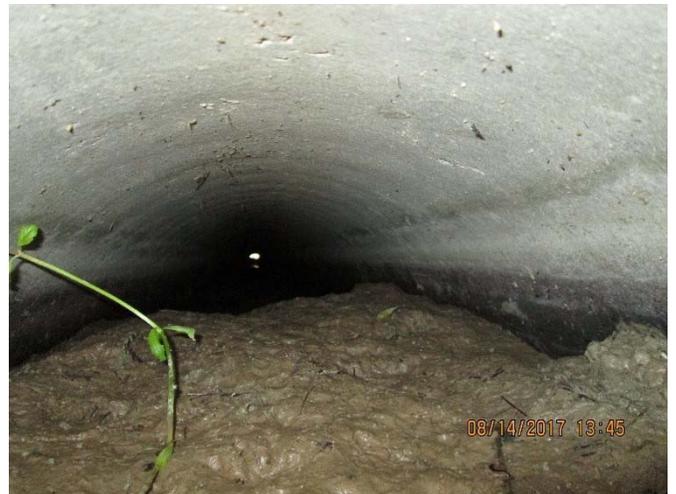
*8114 CMP Culvert (15"), DUF<sub>6</sub>-B, 60' West Of Hobbs Road, North Culvert Looking East*

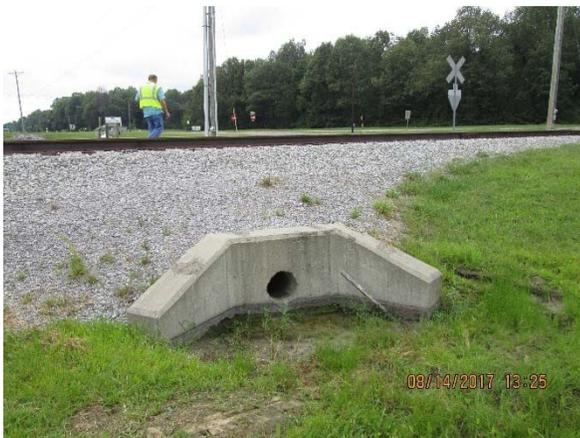
**DUF<sub>6</sub>, one 12" CMP culvert, approximately 50 feet east of the Old Haul Road on the DUF<sub>6</sub>-A track, at approximate GPS coordinates 37.104263° N, 88.817624° W.** This culvert has no sediment, erosion or vegetation issues and the metal appears to be in good condition. However, the culvert size appears to be inadequate for the area being drained. In discussions with residents of the trailer complex (immediately north of the culvert), it was noted that during heavy rain, water backs up under Trailer-06. This is a training trailer and is occupied an average of three times per week. While no work is needed at this location it is recommended that a drainage study be performed to determine if a second culvert is needed. See photographs 8073, 8080, and 8086.

8073 CMP Culvert (12"), DUF<sub>6</sub>-A, South of Trailers, North End

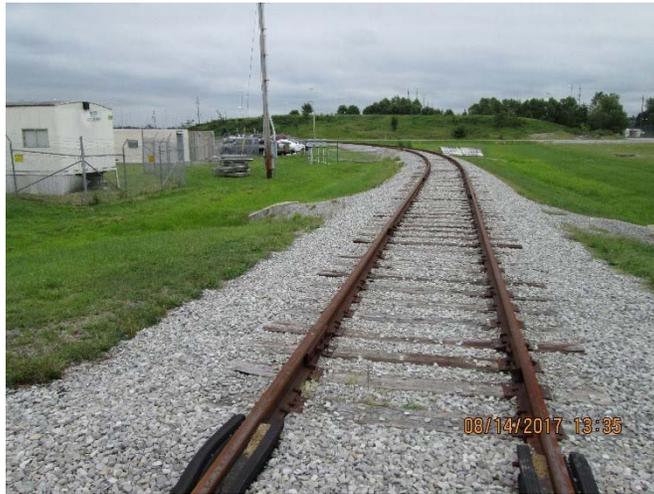
*8086 CMP Culvert (12"), DUF<sub>6</sub>-A, South of Trailers, Looking Eastward toward Culvert and Its Relationship to Trailers*

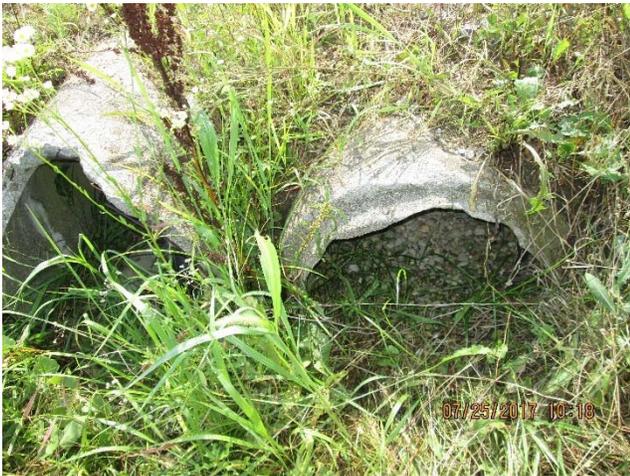
**Track #2, two 24" RCP culverts approximately 175 feet west of 4<sup>th</sup> Street**, at approximate GPS coordinates 37.11591° N, 88.81935° W. Both culverts have approximately 50% sediment build-up and the east end of both culverts have chipped edges, but they are still serviceable. On the west side of the tracks, the separation between the two culverts has experienced minor erosion (2 to 3 feet deep) approximately 9 feet away from the track. Recommend removing the sediment and filling the eroded area. See photographs 7039, 7034, and 7059.

7039 Concrete Culverts (24"), West of 4<sup>th</sup> Street, West Side Looking East

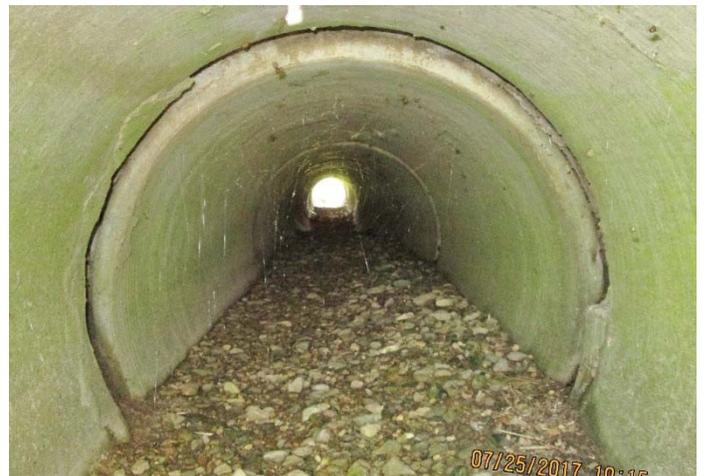
7034 North Concrete Culvert (24"), West of 4<sup>th</sup> Street, West Side (Outlet), Looking East

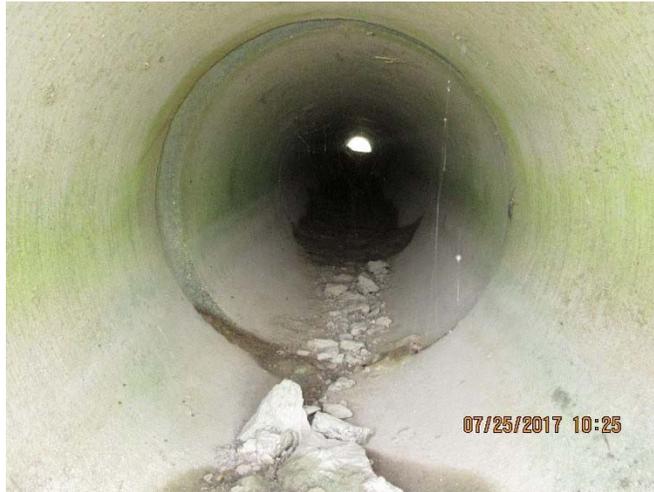
*7059 South Concrete Culvert (24"), West of 4<sup>th</sup> Street, East Side, (Inlet), Looking West*

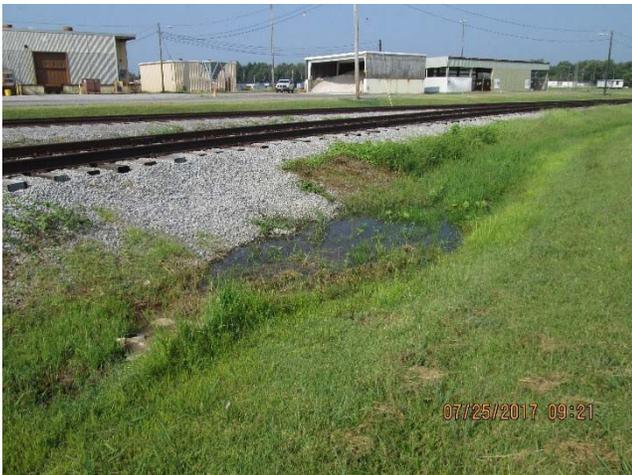
**Track #2, one 16" metal culvert, inside the LA fence, approximately 75 feet west of the 6<sup>th</sup> Street crossing, at approximate GPS coordinates 37.115625° N, 88.817754° W. This culvert crosses beneath Track #6 and is approximately 95% blocked. See photographs 6951 and 6955. Recommend cleaning the silt and rock from this culvert.**

*6951 Metal Culvert (16"), East of Switch 2-6, Looking Southwest*

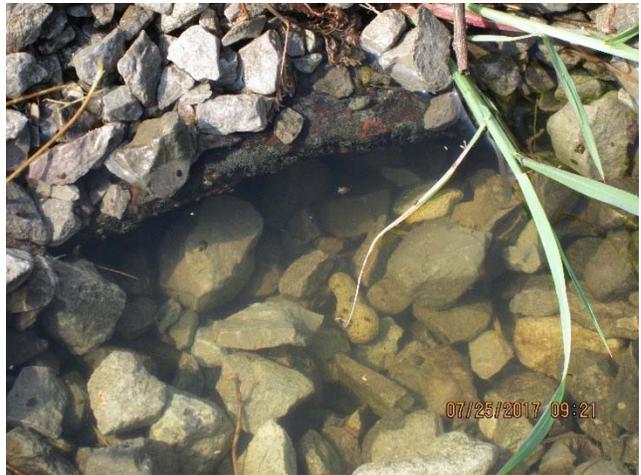
*6955 Metal Culvert (16"), East of Switch 2-6, Close up of Outlet*

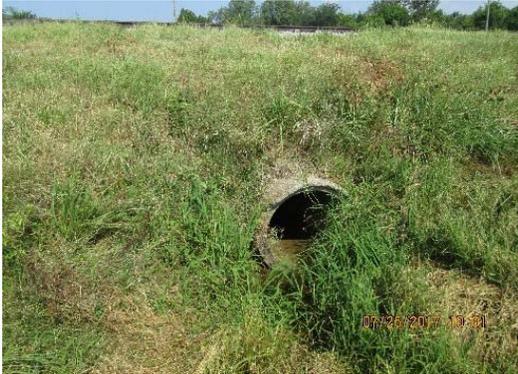
**Track #AT, one 32" RCP culvert, inside the LA fence, approximately 150 feet north of monitoring well 188**, at approximate GPS coordinates 37.11623° N, 88.82044° W. This culvert has a slight amount of erosion on top of the culvert on the west side of the track and erosion on the south side of the culvert on the east side of the track. See photographs 7022, 7002, and 7021. The culvert appears to be clear with no indications of interior degradation. Recommend filling the eroded areas.

*7022 Concrete Culvert (32"), Track-AT.  
East Side*

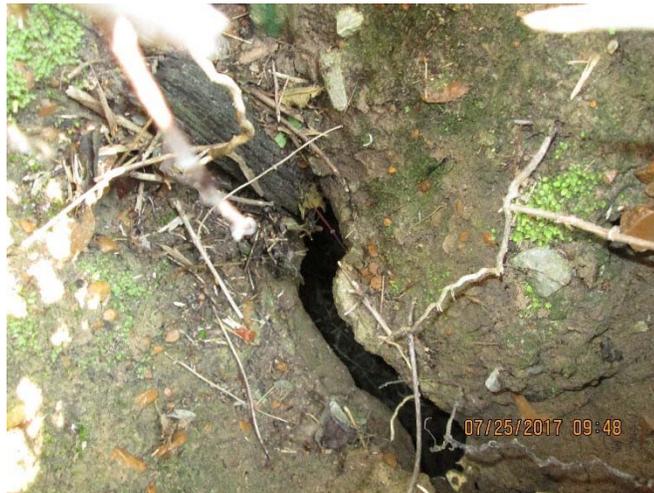
**Track #AT, one 24" RCP culvert, inside the LA fence, approximately 100 yards south of the rail stops near Patrol Road #1**, at approximate GPS coordinates 37.11712° N, 88.82047° W. Washing has occurred on the east side of the track near the radiological zone at the corner of C-745-A1. The culvert is approximately 50% silted and, with the exception of one three foot segment dislodged (on the east side), the concrete segments are uniform and in acceptable condition. Recommend repairing the erosion on the east side, removing the sediment, and repositioning/reconnecting the displaced section to the existing culvert. See photographs 6984, 6989, and 6999.

6999 Concrete Culvert (24"), Track #AT, East End, Outer Section Displaced

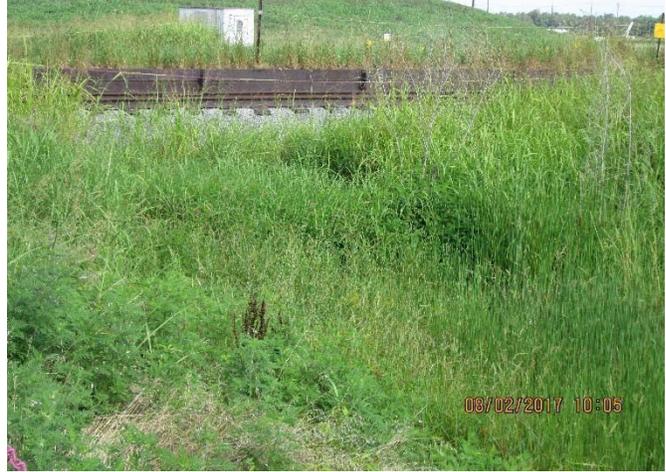
**Track #6, one 36" CMP culvert, inside the LA fence, approximately 25 feet north of Virginia Avenue,** at approximate GPS coordinates 37.116920° N, 88.814529° W. The west (outlet) end of this culvert is covered by rip rap and cannot be seen. The east (inlet) end appears to be 50% silted. No erosion either side of the track centerline, 20 feet each side. Recommend repositioning the rip rap at the culvert outlet (to facilitate inspection), remove sediment and trim the vegetation. See photographs 7903, 7938, and 7955.

7938 CMP Culvert (36"), Track #6, West End Covered by Vegetation

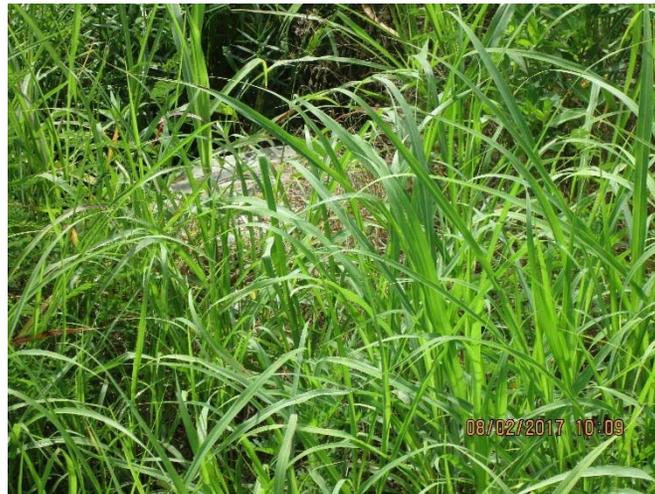
7955 CMP Culvert (36"), Track #6, West End Close Up of Vegetation

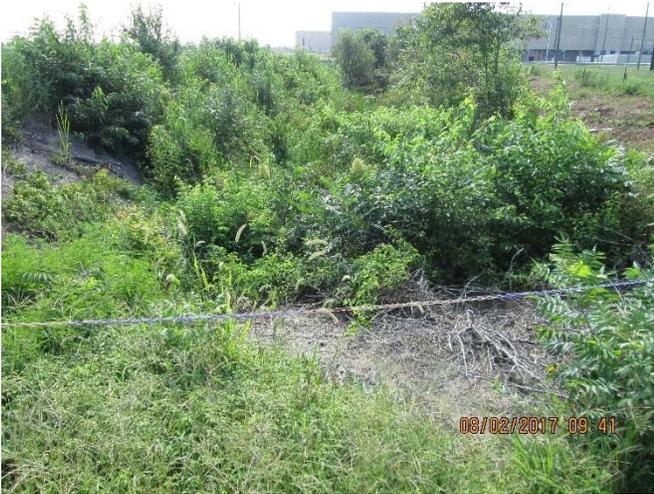
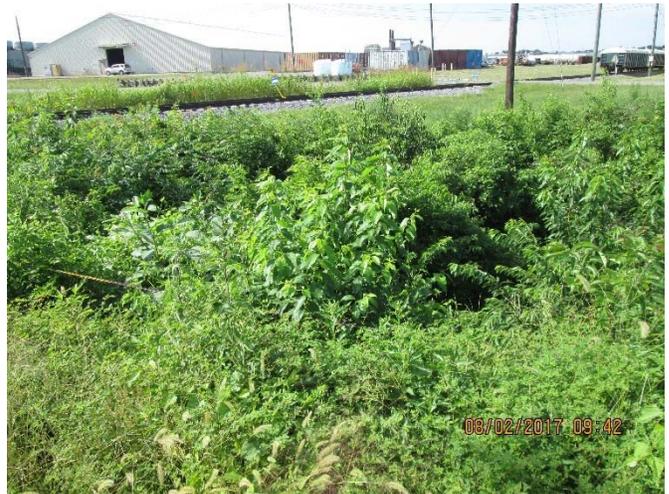
**Track #6, unknown type and size culvert, inside the LA fence, approximately 130 feet north of Texas Avenue, at approximate GPS coordinates 37.119069° N, 88.811962° W.** Both sides of this culvert are in radiological zones and extremely overgrown with vegetation and neither the inlet or outlet could be seen. However, the culvert is sufficiently long to provide a mowed area approximately 60 feet either side of the railroad track and there is no sign of erosion or sinkhole. This is a very active

drainage ditch leading to Outfall 001 and it appears to be draining well. Recommend controlling the vegetation on either side of the track to allow inspection of this culvert. See photos 7891 and 7898.

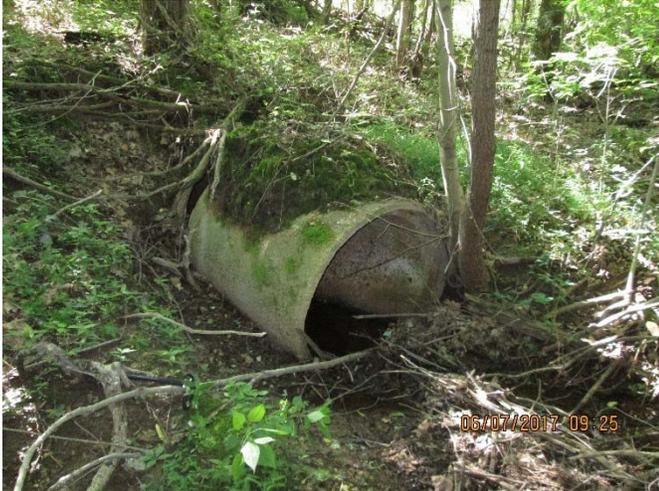
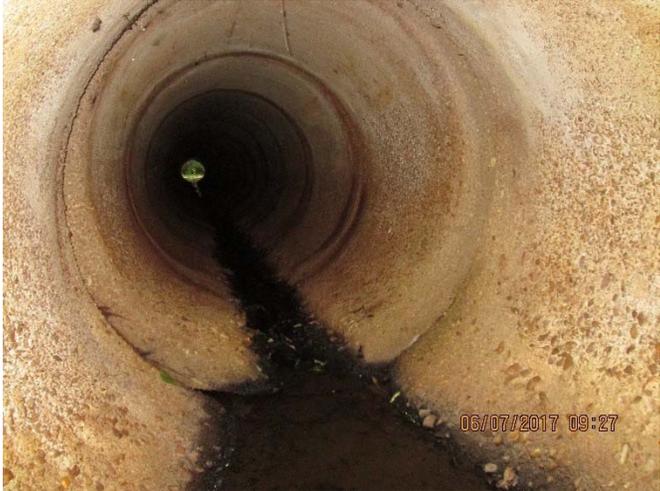
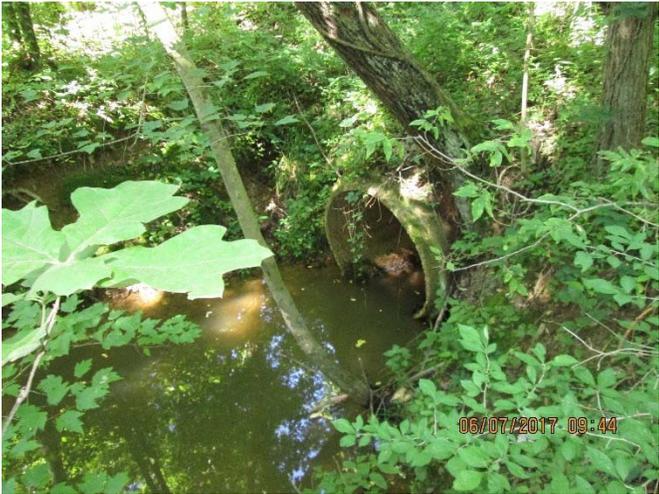
**Warren Road, northwest of Public Warning Siren 1A and 1B. This is a 48" RCP culvert beneath Warren Road, located at approximate GPS coordinates 37.099643° N, 88.837032° W and provides direct drainage from 0.14 square miles of surface area into the stream west of the sinkhole culvert (Culvert ID #5).** Though this culvert is not under the railroads, it provides critical access to public warning sirens A1 and A2 and indirectly provides controlled flow to the railroad culvert at location #5. The Warren Road culvert is deteriorating similar to the Culvert ID #5 railroad culvert, with the bottoms of the culvert beginning to erode away and the outside segments beginning to displace. One segment, on the west side, is displaced and a deep hole has been scoured on the east side. This culvert is most likely not sized correctly for the amount of area being drained and as a result, erosion has begun to occur upstream and downstream of Warren Road. In addition, with the bottoms having been scoured out, erosion may be occurring beneath the culvert. However, the segments have not separated inside the culvert. Recommend repositioning the outer segment on the west end, protecting this side with rip rap and filling the interior eroded bottom with concrete grout or some other permanent repair material. This culvert warrants additional periodic inspection as well as a review of the drainage requirements verses culvert size. See photographs 3450, 3459, and 3484.
