## Domes located in Resource Conservation Recovery Act Permitted Storage Areas

**Overview of Dome Skinning Needs**

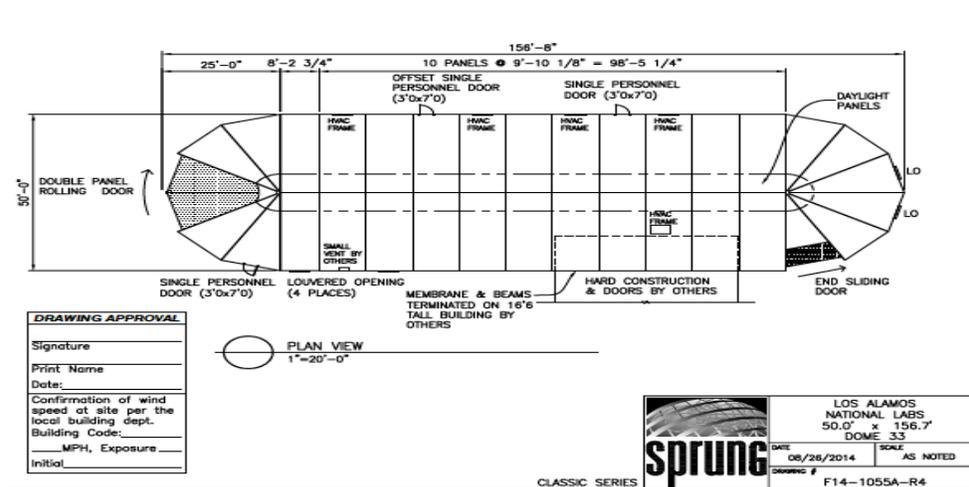
Dome 33 schematic.

Dome 33 (IPL #10) has external dimensions of 50' x 157' with a peak height of 24' and consists of approximately 7,850 ft<sup>2</sup> of space. The dome has 3 single personnel doors and 3 top lights. A concrete-block building that is approximately 40' long and 34' wide is attached to the dome, and has two additional personnel doors. A double-panel door is located on the west end of the dome for vehicle access. A single-panel rolling door is located on the east end of the dome for container-handling access. Dome 33 houses the DVS equipment and empty drums. Fabric for Dome 33 was purchased. Dome 33 does not have any RCRA violations. There are 22 containers in Dome 33. The definitized cost for Dome 33 reskin is \$927,768.

Dome 33 reskin cost is approximately \$927,768. Work begins in FY2016 and work will complete FY17. This includes labor and equipment (booms) and excludes fabric cost because the fabric is already in-house. An anchor failure calculation must be performed to ensure the

anchors hold the weight of the fabric. Dome 33 is a Sprung Structure. Sprung has a patented, proprietary method in which new fabric is installed over the deteriorating fabric eliminated the cost of equipment removal and fabric disposal.

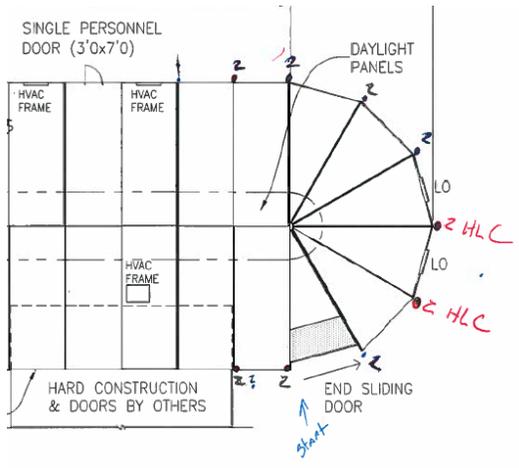
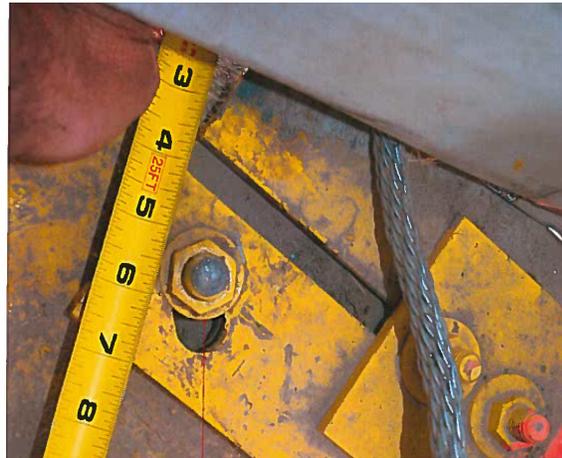
Dome 33 bolt location.

Dome 33 has 6 Hilti bolts. The hold down capacity has been identified as marginal as a result of the engineer study. It is recommended that that the bolts be replaced because the bolts do not meet LANL building standards. Two of the 6 bolts are mounted on a supporting wall and are not part of the anchoring system and thus not a concern of engineering. The remaining 4 bolts are located on the east side of the dome, see below diagram note 2 HLC -HX and anchor 2 metal plates.

Bolt requiring replacement.

The two plates will be replaced by cutting off the existing bolts and fabricating 2 new anchoring plates. The new anchoring plates will then be anchored with Hilti M12 HSL (laboratory standard). After the award is issued, a Field Change Request or a Directed Order Change will be requested to Florida Expo for a new plate design. After LANL approval, the plates will be fabricated and installed.

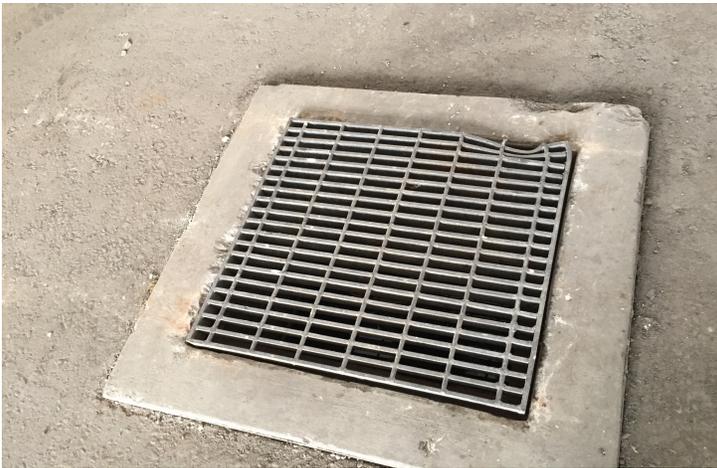
Dome 224 sump access.

Dome 224 has exterior dimensions of 60' x 110' with a peak height of 26' and consists of approximately 5,800 ft<sup>2</sup> of space, houses Gamma Spec and approximately 9 containers. Demolition and completion ROM costs are \$2,200,000 including removal of the dome structure fabric shell (skin), superstructure (aluminum framing), slab, and foundation. The mitigation of water discharge from an unground source into an interior sump (includes soil sampling) was discovered. Therefore, the interior sump will be removed closing a PFITS action. There will be a backfill of voids created by demolition of the slab and foundation and fill is required. Cost estimate includes the packaging, handling, shipping, and disposal of generated LLW streams.
