**ENERGY TECHNOLOGY ENGINEERING CENTER**

No. 029-AR-0001 Rev. \_\_\_\_\_

TITLE: FINAL D&D REPORT FOR BLDG. T029

**PURPOSE.** This report documents work performed to remove residual radioactive contamination in certain relatively inaccessible areas of Building T029, located in Rockwell International's Santa Susana Field Laboratories (SSFL), and to demonstrate that the facility is acceptably free of radioactive contamination.

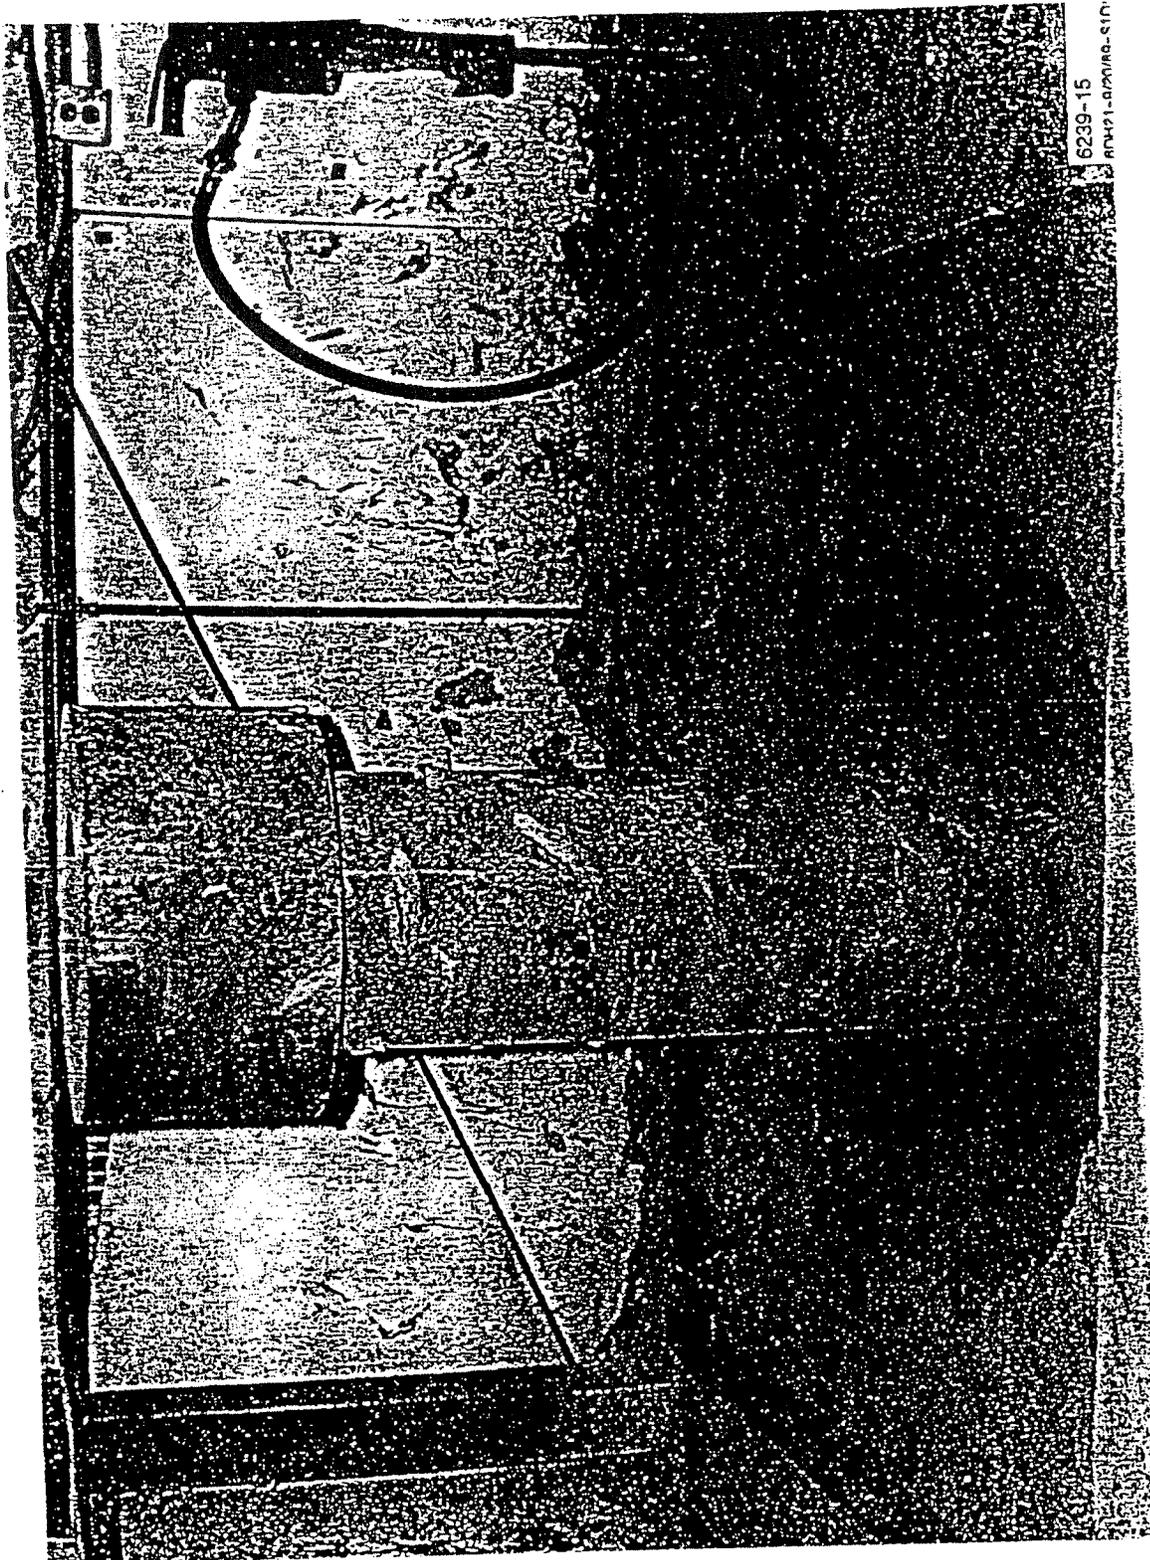
The Co-60 source cell was demolished, and its storage well was excavated partially to a depth of approximately 2 ft below grade in the same manner as the Ra-226 source storage well. Although, as noted previously, there was no contamination present in this location, the Co-60 structure was eliminated to an extent that provides an obstruction-free floor-space for future storage of nonradioactive materials. Routine smear surveys were performed at this location and the pit area to assure absence of contamination. Figures 4-4 and 4-5 show photographs taken during demolition of the Co-60 source cell and its storage well. The facility's exhaust blower was also removed.

Figure 4-4. Co-60 Source Cell After Demolition of Surrounding Concrete

Routine smear survey data on the Co-60 source well components such as the concrete, and the removed and retained portions of the source well showed no activity above background and hence these items were disposed of as normal industrial waste; the lead shielding surrounding the source well was sold as scrap.
