## PHOTOS FOR HWMF - T133 AREA

**MWH**  
 SANTA SUSANA FIELD LABORATORY  
 VENTURA COUNTY, CALIFORNIA  
 SODIUM AND POTASSIUM  
 TREATMENT PROCESS OVERVIEW

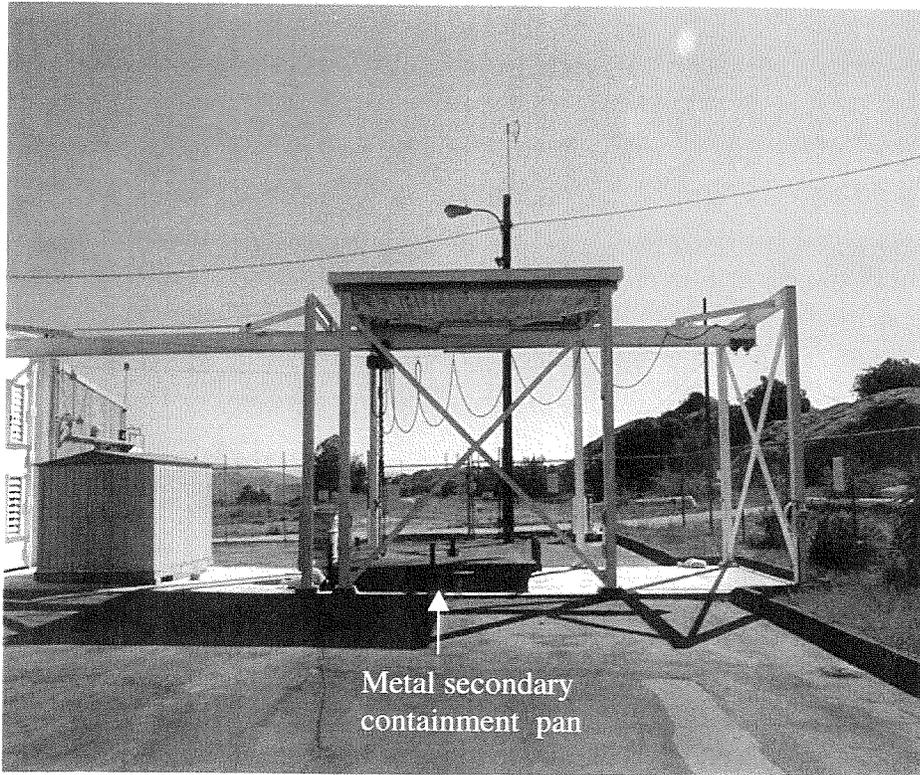
Photo 2: Size reduction area with concrete floor and over head lift (looking east). Size reduction performed under canopy (about 15 ft x 10 ft) within a metal secondary containment pan placed on the concrete.

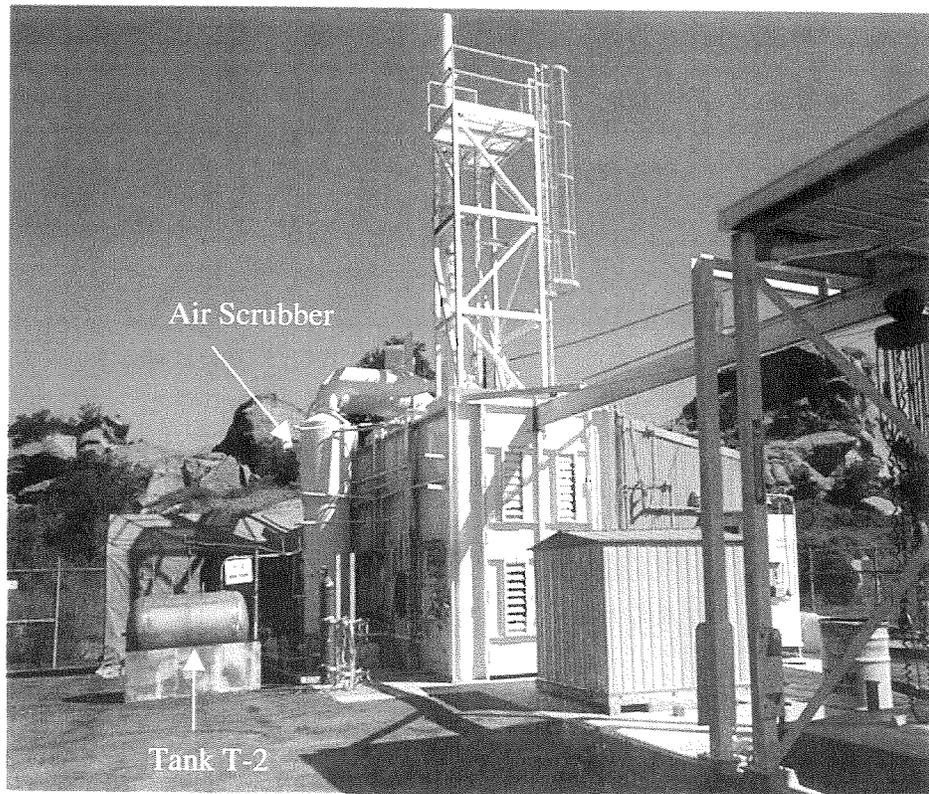
Photo3: View of treatment chamber, Tank T-2, and air scrubber (looking north). Treatment chamber on west side of building, about 10 ft wide x 10 ft long. Air scrubber located on west side of building. Tank T-2 shown within secondary containment, to the west of the scrubber. Cover to Tank T-1 seen in background.

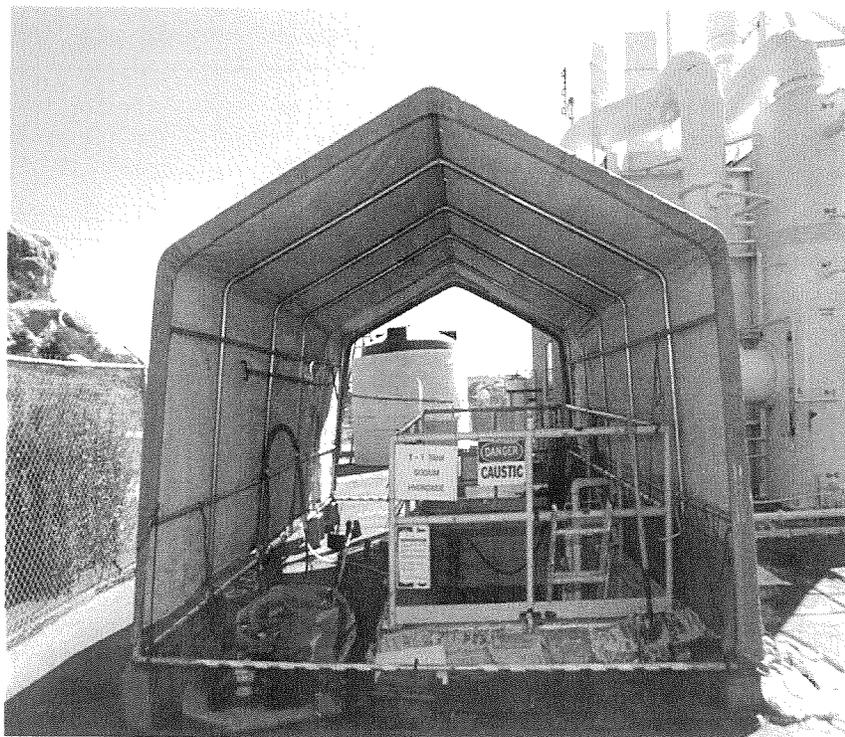
Photo 5 (Left): View of  
Tank T-1 area, looking  
East. Tank size about 5  
ft wide x 10 ft long, and  
6 ft deep. Tank T-3  
seen in background.

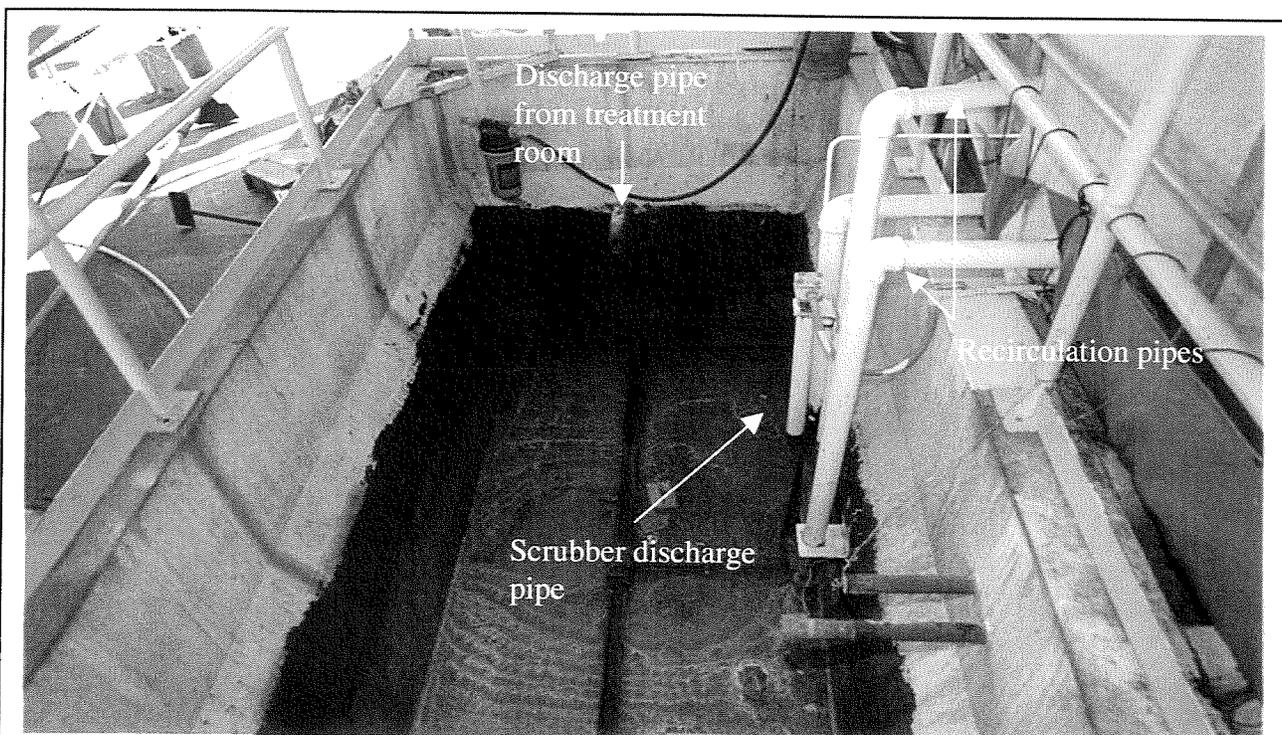
Photo 6 (Above): Detail of metal-lined tank T-1.

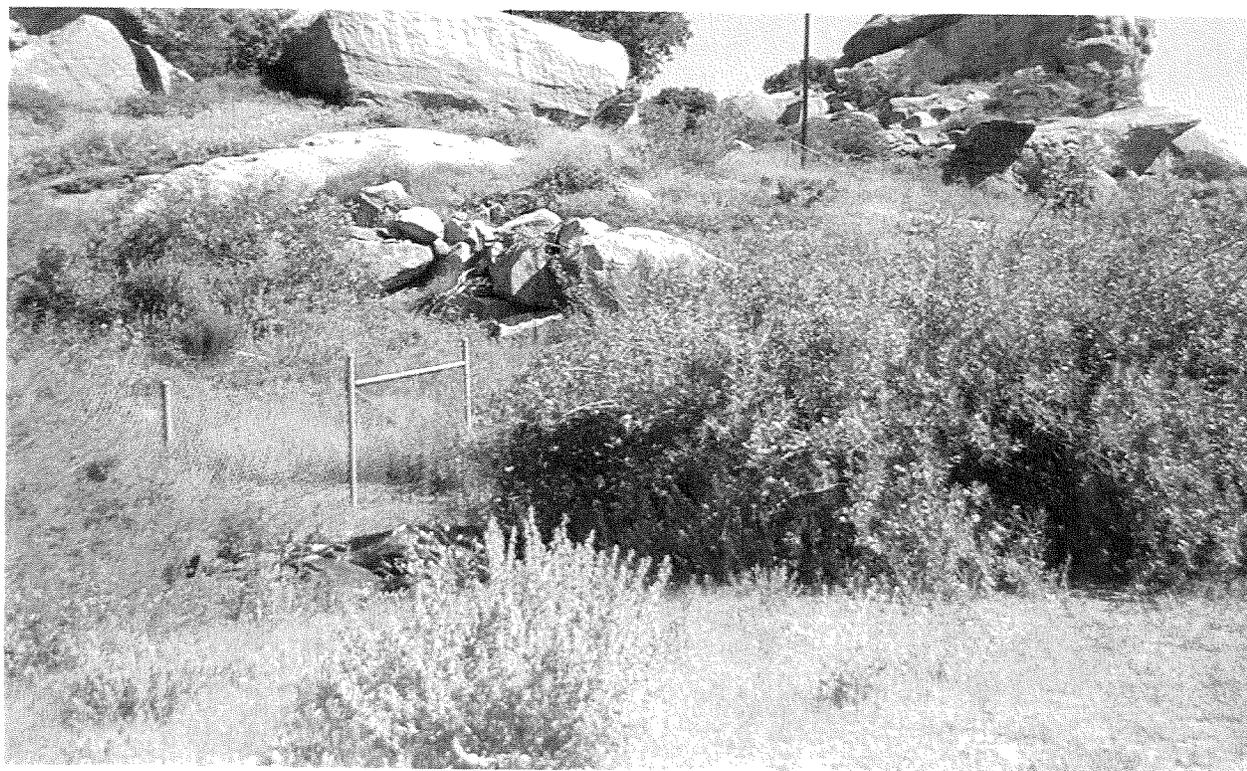
Photo 7 (Below): Area to the North of T133. Note topography slopes to the north.

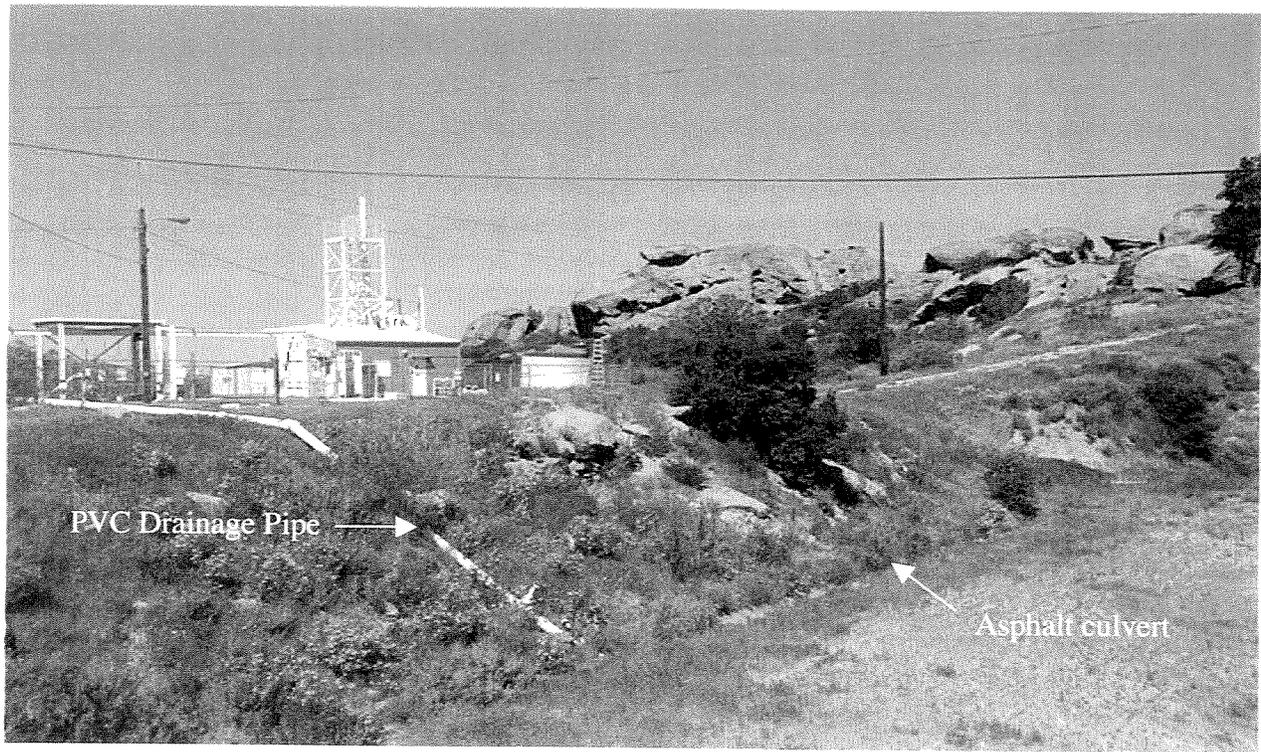
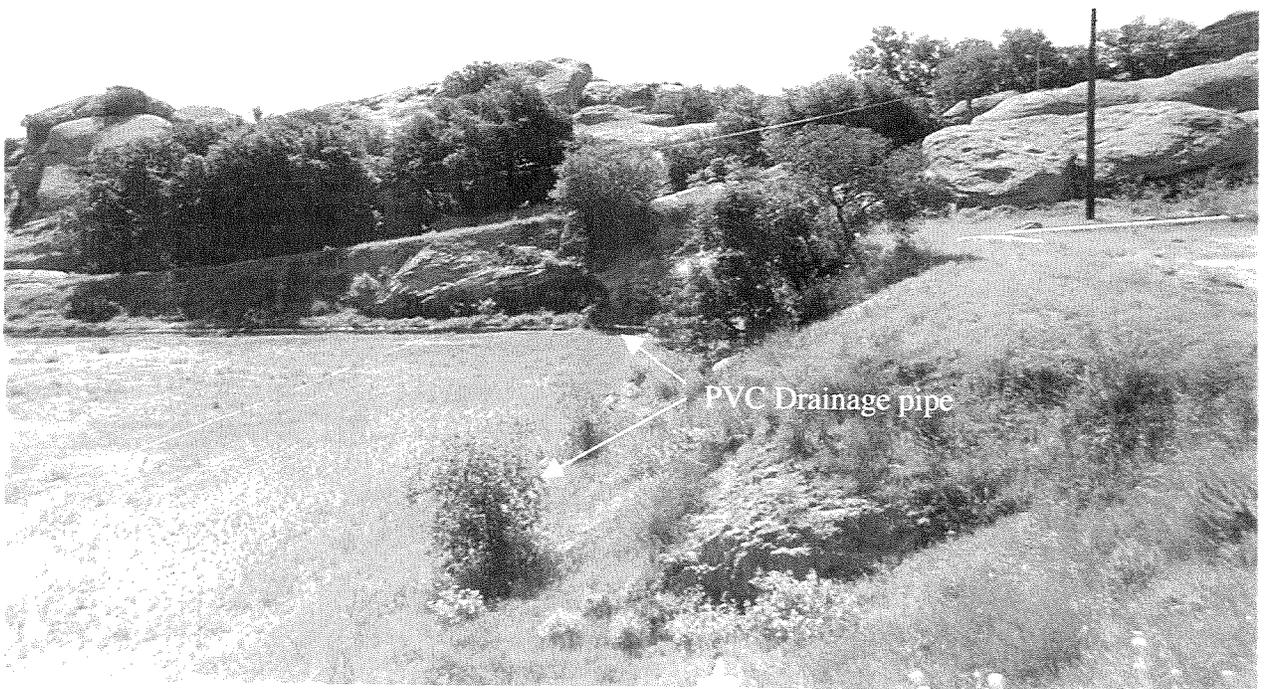
Photo 12 (Above): Area East of building T133, drainage line and drainage ditch looking west.  
Photo 13 (Below): Culvert, East of building T133.
