LIST OF FIGURES

THE BOEING COMPANY
 SANTA SUSANA FIELD LABORATORY
 VENTURA COUNTY, CALIFORNIA

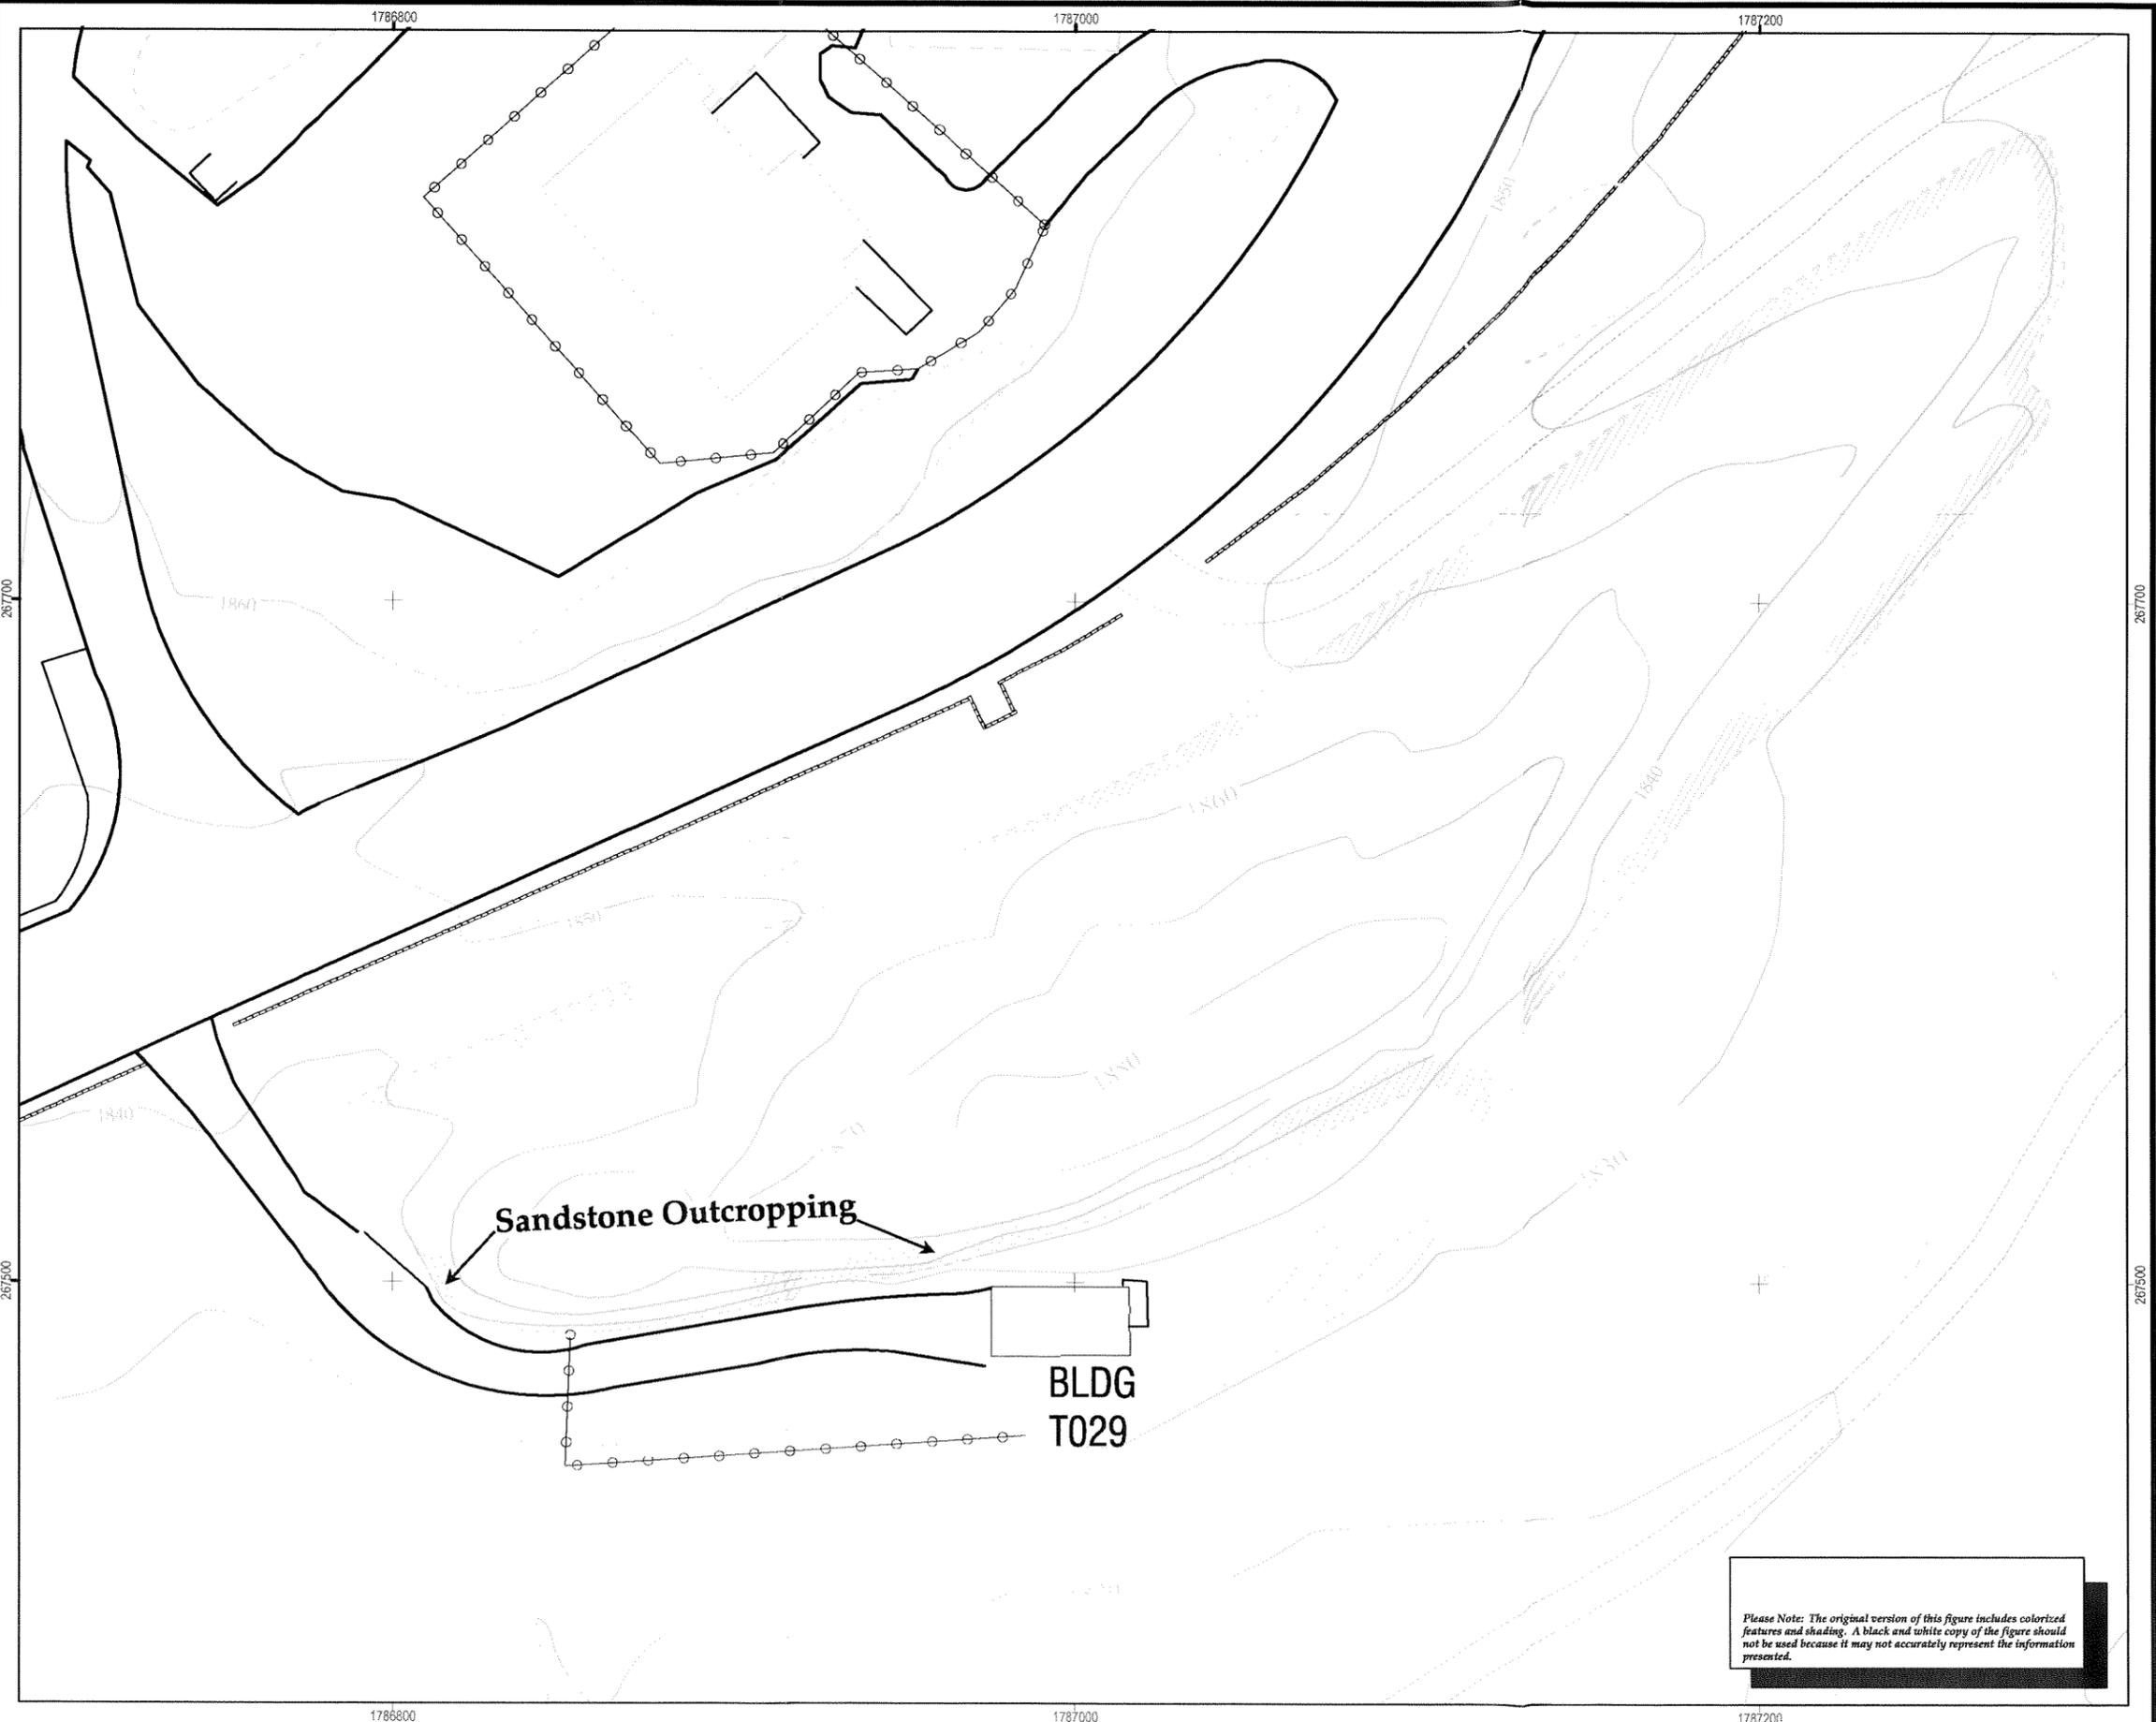
FIGURE 8

CRACK (PATCHED)

4" PVC DRAIN PIPE

BUILDING T029
AREA LAYOUT

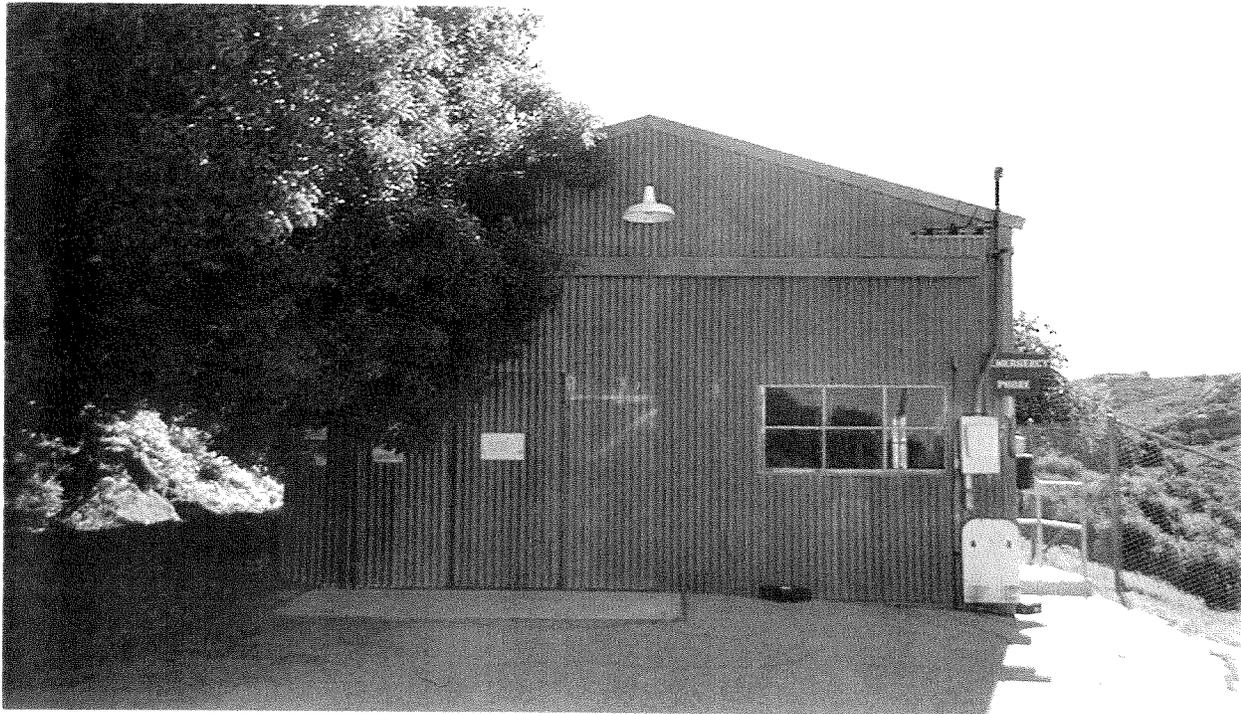
Photo 1 (Above): View of Building T029, note concrete loading pad at entrance, looking East. Concrete loading pad is 10 ft x 4 ft, in front of the 8 ft loading door.

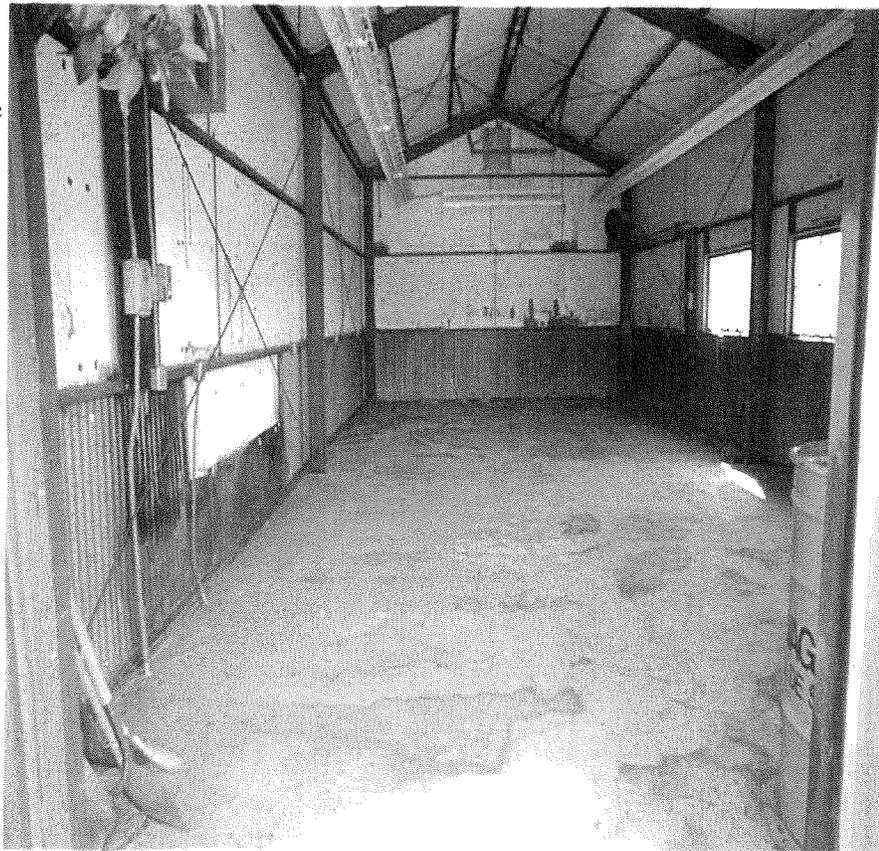
Photo 2 (Right): View inside Building T029, looking East. Size of building is 20 ft x 40 ft.

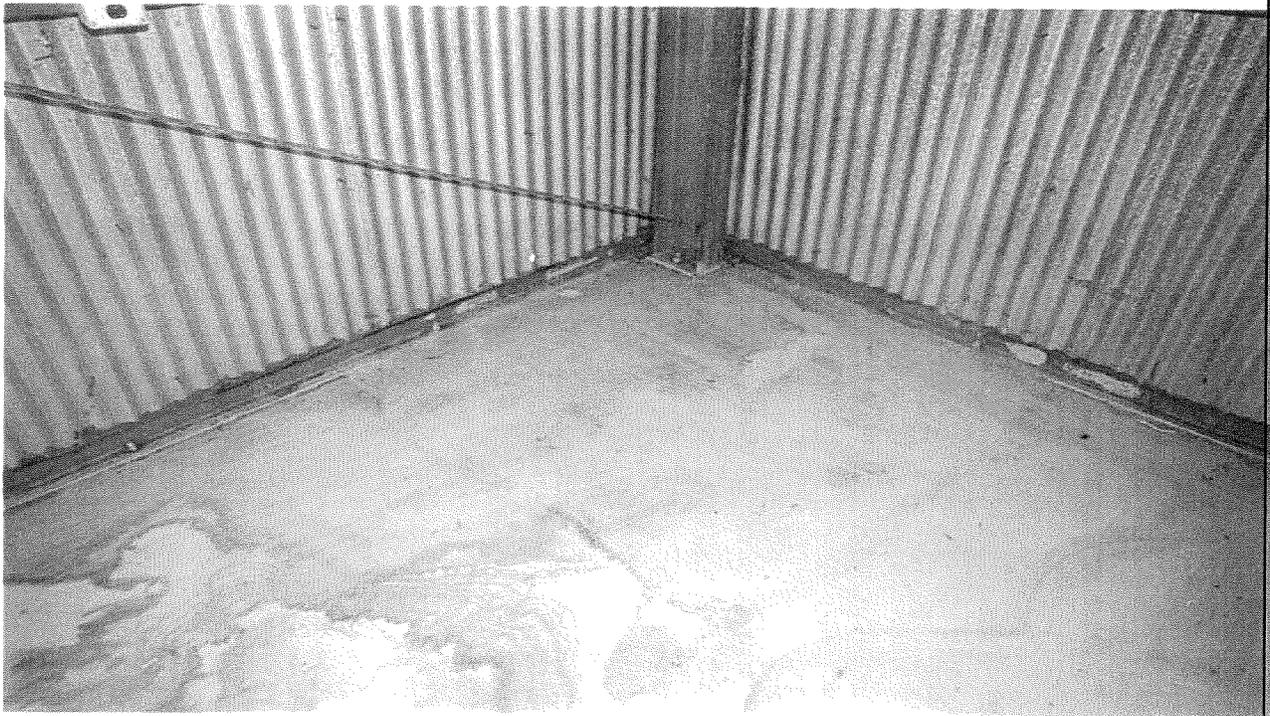
Photo 3 (Above): Patched concrete area (approximately 4 ft x 4 ft) on North-Eastern corner of floor in Building T029.

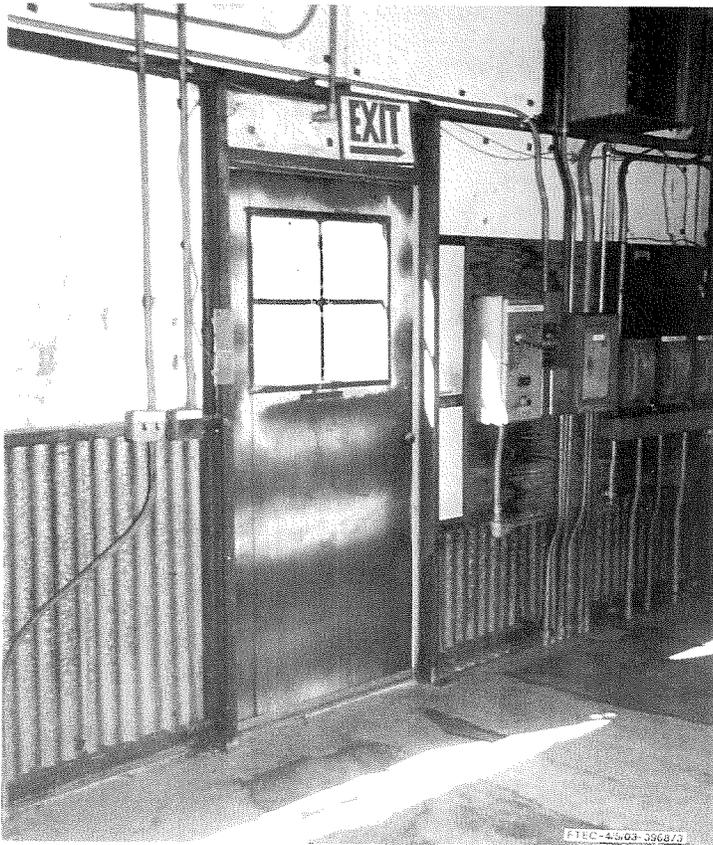
Photo 4 (Left): View of South-Western area of Building T029, including pedestrian entrance.

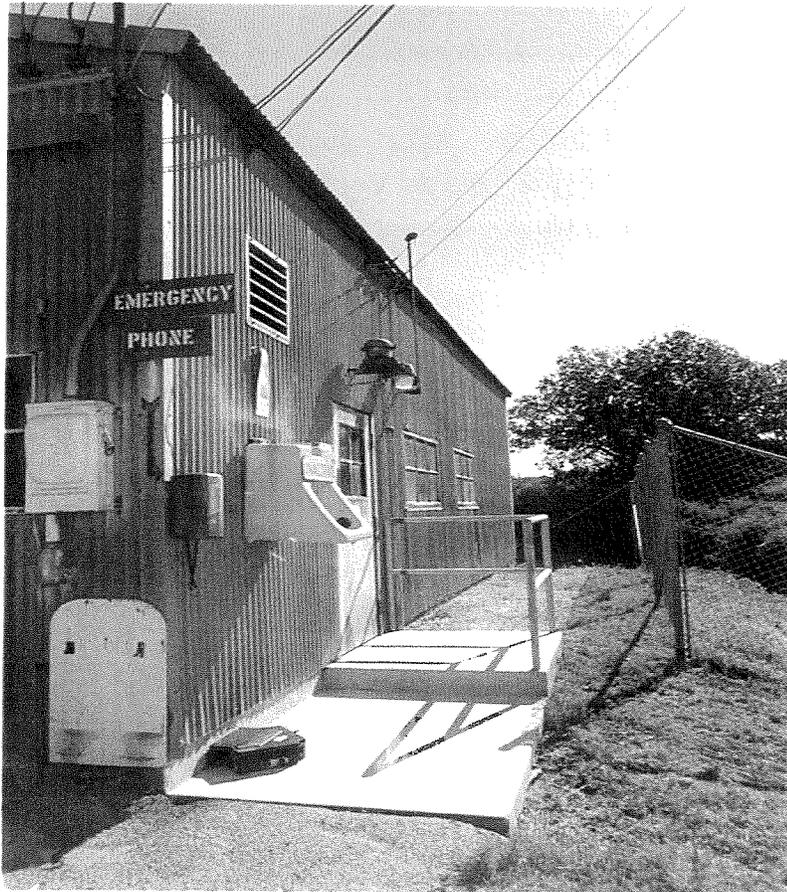
Photo 5 (Left): View of southern side of Building T029, looking East. Pedestrian entrance to building on south side.

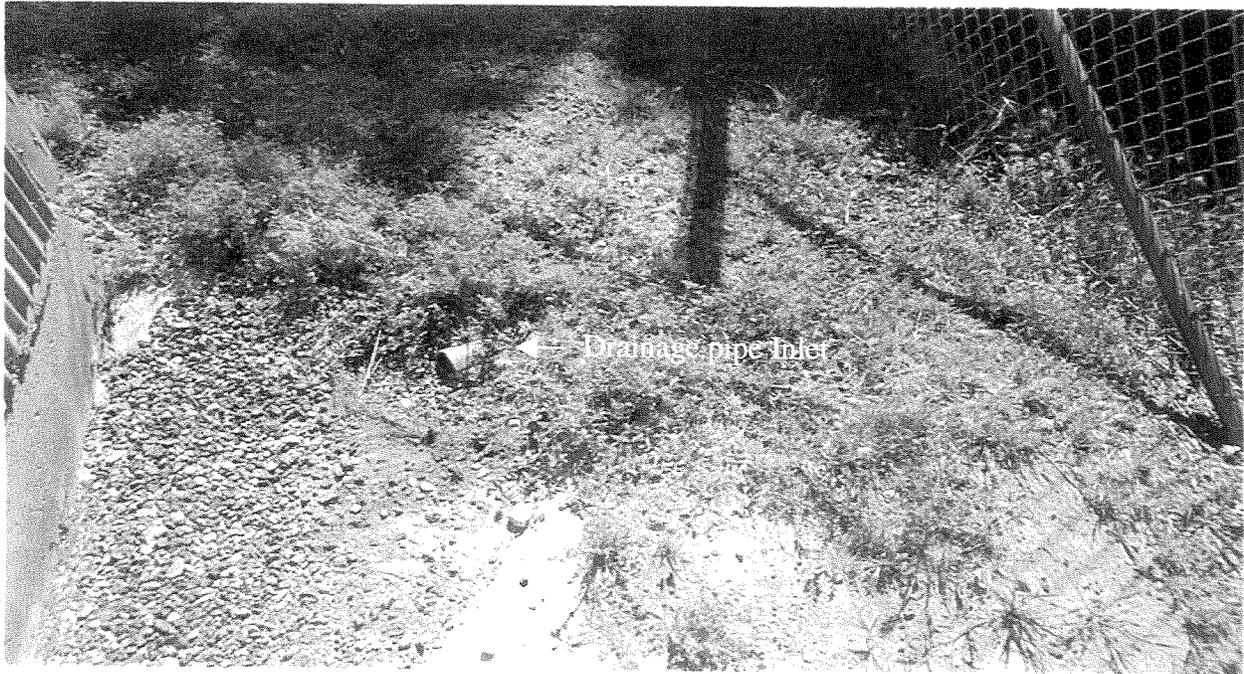
Photo 6 (Below): Drainage pipe on South-Eastern corner of Building T029. Total length of drainage pipe is approximately 6 ft. Purpose of pipe is for drainage of rainfall from south side of the building, including rainfall from the roof of the building.

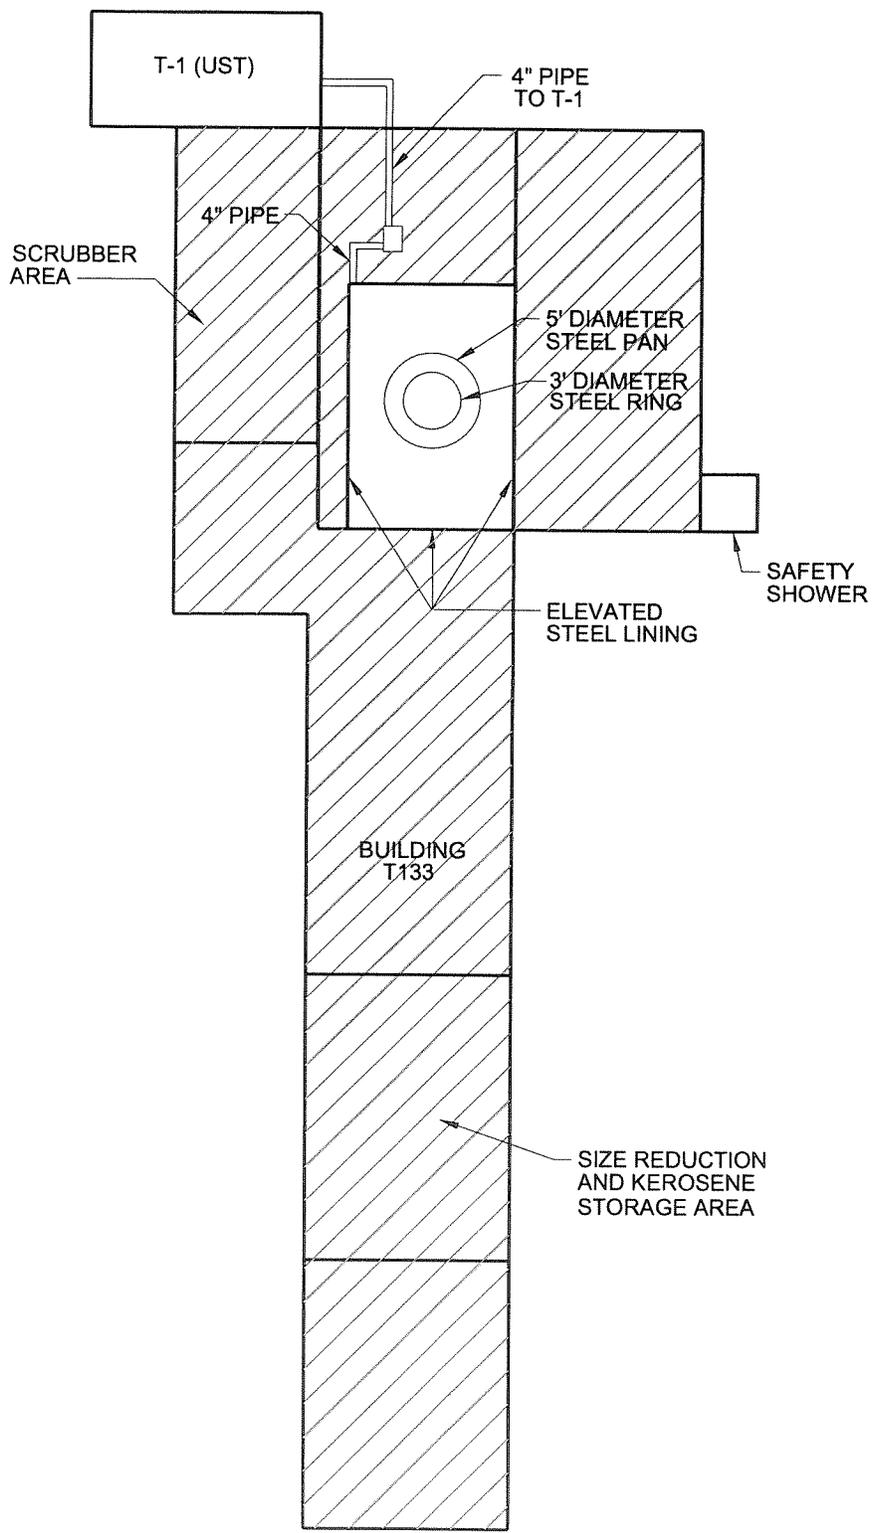
MWH
	SANTA SUSANA FIELD LABORATORY VENTURA COUNTY, CALIFORNIA
TREATMENT CHAMBER DETAIL AT BUILDING T133	
FIGURE 15

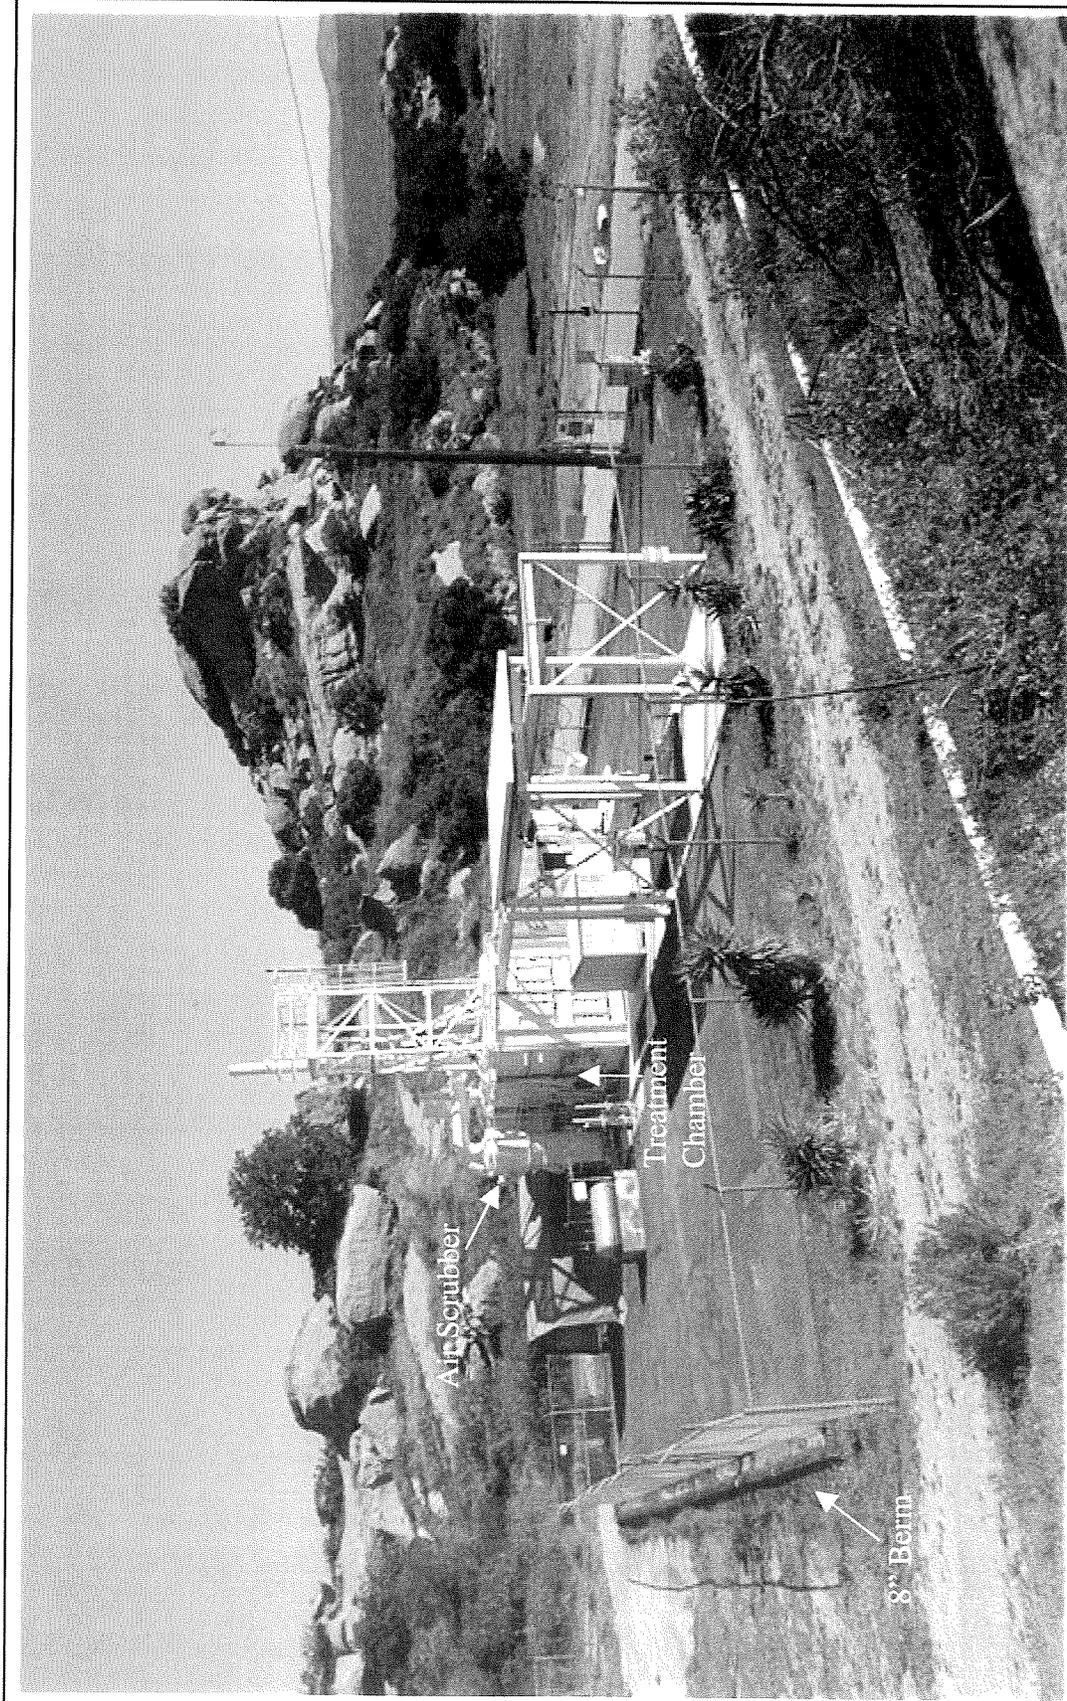
Figure 16

Photo 1: View of Building T133 (looking north). Fenced area is approximately 70 ft wide (i.e. east-west direction) x 85 ft long (i.e. north-south direction).

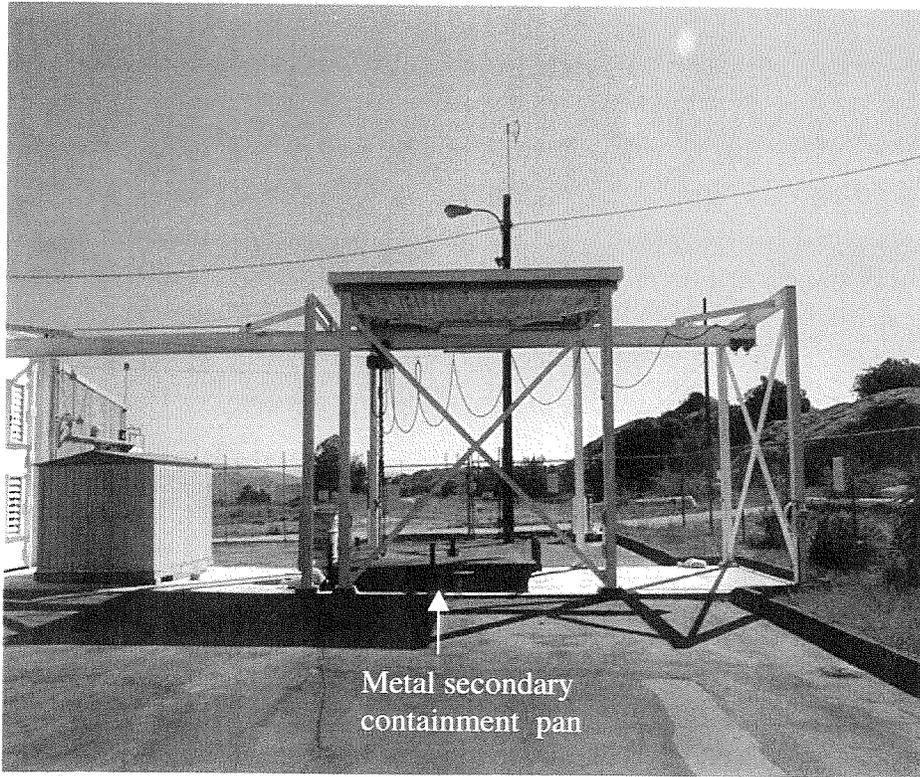
Photo 2: Size reduction area with concrete floor and over head lift (looking east). Size reduction performed under canopy (about 15 ft x 10 ft) within a metal secondary containment pan placed on the concrete.

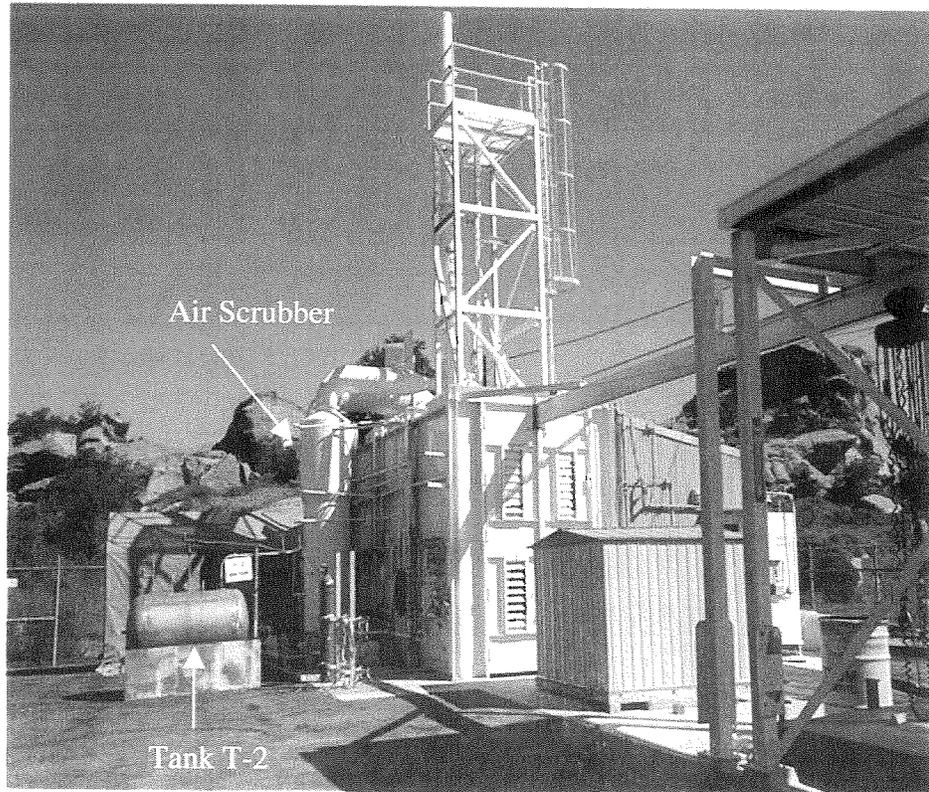
Photo3: View of treatment chamber, Tank T-2, and air scrubber (looking north). Treatment chamber on west side of building, about 10 ft wide x 10 ft long. Air scrubber located on west side of building. Tank T-2 shown within secondary containment, to the west of the scrubber. Cover to Tank T-1 seen in background.

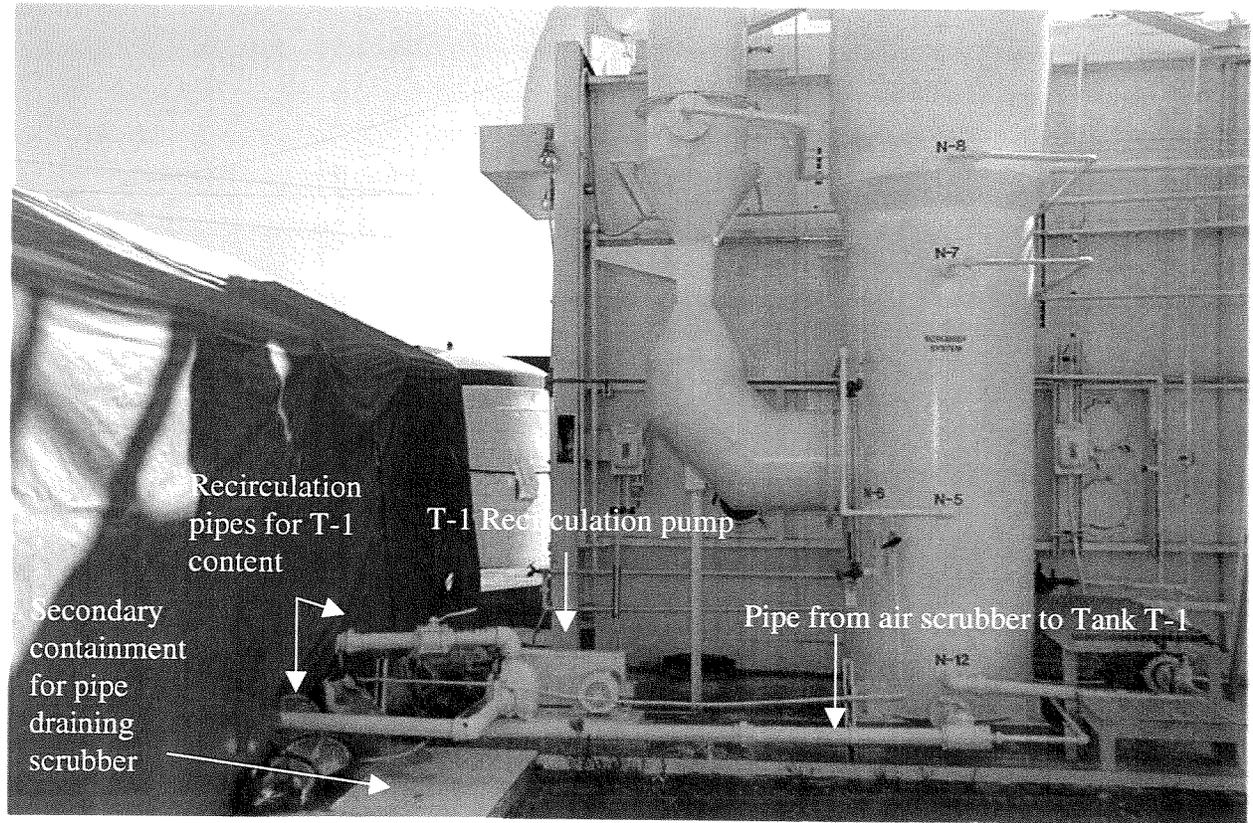
Photo 4 (Above):
Detail of scrubber area
looking east.

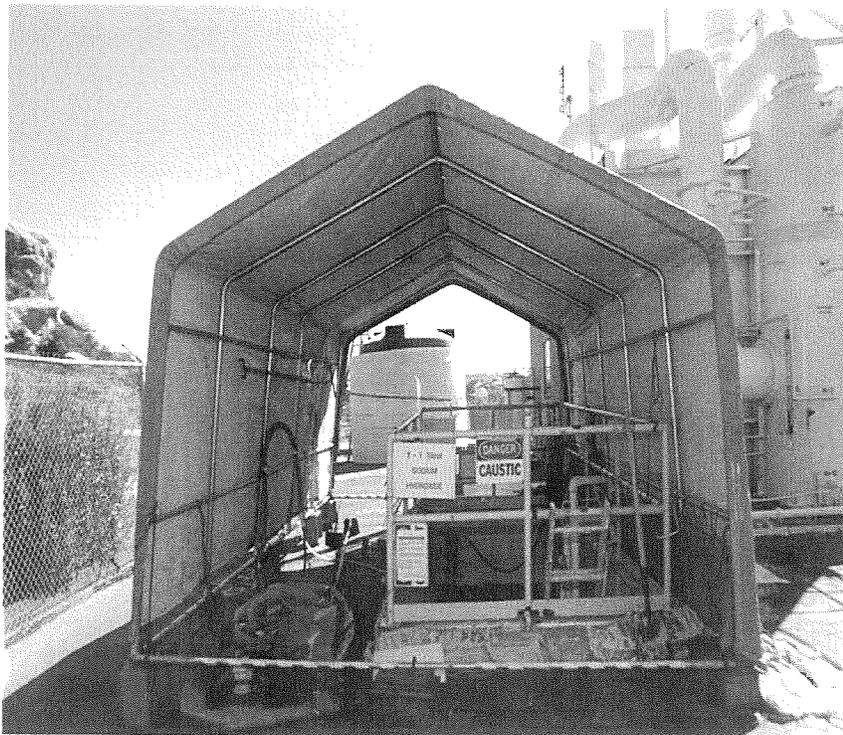
Photo 5 (Left): View of
Tank T-1 area, looking
East. Tank size about 5
ft wide x 10 ft long, and
6 ft deep. Tank T-3
seen in background.

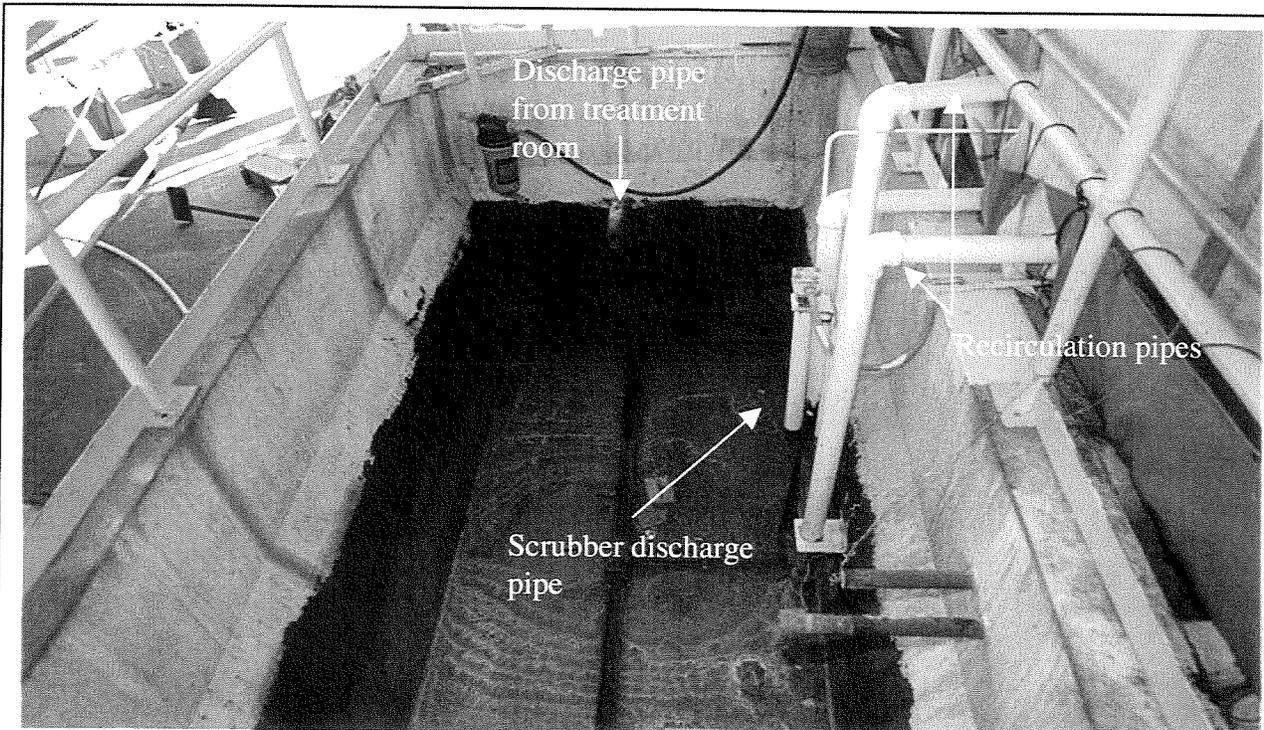
Photo 6 (Above): Detail of metal-lined tank T-1.

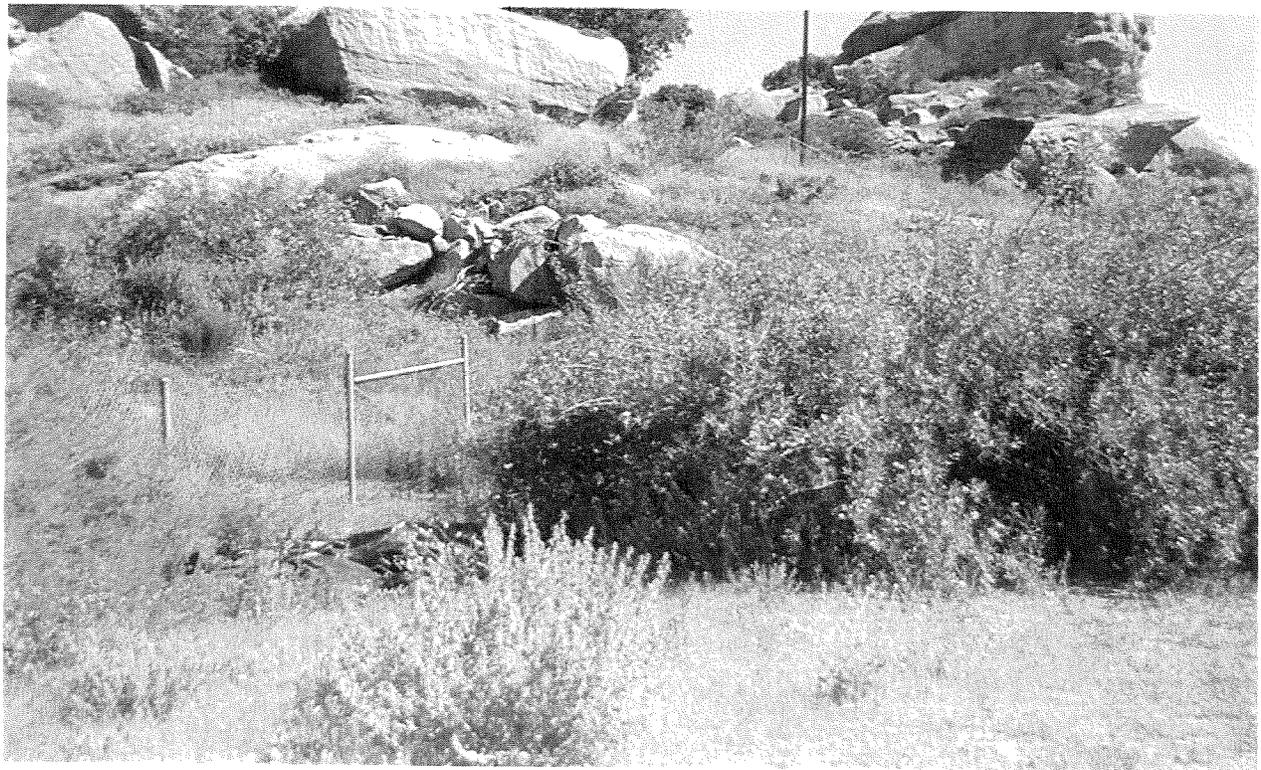
Photo 7 (Below): Area to the North of T133. Note topography slopes to the north.

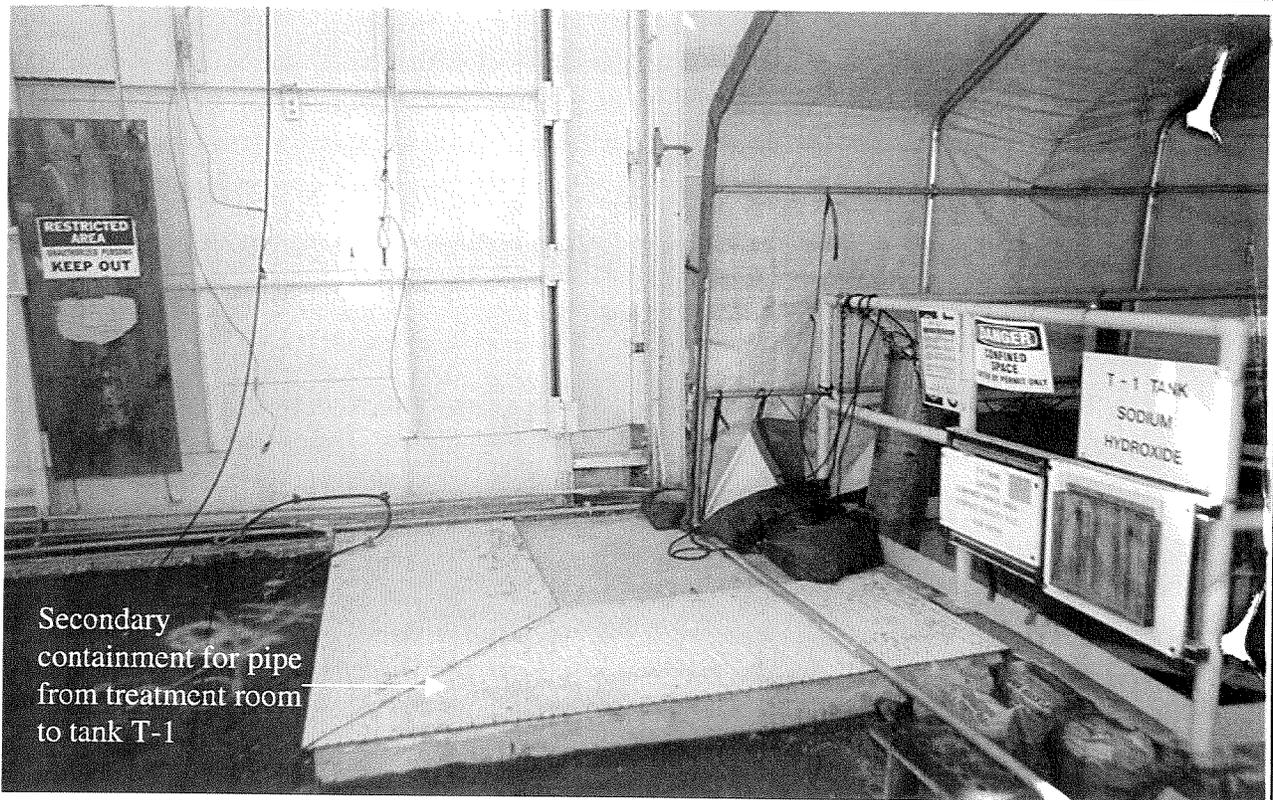
Secondary containment for pipe from treatment room to tank T-1

Photo 8 (Above): Secondary containment for pipe from treatment chamber to tank T-1 (looking south).

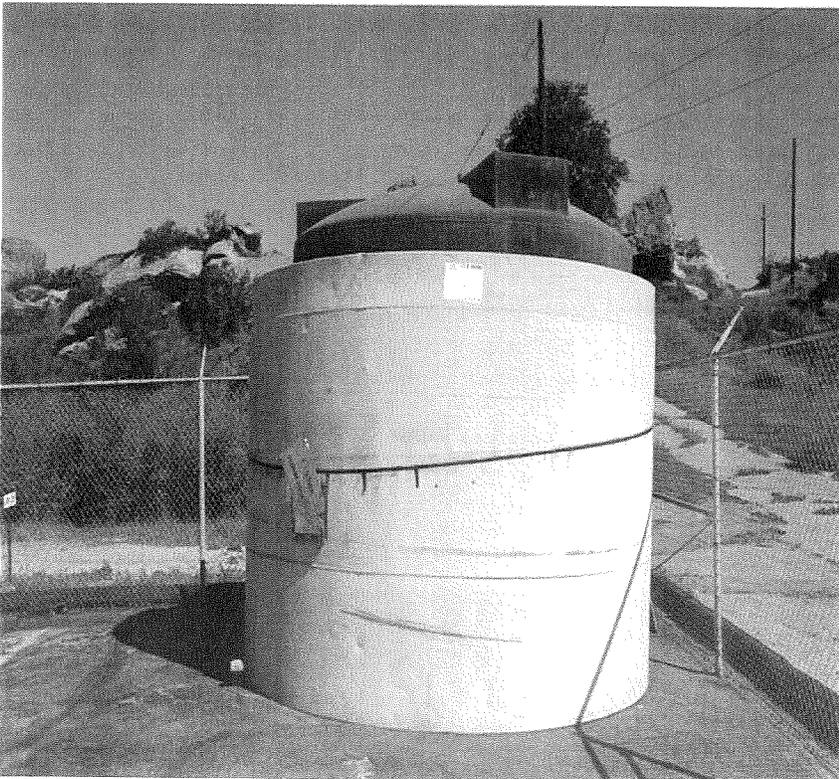
Photo 9 (Left): View of tank T-3 (tank and secondary containment, looking north).

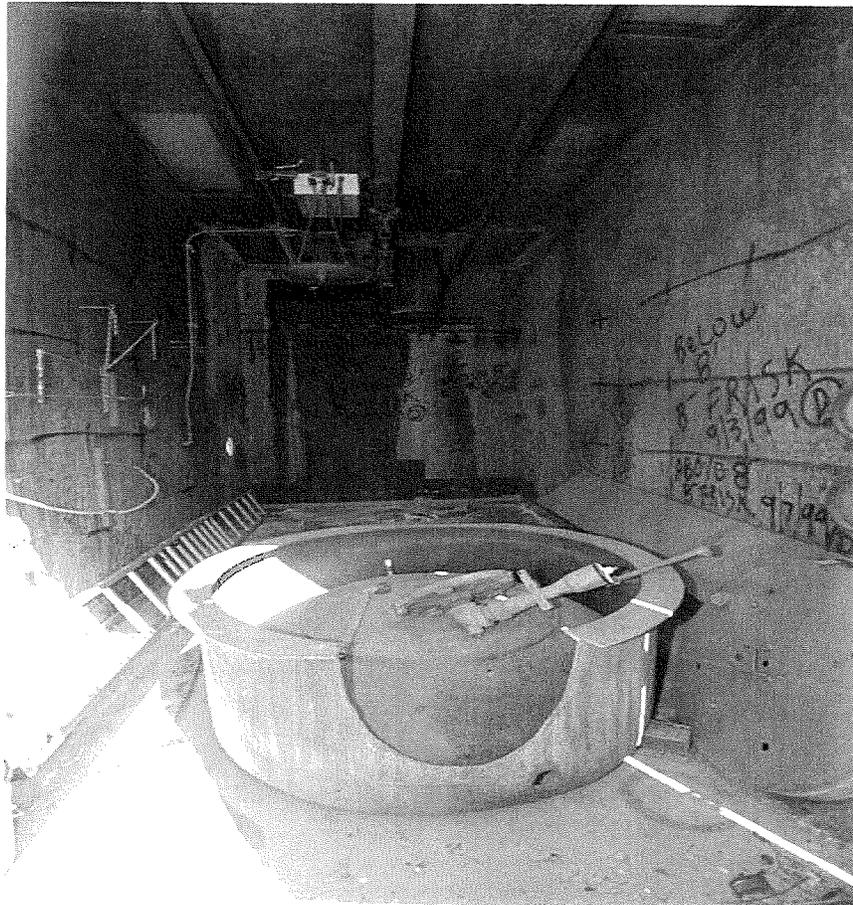
Photo 10 (Left): View inside treatment chamber. Note that for examination of the area, the items located in the treatment room, such as burners, treatment bowl, and the metal liner have been moved from their original locations. The treatment bowl is presented upside down.

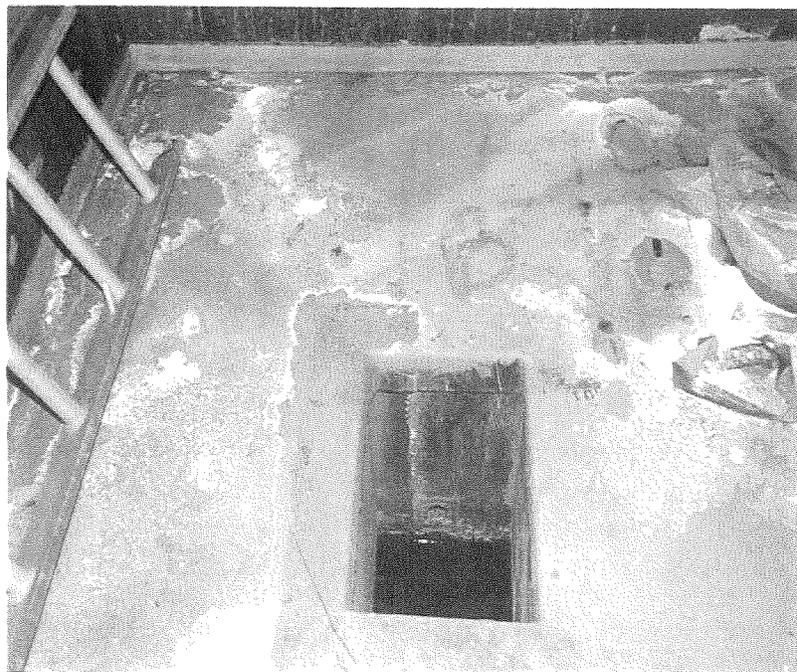
Photo 11 (Right): Sump towards northwestern area of treatment chamber. Size of sump is 16 inches x 21 inches and 27 inches deep.

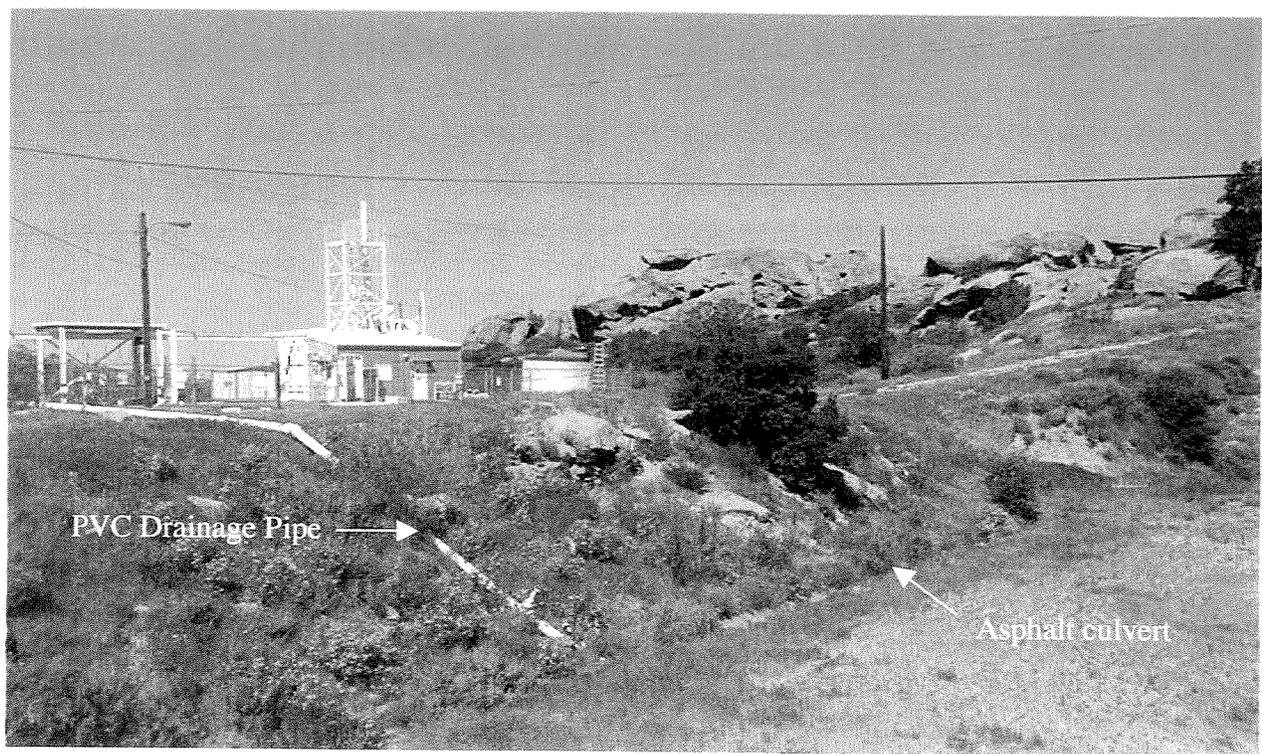
Photo 12 (Above): Area East of building T133, drainage line and drainage ditch looking west.
Photo 13 (Below): Culvert, East of building T133.

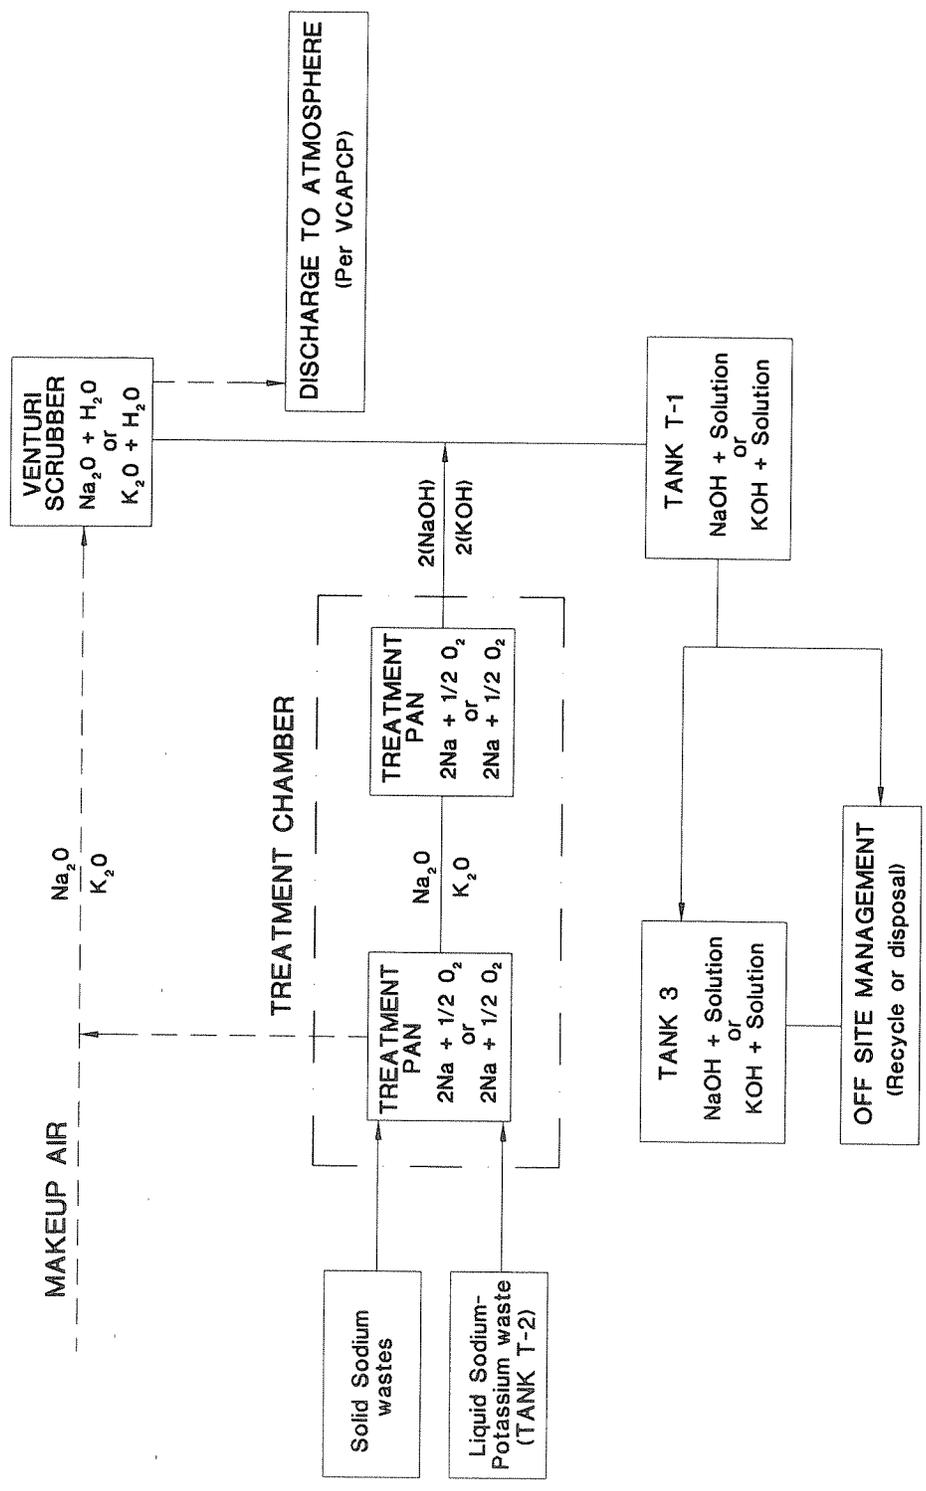
FIGURE 23

MWH
 SANTA SUSANA FIELD LABORATORY
 VENTURA COUNTY, CALIFORNIA
 SODIUM AND POTASSIUM
 TREATMENT PROCESS OVERVIEW
