LIST OF FIGURES

THE BOEING COMPANY
 SANTA SUSANA FIELD LABORATORY
 VENTURA COUNTY, CALIFORNIA

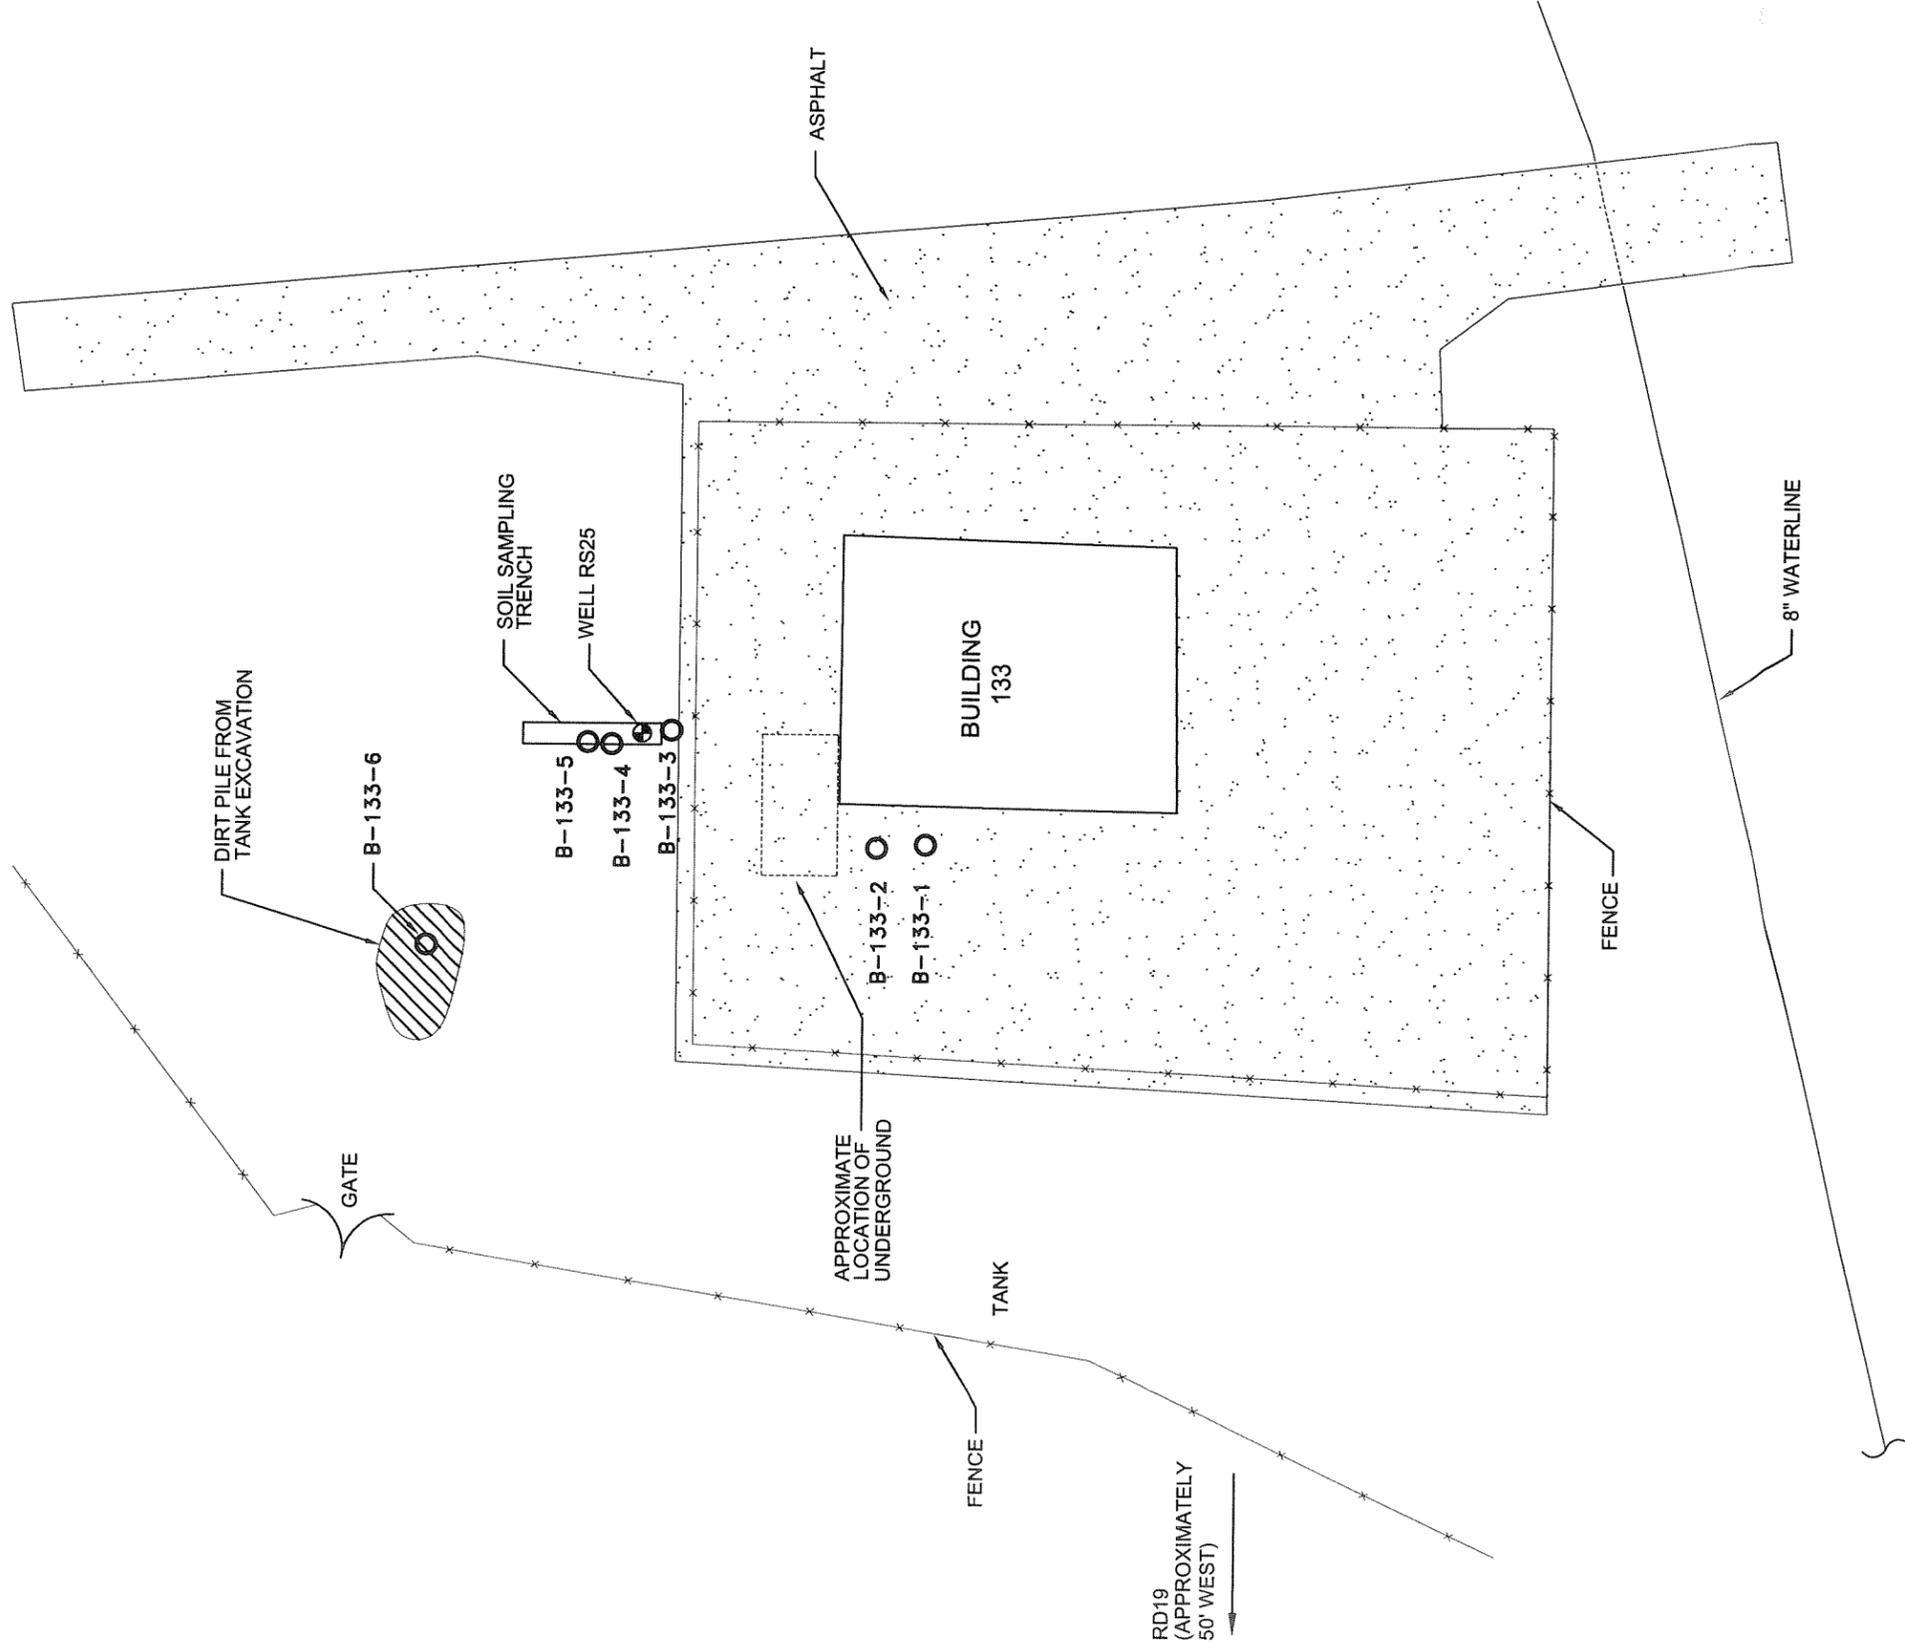
FIGURE 29

- 1) ALL RESULTS IN mg/kg.
- 2) ONLY COMPOUNDS DETECTED ABOVE REPORTING LIMITS ARE INCLUDED IN THIS FIGURE.

1988 BUILDING T133
 INVESTIGATION DATA FOR SOIL
