Geophysical Investigation of Bayo Canyon Aggregate Area Los Alamos, New Mexico

ARM Project No.: 07254

December 14, 2007

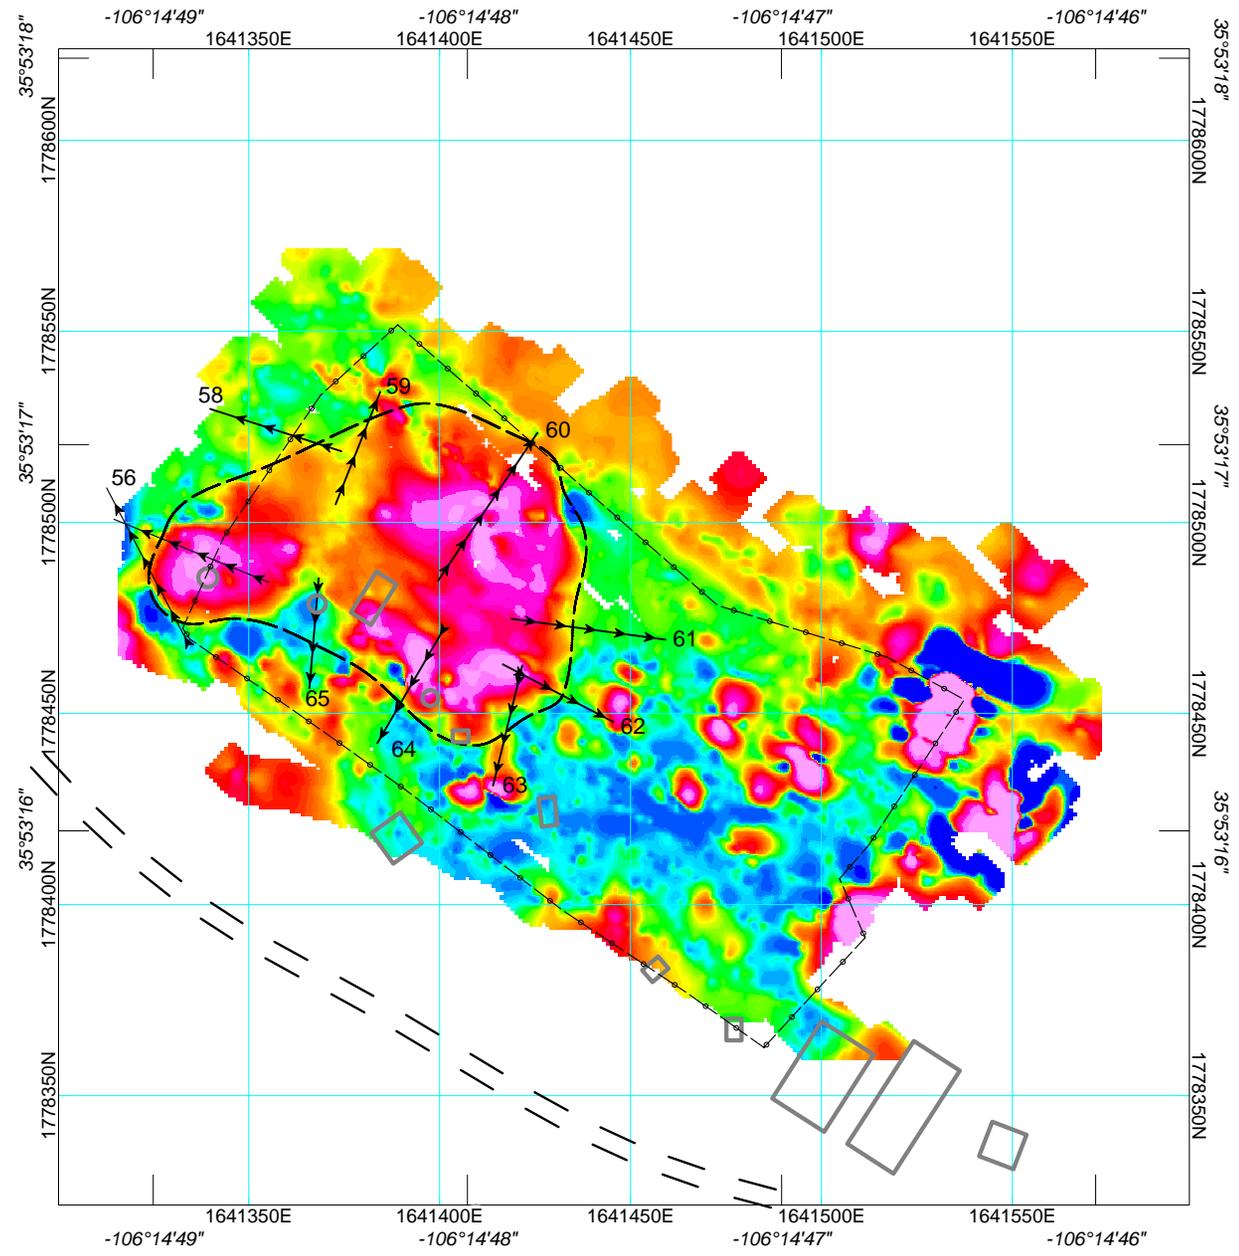
Figure 1
Buried Metal Anomaly (EM61) Map
SWMU 10-007 Building Debris Landfill

Figure 1 presents a plan map of the EM61 data. These data show high amplitude anomalies and abrupt lateral variations that suggest the presence of buried metal objects. Since the EM61 only responds to metal objects, values above background indicate the presence of metal. The results presented in Figure 1 show a kidney-shaped anomaly in the western portion of the survey area that is consistent with the suspected location of the debris landfill. Additional anomalies (reddish to pink in color) located near the eastern border of this survey area are attributed to interference from fence posts and other metal objects that were being temporarily stored there. Figure 2 presents a plan map of the EM31 data, which generally conforms with the EM61 data. The interpreted boundary of the debris landfill was refined using the GPR data. Nine GPR lines were run in a radial pattern over the suspected landfill boundaries. The GPR data is presented in Appendix A. The results generally corroborate the EM data with a one exception. The area near GPR line 65 appears to be outside the main EM anomaly. However, the GPR results indicate an anomaly exists outside the interpreted EM anomaly area. It is likely that the source of the GPR anomaly is nonmetallic (probably concrete) and therefore did not produce a significant EM response. The debris landfill boundary shown in Figure 1 is a combined interpretation of all geophysical data sets (EM31, EM61 and GPR). The inferred area of the debris landfill is 6010 square feet.

Finally geophysical techniques were applied to SWMU 10-007 to delineate the extent of the buried construction debris known to exist in the area.. The EM results identified a kidney shaped anomaly that was attributed to buried material and disturbed subsurface conditions. GPR data acquired over this same area identified various anomaly shapes including tabular bodies that are interpreted as demolition debris. The inferred area of the debris landfill is 6010 square feet.

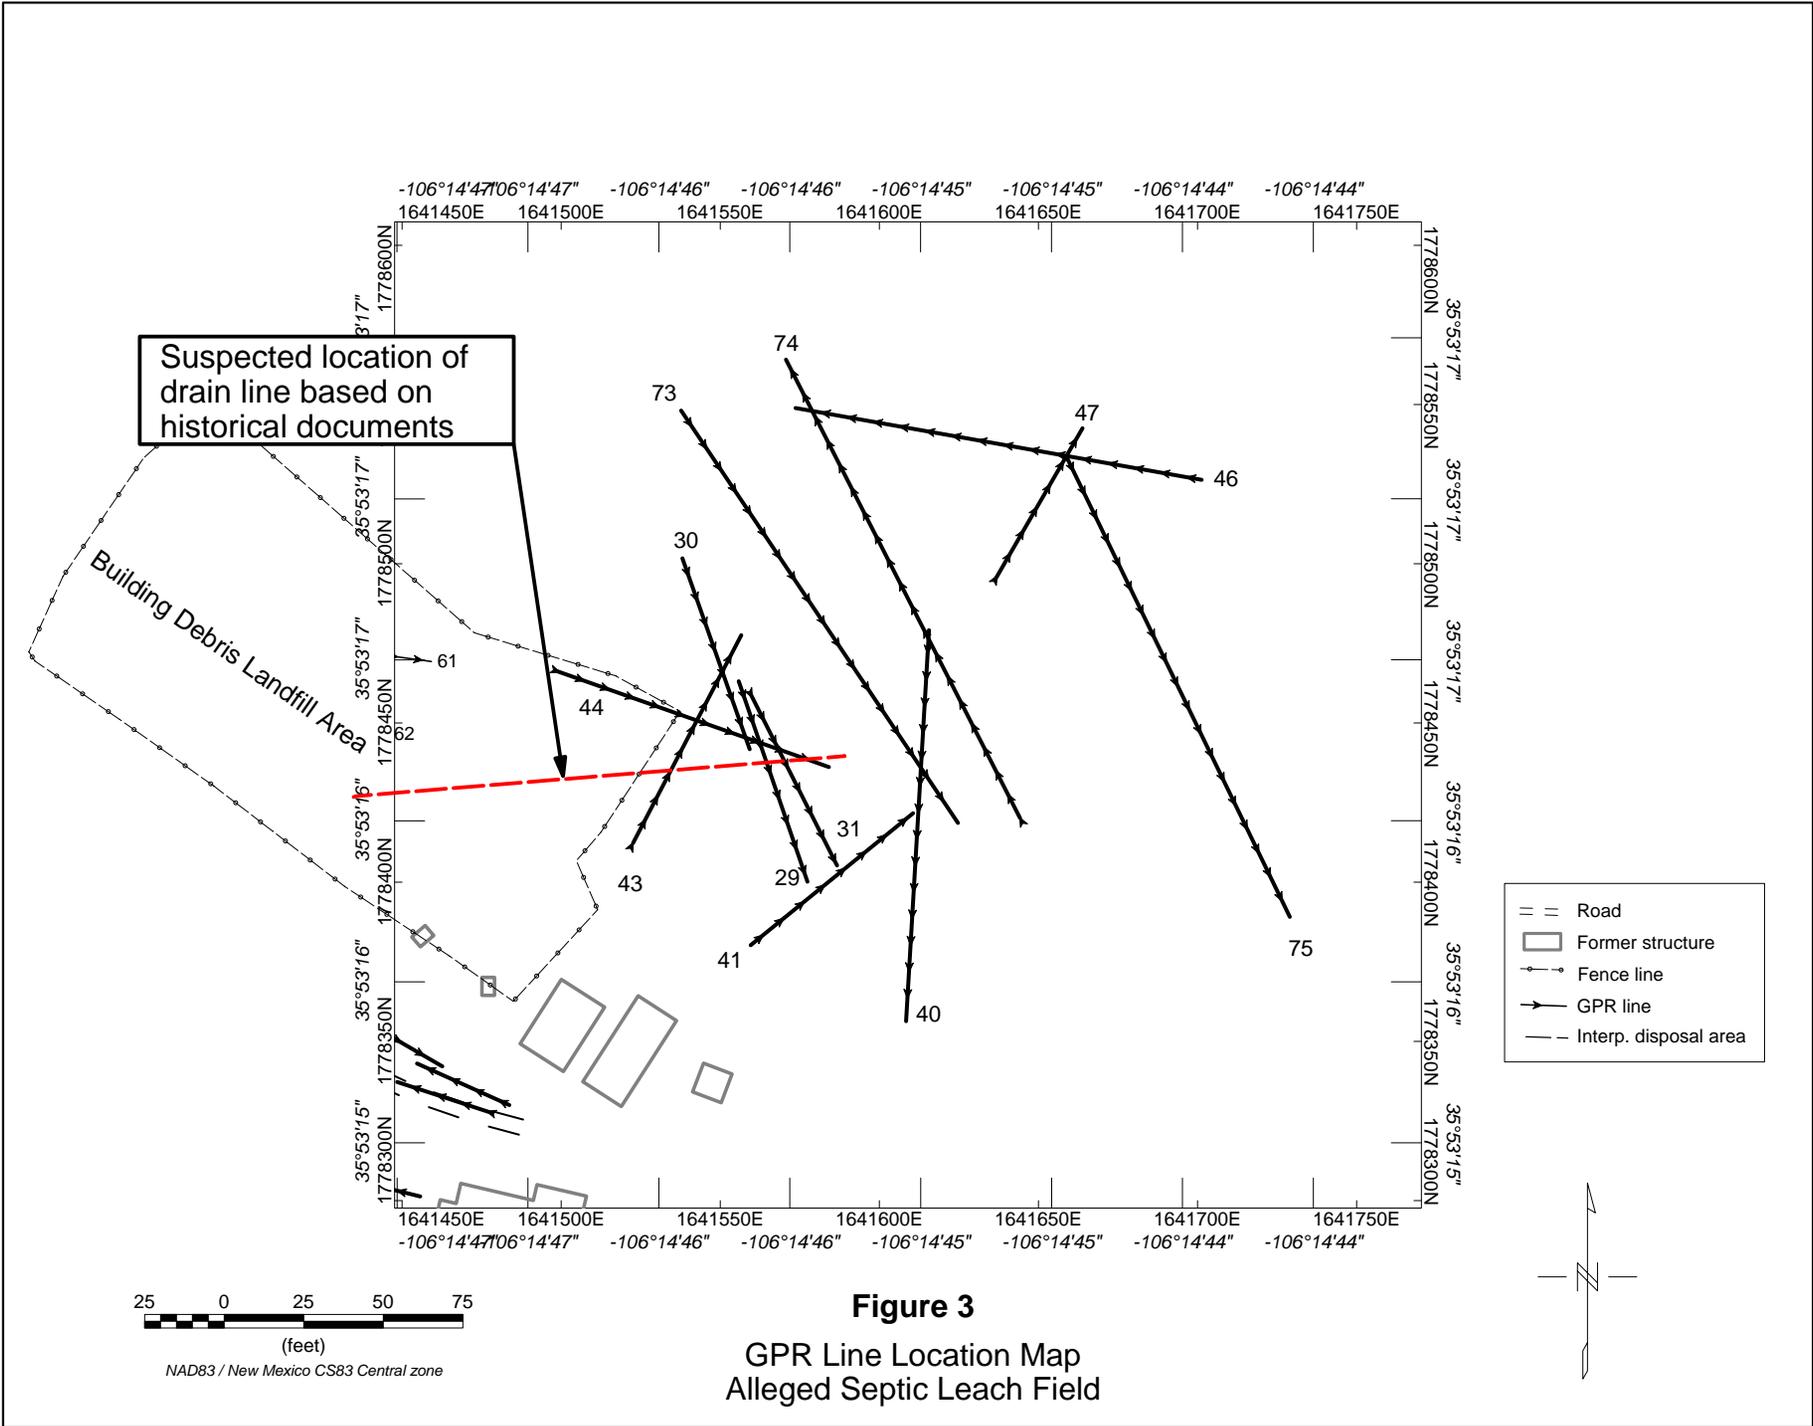
Historical documents indicate a former septic leach field exists northeast of the Central Area. The alleged leach field was apparently associated with structures that were removed from the area that is now considered the Central Area (within the fenced boundary). Based on ARM's professional judgment and experience with these types of structures at LANL, they usually contained no metal and cannot be mapped using EM techniques. For this reason only GPR was used. Numerous GPR lines were collected in an attempt to identify any existing buried pipelines extending into the suspect area. In addition, lines were run to look for lateral variations that may be associated with disturbed subsurface conditions. The locations of the GPR lines are shown in Figure 3.

Detailed computer analysis of the GPR data showed no anomalies that could be confidently attributed to the alleged leach field.

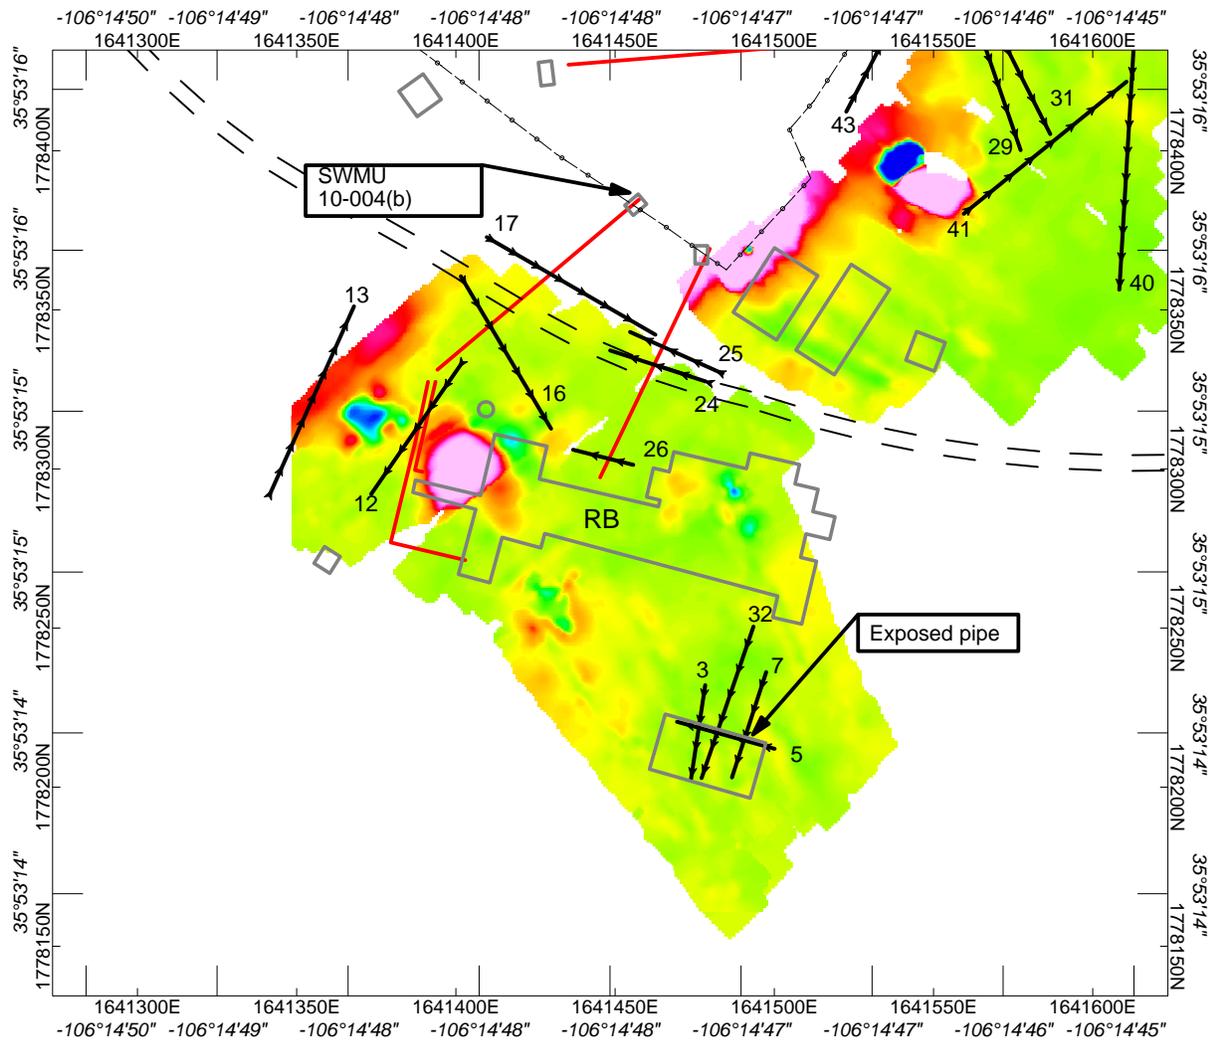
Figure 4

Historical documents show the presence of buried pipes extending from the former Radiochemistry Building to a septic tank(s) located north of the building and within the present Central Area. EM data were acquired over these areas as shown in the terrain conductivity (EM-31) map (Figure 4). These results do not show any linear anomalies that would suggest the presence of pipelines. GPR data were acquired over these areas as well but no anomalies were observed that could be confidently attributed to pipelines.

**Terrain Conductivity (EM31) Map
Former Radiochemistry Building (RB) Area
& SWMU 10-004(b)**

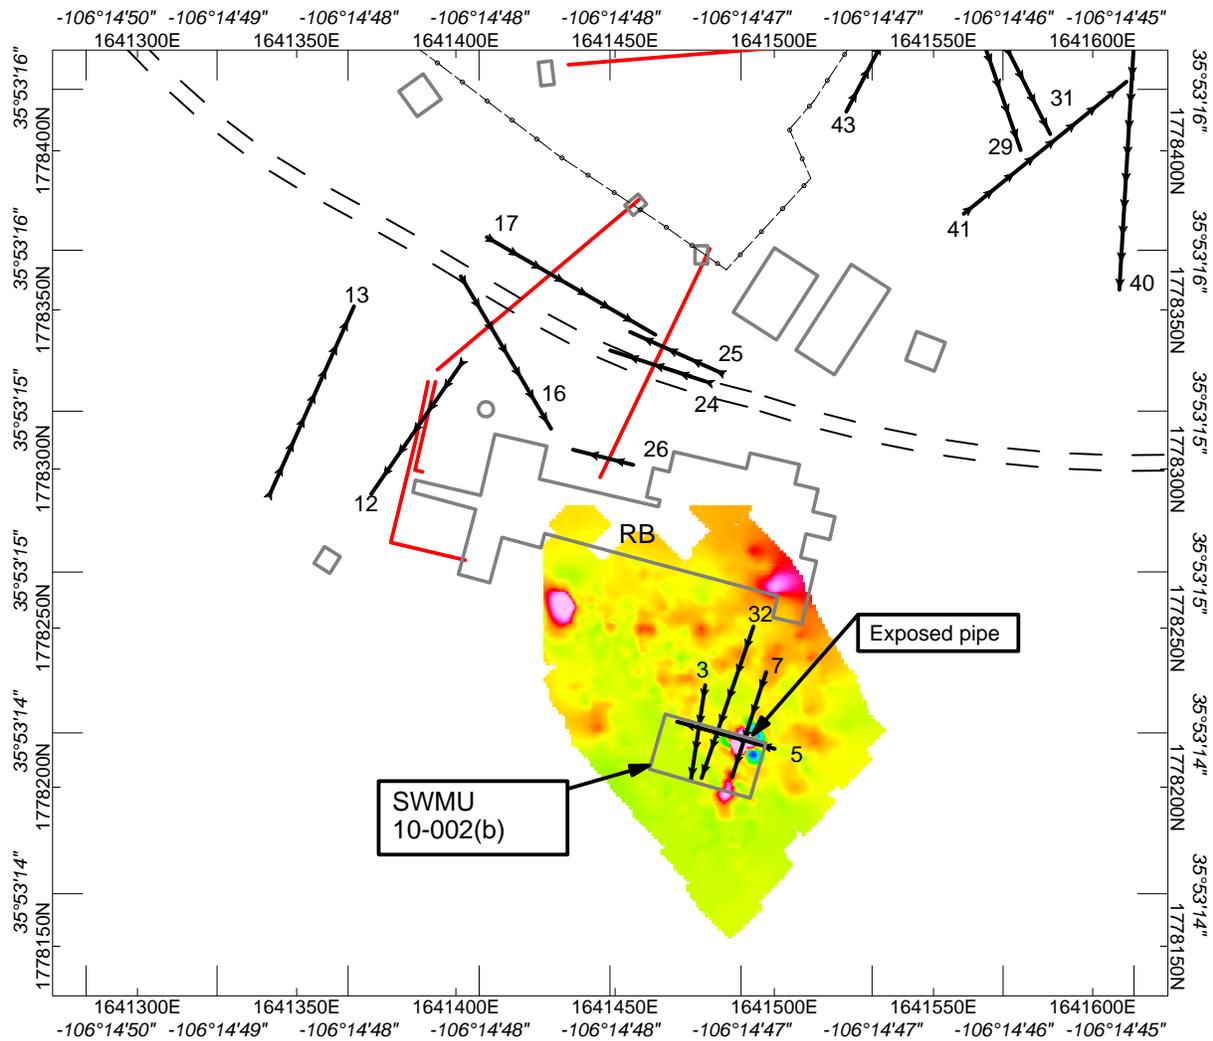
Figure 5
Buried Metal Anomaly (EM61) Map
Former Radiochemistry Building (RB) Area
SWMU 10-002(b)

SWMU 10-002(b) was a solid and liquid waste pit located on the south side of the radiochemistry laboratory building. At the time of this investigation, a large (~4-inch) metal pipe with elbow joint was visually observed at the surface on at east side of the suspected pit

location (this pipe has since been removed). EM61 data were acquired over the area in an attempt to map any buried metal objects such as tanks or pipes. The EM61 data are shown in Figure 5. The only anomalies observed in this area were associated with surface interference from the pipe observed at the ground surface.

GPR data were also acquired over the area shown in Figure 5, but no evidence of a buried structure was observed and delineating a disturbed area was not possible. Finally, radiofrequency pipe locator methods were used in an attempt to trace the possible subsurface route of the exposed pipe, but no consistent signal was observed.

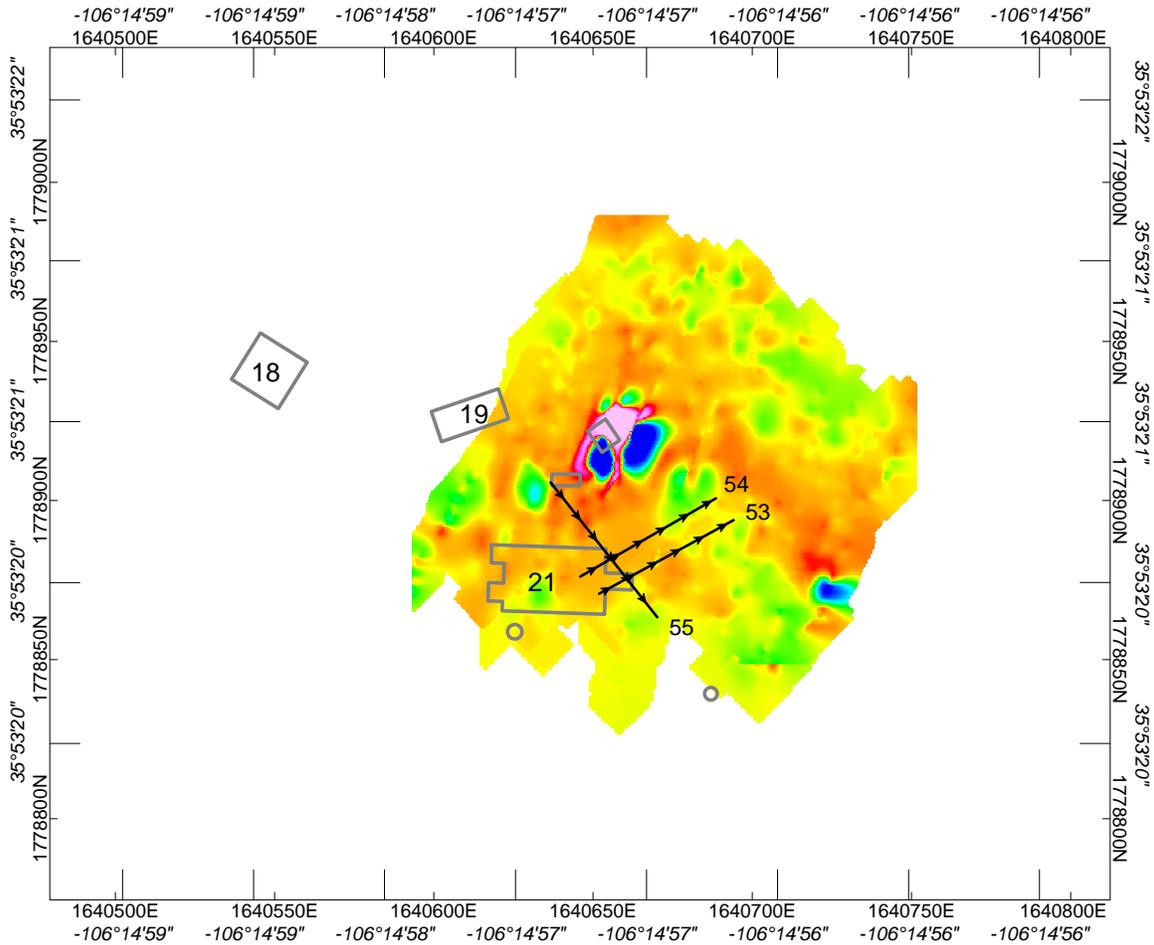
Figure 6
Terrain Conductivity (EM31) Map
SWMU 10-004(a)

EM and GPR techniques were used at SWMU 10-004(a) to detect any subsurface anomaly that may be attributed to buried structures. The terrain conductivity data are shown in Figure 6. The high amplitude anomaly near the center of the survey area is attributed to surface metal interference caused by equipment temporarily stored at the surface in this area. Similarly, the EM61 data shown in Figure 7 also shows this interference. No other EM anomalies were observed that could be attributed to buried structures or pipes. GPR data (lines 53, 54, 55 on Figure 7) were acquired over a subtle linear EM anomaly, but the results showed no evidence of buried objects.

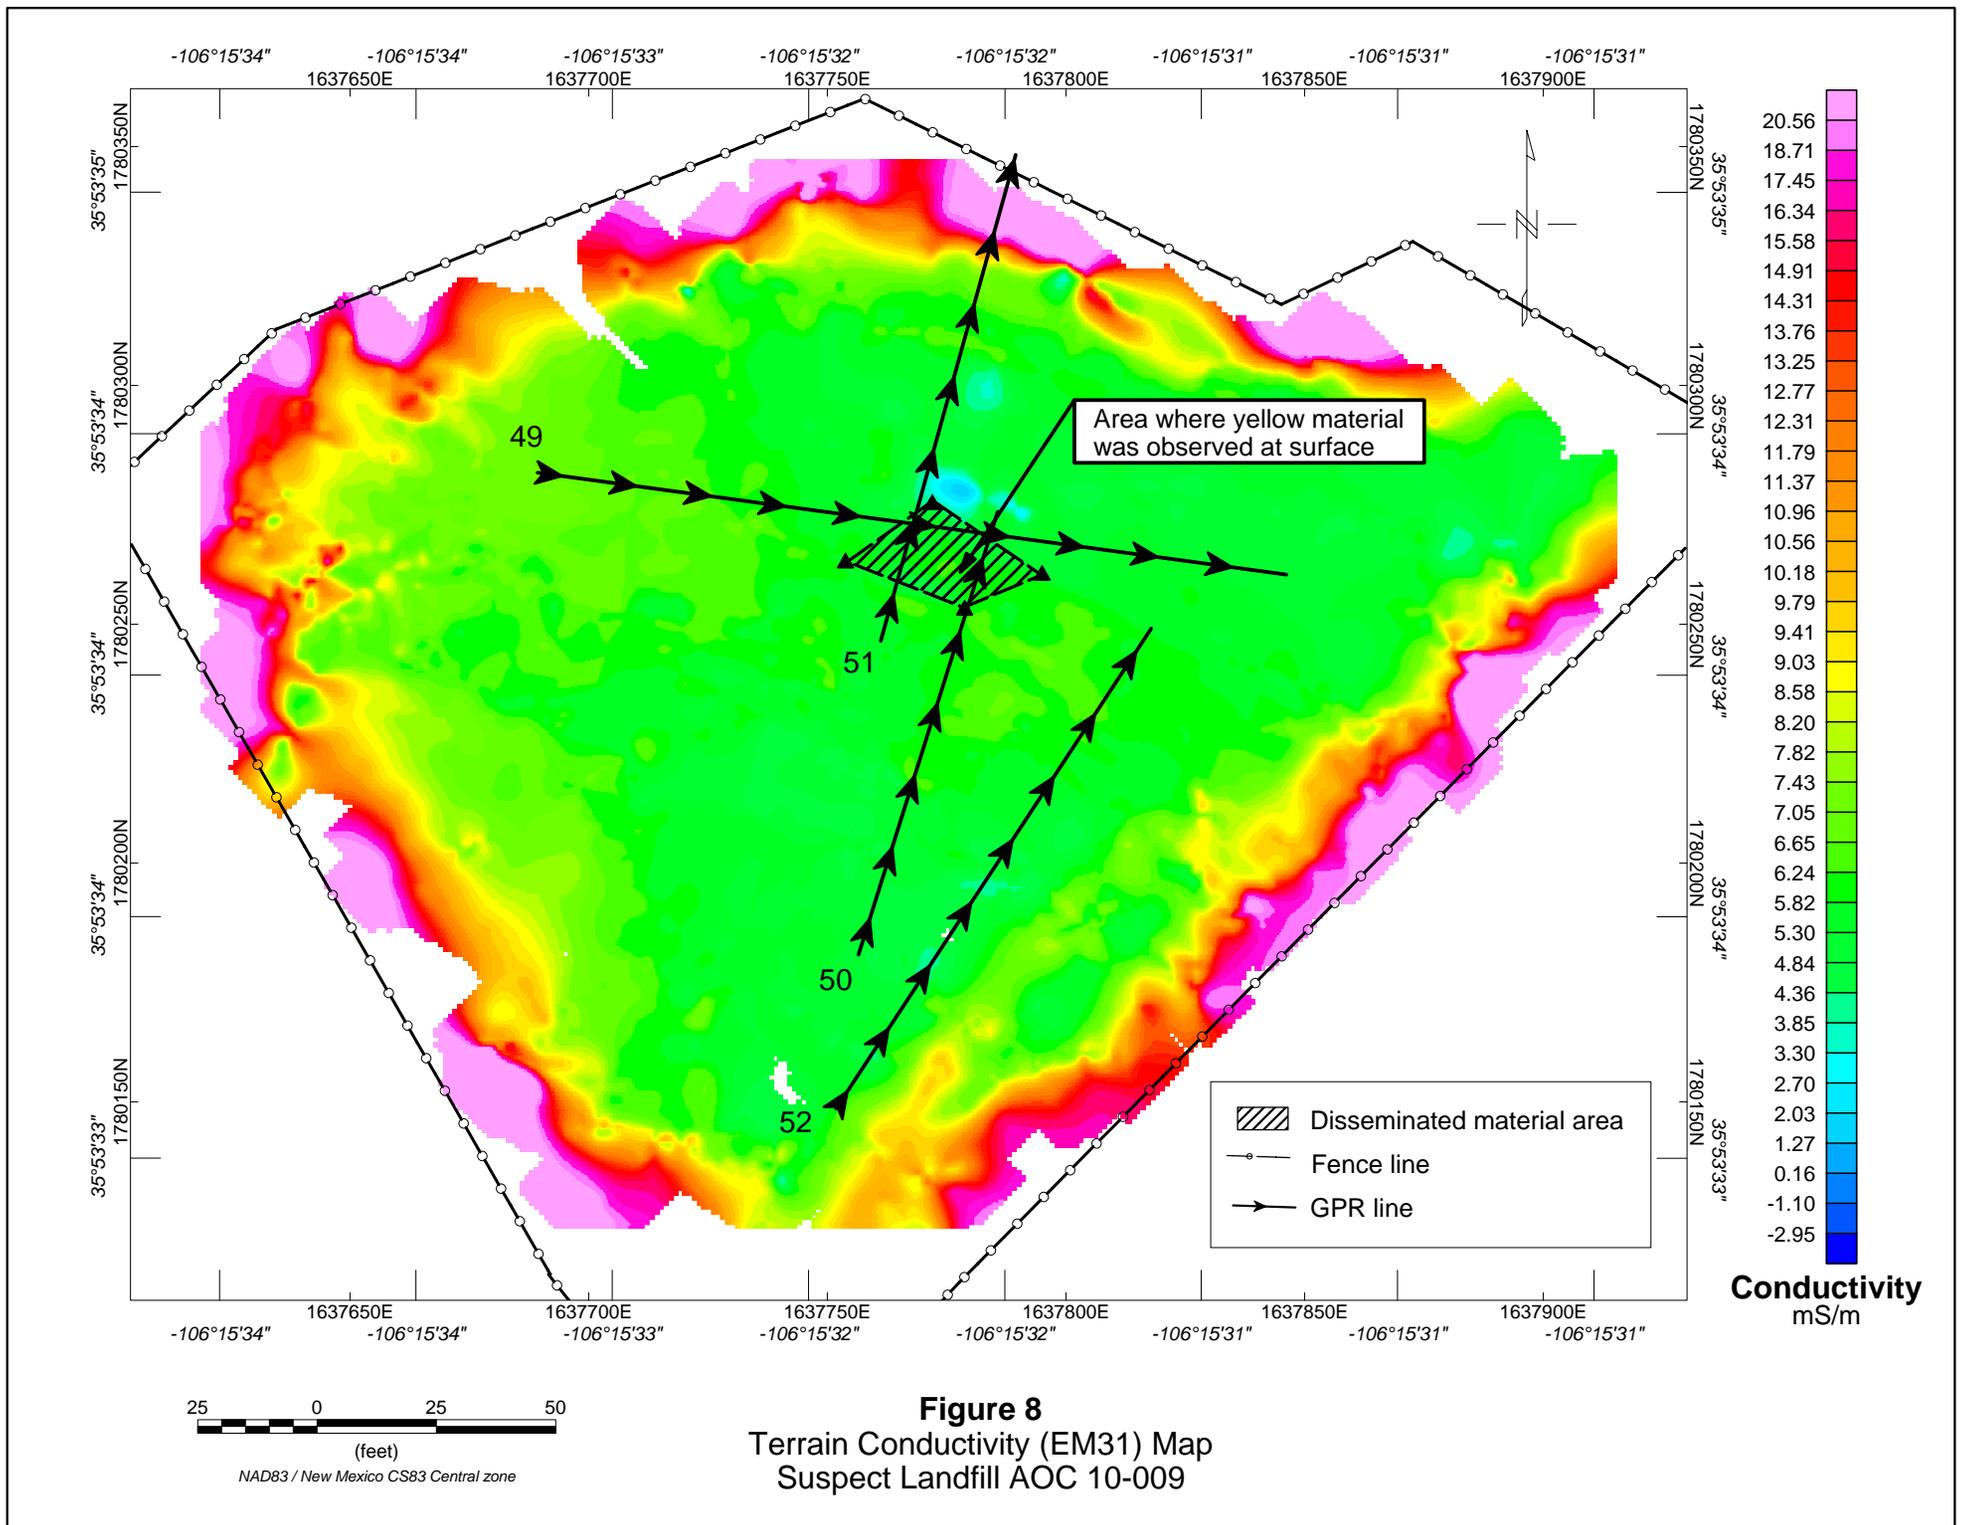
The suspect landfill area was surveyed with EM and GPR techniques in an attempt to delineate the lateral extent of the alleged disposal area. The terrain conductivity data (EM31) is shown in Figure 8. These data exhibit a halo of high conductivities associated with interference from the surrounding chain-link fence. No other anomaly inside the chain-link fence interference suggest the presence of buried debris. The EM61 data shown in Figure 9 shows a similar response; no significant target anomalies were observed. A previous radiological survey identified a "hotspot" within the survey area (stripped area in figures). ARM relocated in this area using GPS during the geophysical investigations. Further visual observations of this area revealed the presence of disseminated quantities of mm-size yellow material exposed at the surface. GPR data were acquired over this area to identify possible buried materials. The GPR results showed no evidence that would suggest the presence of a significant quantity of buried debris.
