# **Petrographic Analysis of Concrete Core Samples from Saltstone Disposal Unit #6 at the Savannah River Site, Aiken, SC**

Robert D. Moser, E. Rae Gore, and Kyle L. Klaus

March 2016

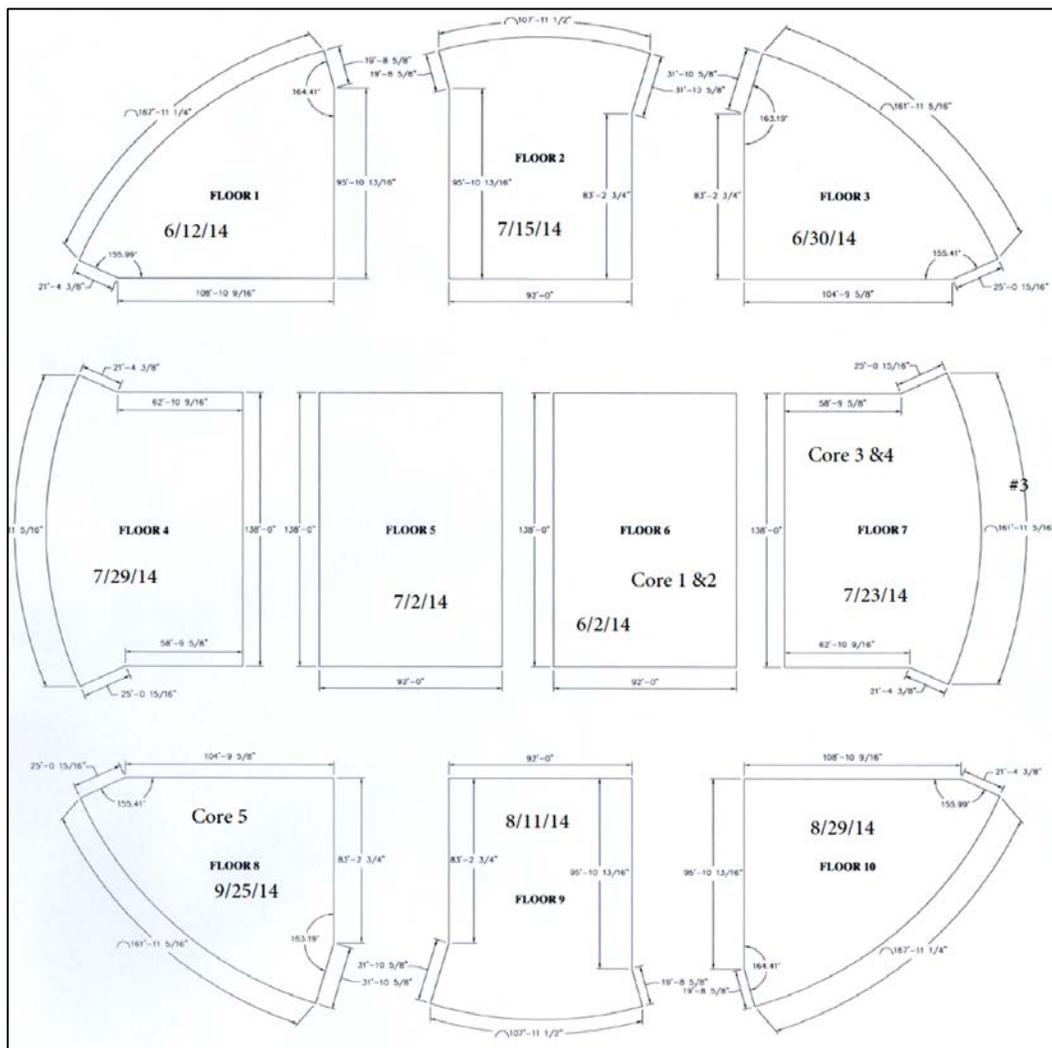
Figure 1. Floor placement layout and sequence placement noted by dates on floor slabs. Location of five cores sent to ERDC for analysis are also noted.

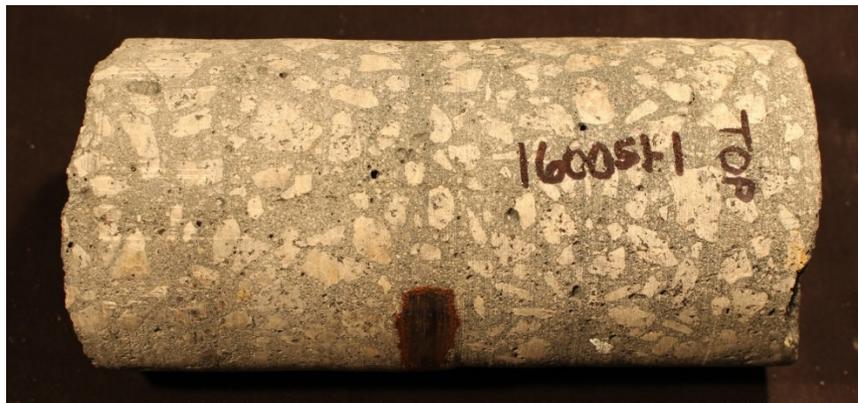
Figure 3. As received concrete Core Sample #1.

The typical as-received core from location #1 is shown in Figure 3. A small crack was observed on the top surface of the core (see Figure 4). This crack had been coated by the gravity fed epoxy (see Figure 5). The core was 9.5 cm diameter and 21.6 cm long. One piece of reinforcing steel was included in the core at a depth of approximately 10 cm. The reinforcing steel was located at the edge of the core and was not examined further due to potential degradation in bond during coring. No segregation was observed on the surface of the core and the aggregates and voids appeared to be uniformly distributed. No honeycombs or entrapped air voids were noted.

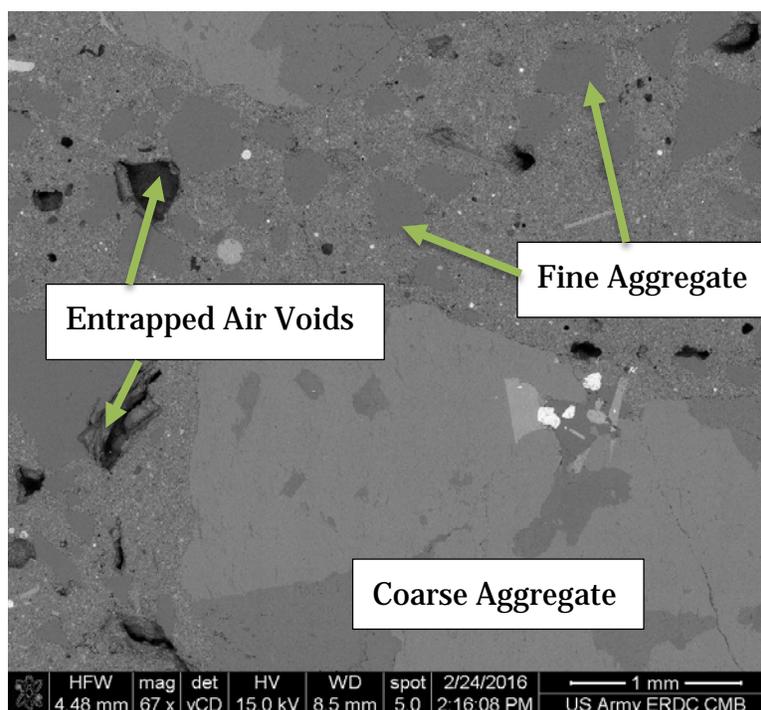
A low magnification montage image of the concrete microstructure is shown in Figure 14, with the presence of coarse and fine aggregates as well as paste and pores indicated. Higher magnification imaging of the polished paste microstructure indicated anticipated phases. An example of the microstructure observed at higher magnification is shown in Figure 15. Unreacted fly ash, slag, and cement particles were observed with the fly ash particles being spherical in shape and unreacted cement and slag particles being angular. Smaller silica fume particles were observed as sub-micron sized spheres distributed throughout the paste. The paste appeared to be dense and near full reaction, with minimal porosity. The water-to-cementitious materials ratio appeared to be less than 0.40 based on the minimal porosity observed. At higher magnification, distributed microcracking was observed which is likely due to shrinkage (drying or autogenous) (see Figure 16). Epoxy was observed to have infilled the crack in the near surface concrete. The epoxy infilling appeared to be effecting in a majority of the crack with the exception of areas where the crack intersected a large void. An example of this cracking and the partial infilling with epoxy is shown in Figure 17.

Figure 14. Low magnification montage of concrete microstructure.

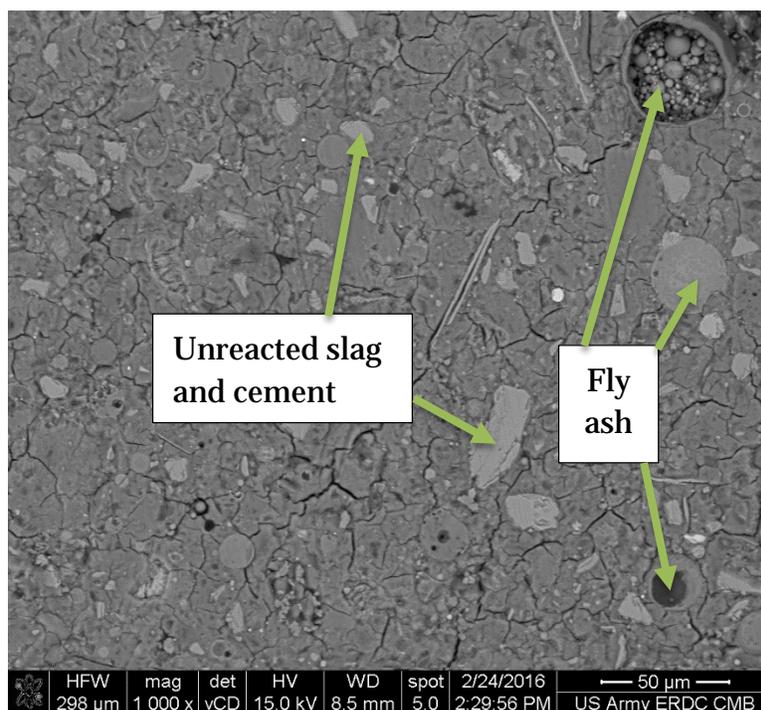
Figure 15. High magnification image of paste microstructure.

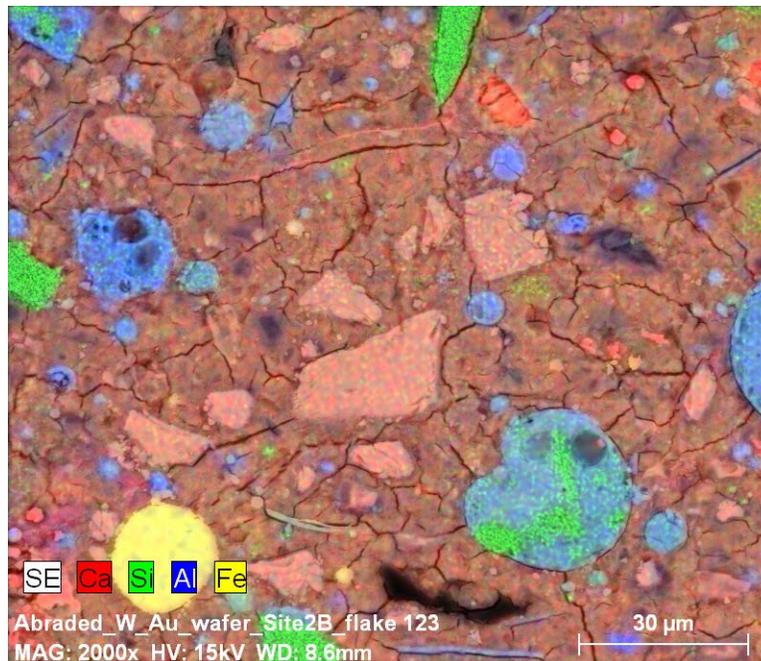
An elemental map of the paste microstructure typically observed in Core Sample #1 is shown in Figure 18 with colors to note the location of Ca, Si, Al, and Fe rich regions which can be used to identify the location of fly ash, slag, siliceous aggregates, calcium hydroxide, silica fume, and unhydrated cement particles. The anticipated microstructure was observed in the elemental maps. Blue / green spherical particles were unreacted fly ash particles. Larger Si-rich particles are likely contributed by the fine aggregates. Minimal free lime (calcium hydroxide) was observed. Angular particles with red / green color indicative of cement dominated the unreacted phases followed by slag. Overall, the microstructure corresponded to the mixture proportion with a significant proportion of unreacted phases which are anticipated based on the low w/cm and high supplementary cementitious materials content in the concrete used.

Figure 18. Elemental map with Ca, Si, Al, and Fe indicated.

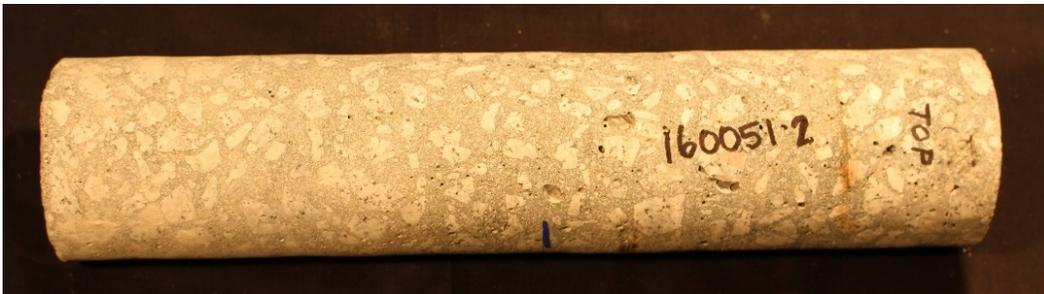
Figure 19. As received core sample #2.

The typical as-received core from location #2 is shown in Figure 19. The core was 7 cm in diameter and 30.5 long. No cracks were observed by visual inspection of Core Sample #2 upon examination of the top surface and sides of the core (see Figure 20). No segregation was observed on the surface of the core and the aggregates and voids appeared to be uniformly distributed. No large honeycombs or entrapped air voids were noted.

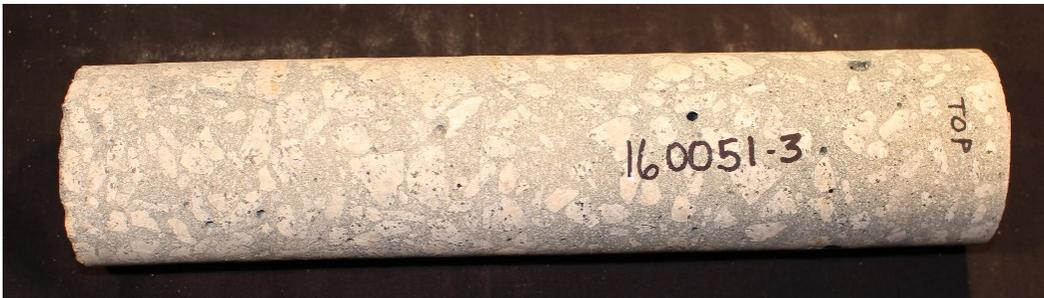
Figure 23. As received Core Sample #3.

The typical as-received core from location #3 is shown in Figure 23. A small crack was observed on the top surface of the core (see Figure 24). This crack had been coated by the gravity fed epoxy. The core was 7 cm in diameter and 30.5 cm long. No segregation was observed on the surface of the core and the aggregates and voids appeared to be uniformly distributed. No large honeycombs or entrapped air voids were noted.

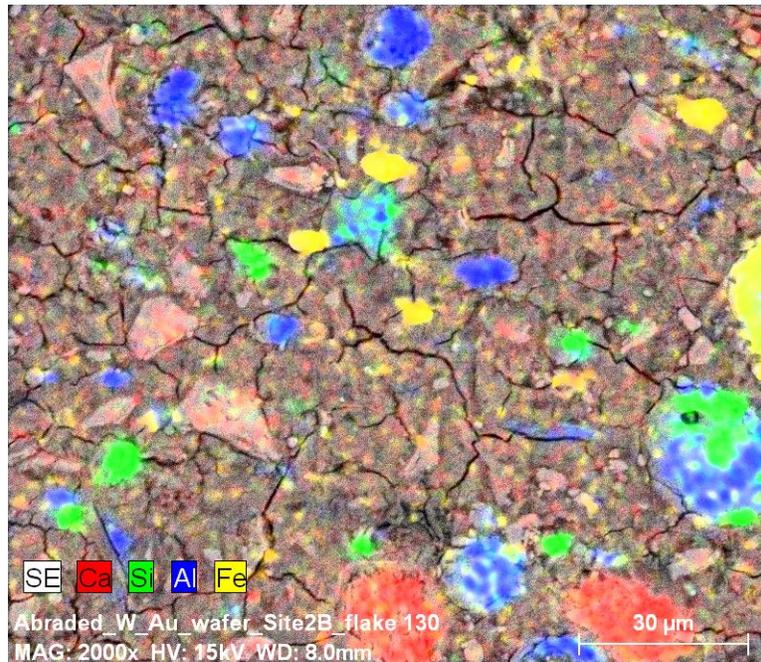
An elemental map of the paste microstructure typically observed in Core Sample #3 is shown in Figure 35 with colors to note the location of Ca, Si, Al, and Fe rich regions which can be used to identify the location of fly ash, slag, siliceous aggregates, calcium hydroxide, silica fume, and unhydrated cement particles. The anticipated microstructure was observed in the elemental maps. Blue / green spherical particles were unreacted fly ash particles. Larger Si-rich particles are likely contributed by the fine aggregates. Minimal free lime (calcium hydroxide) was observed. Angular particles with red / green color indicative of cement dominated the unreacted phases followed by slag. Overall, the microstructure corresponded to the mixture proportion with a significant proportion of unreacted phases which are anticipated based on the low w/cm and high supplementary cementitious materials content in the concrete used.

Figure 35. Elemental map with Ca, Si, Al, and Fe noted based on colors to aid in identification of phases in hydrated cement paste microstructure.

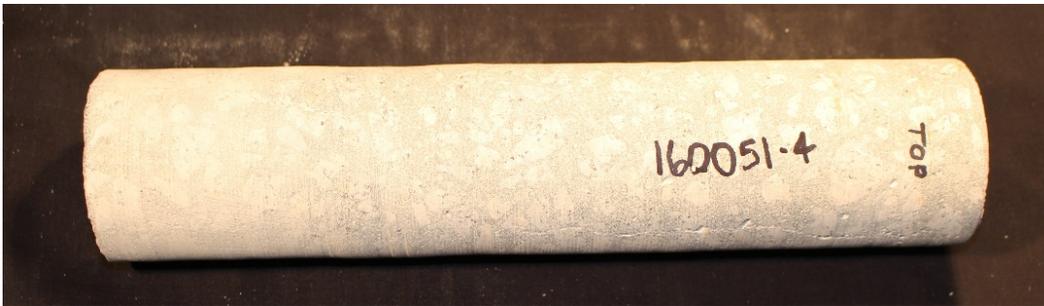
Figure 36. As received concrete core sample #4.

The typical as-received core from location #4 is shown in Figure 36. A small crack was observed on the top surface of the core (see Figure 37). This crack had been coated by the gravity fed epoxy. The core was 7 cm in diameter and 30.5 cm long. No segregation was observed on the surface of the core and the aggregates and voids appeared to be uniformly distributed. No large honeycombs or entrapped air voids were noted.

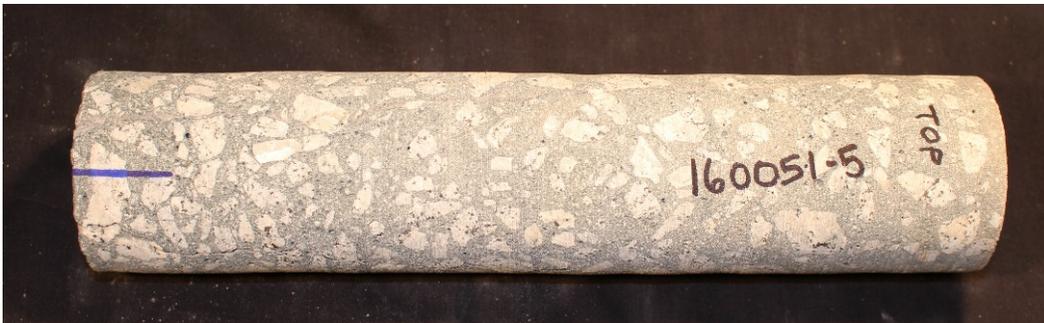
Figure 42. As received core sample #5.

The typical as-received core from location #5 is shown in Figure 42. A large crack was observed on the top surface of the core (see Figure 43). This crack had been coated by the gravity fed epoxy. The core was 7 cm in diameter and 30.5 cm long. No segregation was observed on the surface of the core and the aggregates and voids appeared to be uniformly distributed. No large honeycombs or entrapped air voids were noted.

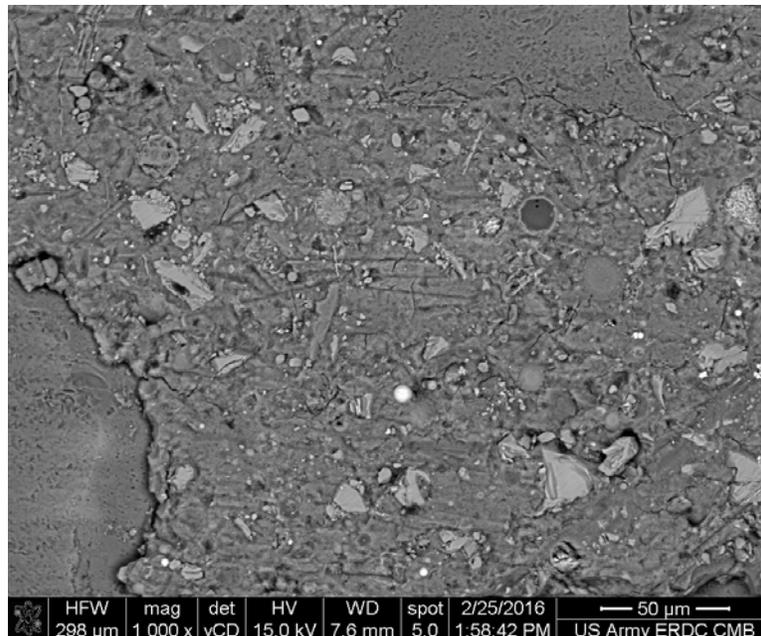
Figure 52. High magnification image of paste microstructure. Spherical particles associated with fly ash. Angular particles associated with unreacted slag and cement particles.

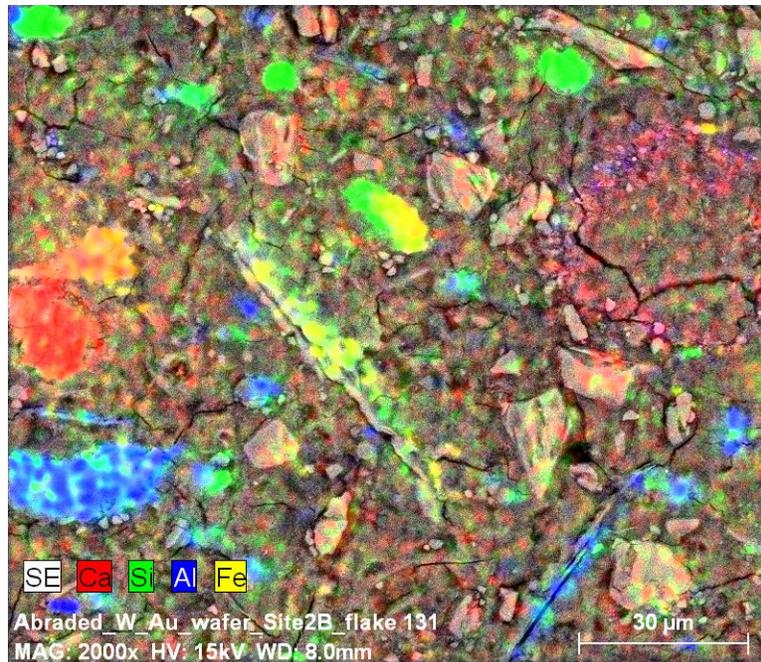
An elemental map of the paste microstructure typically observed in Core Sample #5 is shown in Figure 53 with colors to note the location of Ca, Si, Al, and Fe rich regions which can be used to identify the location of fly ash, slag, siliceous aggregates, calcium hydroxide, silica fume, and unhydrated cement particles. The anticipated microstructure was observed in the elemental maps. Blue / green spherical particles were unreacted fly ash particles. Larger Si-rich particles are likely contributed by the fine aggregates. Minimal free lime (calcium hydroxide) was observed. Angular particles with red / green color indicative of cement dominated the unreacted phases followed by slag. Overall, the microstructure corresponded to the mixture proportion with a significant proportion of unreacted phases which are anticipated based on the low w/cm and high supplementary cementitious materials content in the concrete used.

Figure 53. Elemental map of paste microstructure with Ca, Si, Al, and Fe noted in colors to aid in phase identification.
