## Paducah Railroad Culvert Evaluation

There were a total of 13 railroad culvert locations walked down outside the Limited Area (LA) fence and 9 inside the LA fence. One culvert on Warren Road was also included because of its potential impact to the railroads and access to public warning sirens.

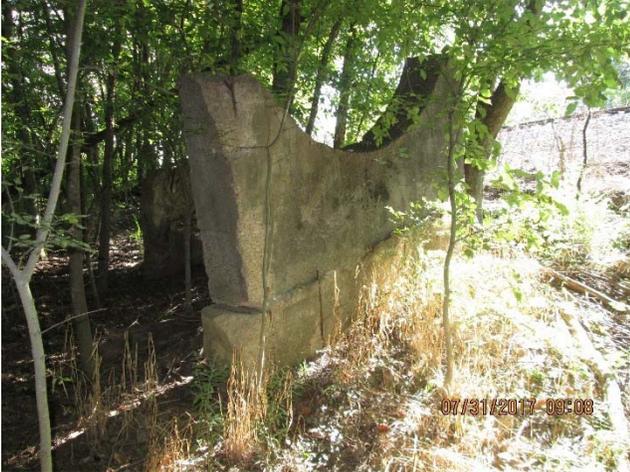
In addition, two large concrete tank pedestals (over seven feet tall) and associated piping are strewn haphazardly on the west side of the railroad. See photographs 7427 and 7432 below.

7427 Concrete Tank Supports, West of Tracks

These present a hazard if railcars should derail at this location. The concrete structures and/or metal pipe could easily puncture a loaded tank car.

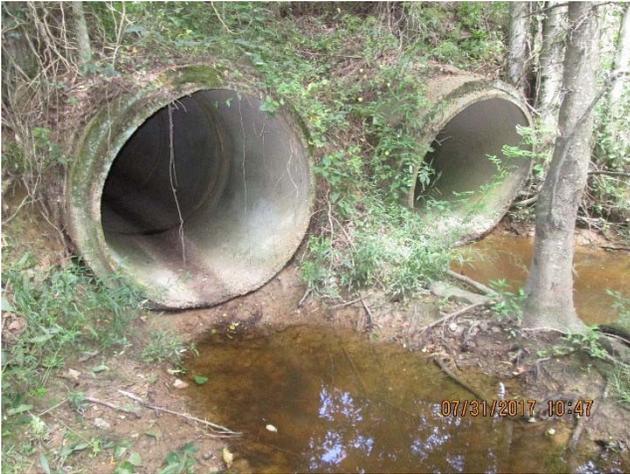
On the east side of the track, both culverts have begun to slump on the outer segments, see photo 7560. The north culvert, outer segment, has slumped approximately 6 inches and separated from the main culvert, see photo 7583. The outer segment of the south culvert has slumped approximately 3 inches, see photo 7575, but has not separated completely from the main culvert.

7560 Two RCP Culverts (60"), East Side, Outlet

Water appears to be clearing the ditch well and the high-water marks (indicating stream stage) are very slight. However, the earth is beginning to give way on both sides, and above, the east end of the culverts. Slight washing has occurred between the two culverts. A small amount of concrete spalling was observed on the sides of the north culvert. Spalling is approximately 1/4" deep. Both culverts have grouted segment joints but, in many cases, the grouting has fallen out. It is recommended that both the inlet and outlet sides of these culverts be stabilized, erosion control be performed, and new grouting

installed. There appears to be no immediate danger (in terms of sinkholes or subsidence) but repairs and cleanup work should be completed within the next year.

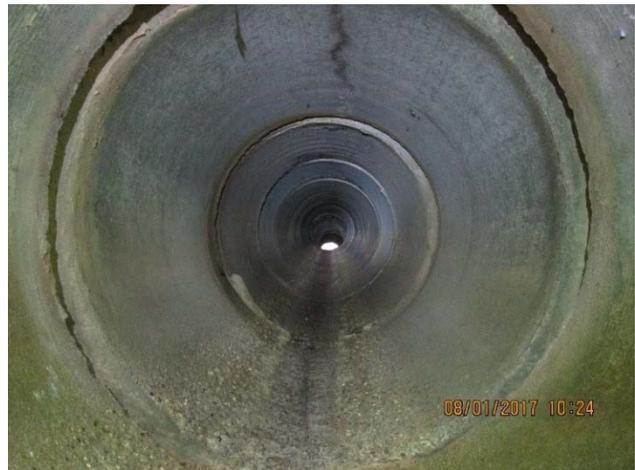
*7810 RCP Culvert (36") Interior, Looking East from West Side*

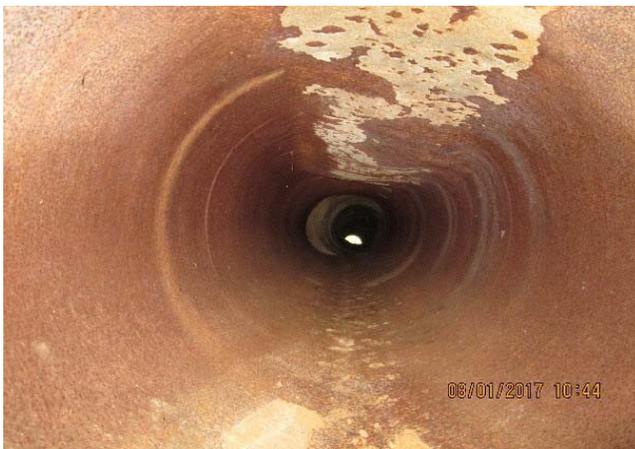
downward at least 6 inches. This creates a significant disturbance in water flow through the culvert and into the pipe. In addition, the concrete culvert appears to have a significant hump, and downward slope, approximately 20 feet further inside the culvert. This places the hump location approximately beneath the east rail and it may indicate erosion below the culvert or below the connection to the metal pipe. The metal pipe was observed to have a bent roof (possibly due to heavy loads having traversed the roadway at some time in the past). See photographs 7874, 7835, 7848, and 7867.

7848 Culvert (36"), East End, Metal Pipe Showing Dented in Top

Though it does not appear to be an immediate hazard, it is recommended further inspections be performed of this culvert and a determination as to the need for repairs (if any) or replacement. Consideration should be given to making repairs to this location in conjunction with the repair to the sinkhole culvert issue identified in May, 2017. Without some level of repair, within the next several years, this culvert may become a major issue.

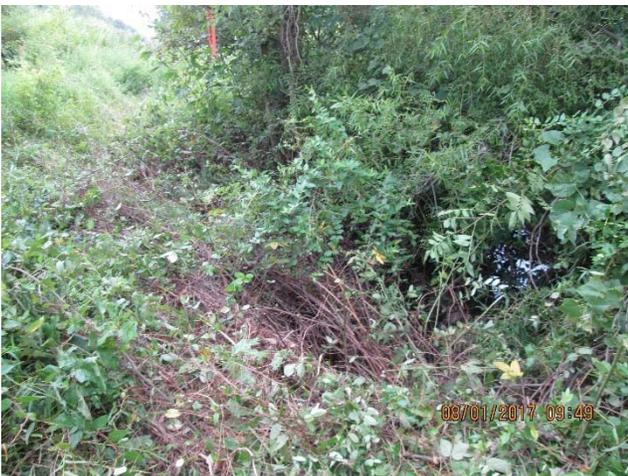
On the east side of the railroad embankment, rip rap is located above the two 48 inch culverts for a distance of approximately 40 feet. This rip rap has become heavily overgrown with low growing vegetation and access to the stream bed must be made on the east side of the track, approximately 30 feet north of the Danger High Voltage Sign. No subsidence or potholes were observed above or to the sides of the culverts. There is slight erosion between the culverts. Water is standing in the stream bed at the culvert outlet. This stream appears to be effectively draining, however, vegetation is heavily overgrown downstream of the culvert outlets. See photographs 7783, 7786, and 7793. It is recommended to remove the sediment, repair the erosion, and perform vegetation control to facilitate inspection access.

*7793 RCP Culverts, Two (48"), South of 2-DUF<sub>6</sub> Switch, Access to East Side is 20' North of Danger High Voltage Sign*

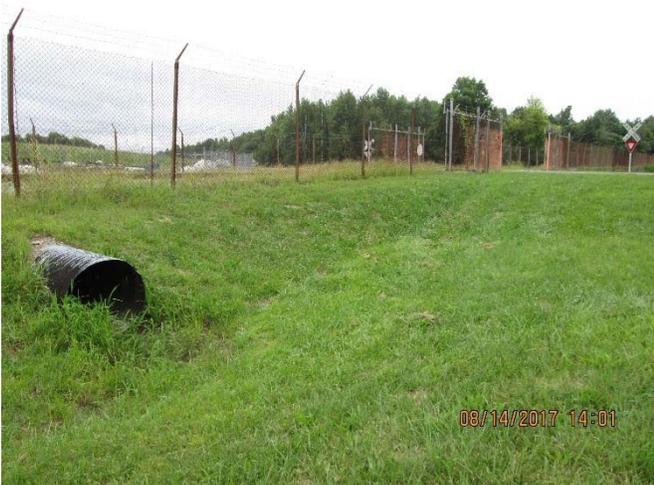
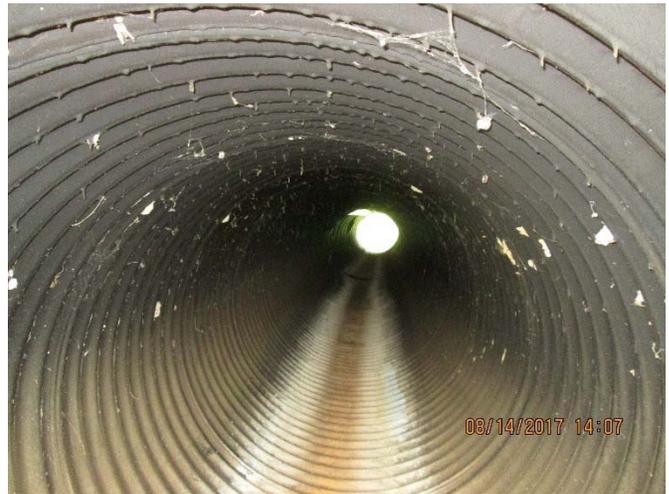
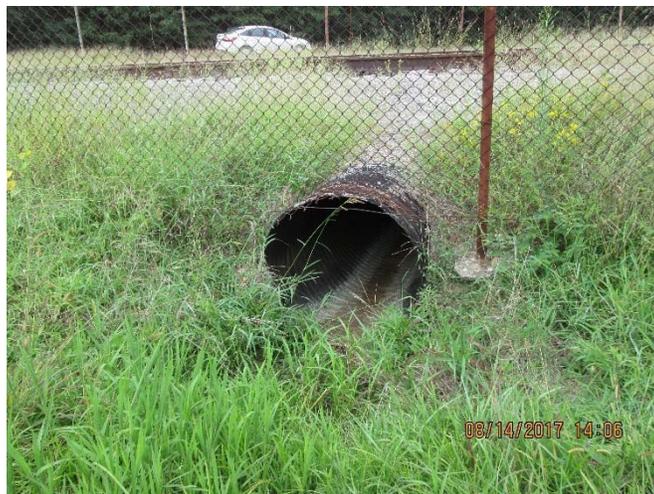
**Track #2, one 36" CMP culvert approximately 60 feet north of Curlee Road crossing, at approximate GPS coordinates 37.112768° N, 88.821301° W.** This culvert is clear, and there are no erosion or vegetation issues. However, there is a dented in deformation (approximately 4 inches deep) on the north side of the culvert top, approximately 25 feet inside the culvert from the west end. The dent is not considered an issue at this time and it does not affect drainage. No work is needed at this culvert location. See photographs 8141, 8161, and 8158.

8141 CMP Culvert (36"), 60' North of Curlee Road, West End

8161 CMP Culvert (36"), 60' North of Curlee Road, West End, Interior Looking East

8158 CMP Culvert (36"), 60' North of Curlee Road, East End

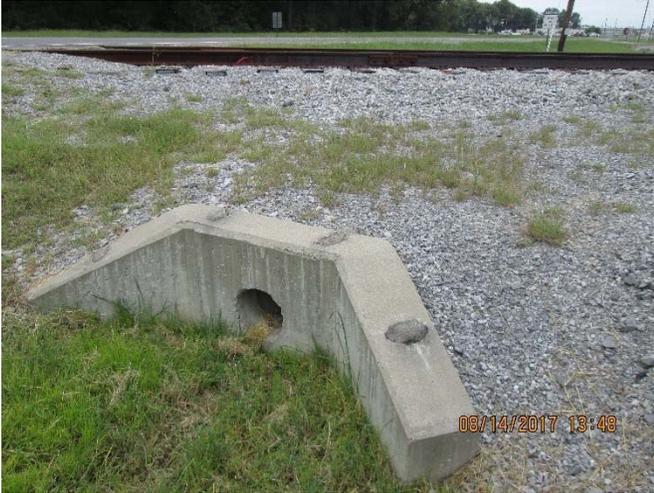
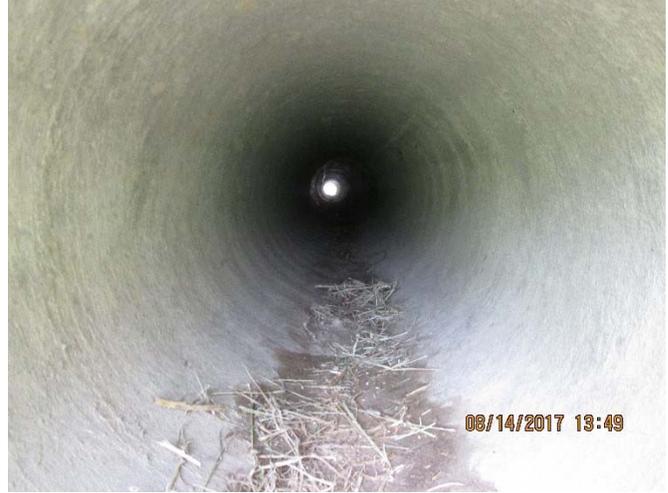
issues and the metal appears to be in good condition. Recommend no work at this location. See photographs 8120 and 8122.

8120 CMP Culvert (12"), DUF<sub>6</sub>-B, Between Hobbs and Old Haul Road, South End Looking North

8122 CMP Culvert (12"), DUF<sub>6</sub>-B, Between Hobbs and Old Haul Road, South End Looking North, Interior

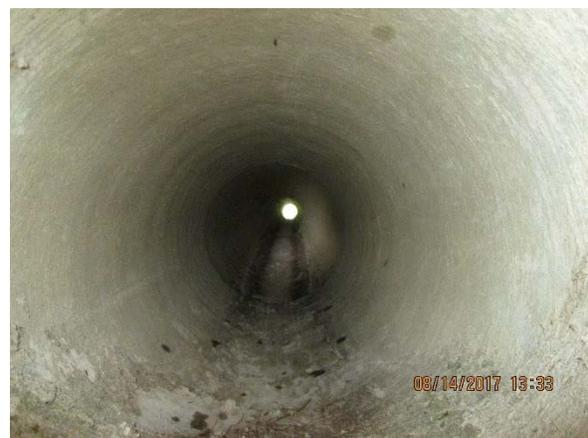
**DUF<sub>6</sub>, one 12" CMP culvert, approximately 50 feet east of the Old Haul Road on the DUF<sub>6</sub>-A track, at approximate GPS coordinates 37.104263° N, 88.817624° W.** This culvert has no sediment, erosion or vegetation issues and the metal appears to be in good condition. However, the culvert size appears to be inadequate for the area being drained. In discussions with residents of the trailer complex (immediately north of the culvert), it was noted that during heavy rain, water backs up under Trailer-06. This is a training trailer and is occupied an average of three times per week. While no work is needed at this location it is recommended that a drainage study be performed to determine if a second culvert is needed. See photographs 8073, 8080, and 8086.

8080 CMP Culvert (12"), DUF<sub>6</sub>-A, South of Trailers, North End, Looking South, Interior

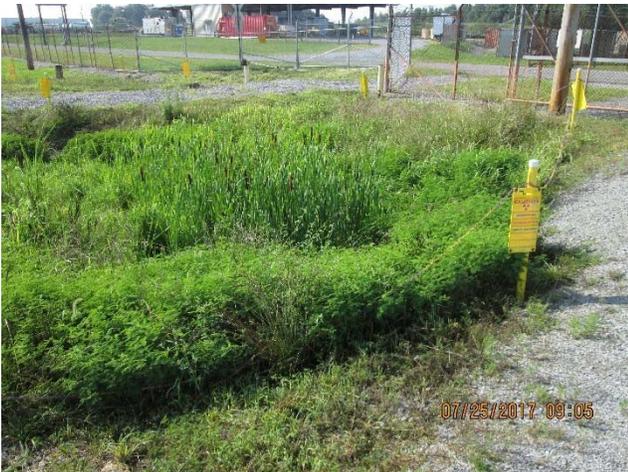
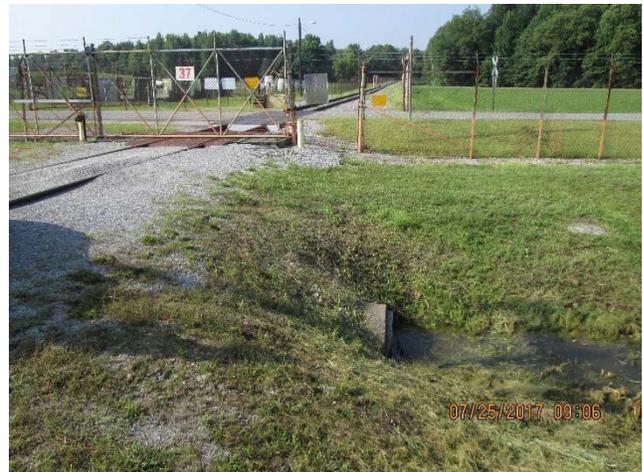
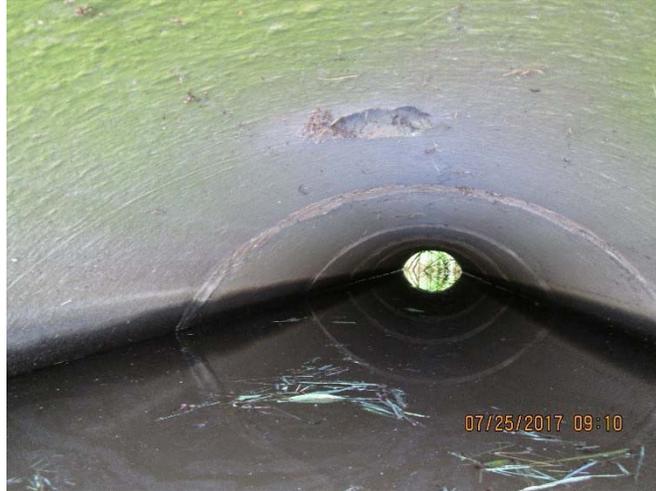
**Track #2, one 48" RCP culvert inside the LA fence, north of Gate 37 and south of Service Road A**, at approximate GPS coordinates 37.113718° N, 88.820853° W. This culvert appears to be approximately 50% silted. There is a radiological zone on the east side (of the culvert) and due to vegetation inside the ropes, the culvert inlet could not be seen. The west side could be accessed and the culvert appears to be in good condition, with no erosion or deterioration. See photographs 6927, 6934, and 6942.

*6927 Concrete Culvert (48"), Near Gate 37, East Side, Inlet*

*6934 Concrete Culvert (48"), Near Gate 37, West Side, Outlet*

6942 Concrete Culvert (48"), Near Gate 37, Interior as Viewed From the West End

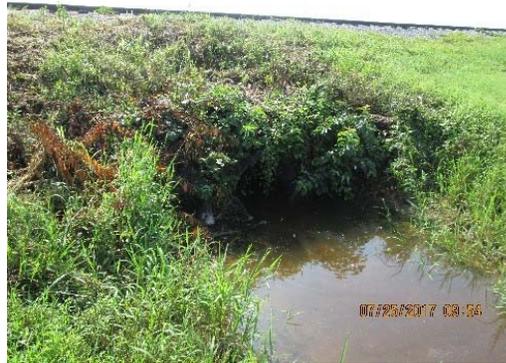
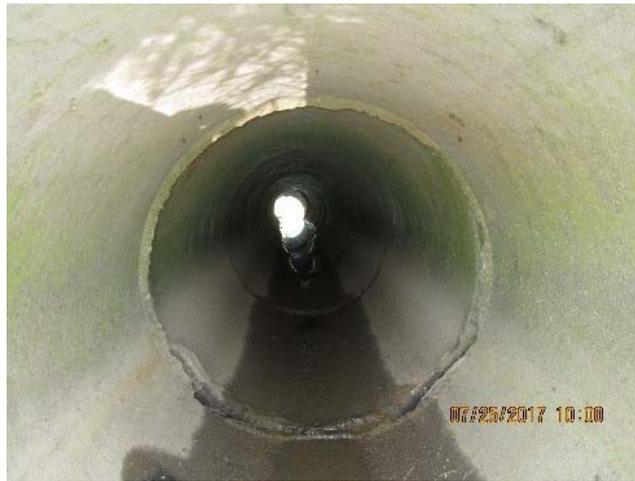
**Track #AT, one 32" RCP culvert, inside the LA fence, approximately 150 feet north of monitoring well 188**, at approximate GPS coordinates 37.11623° N, 88.82044° W. This culvert has a slight amount of erosion on top of the culvert on the west side of the track and erosion on the south side of the culvert on the east side of the track. See photographs 7022, 7002, and 7021. The culvert appears to be clear with no indications of interior degradation. Recommend filling the eroded areas.

*7002 Concrete Culvert (32"), Track-AT.  
West Side*

*7021 Concrete Culvert (32"), Track #AT,  
Interior View from East Side Looking West*

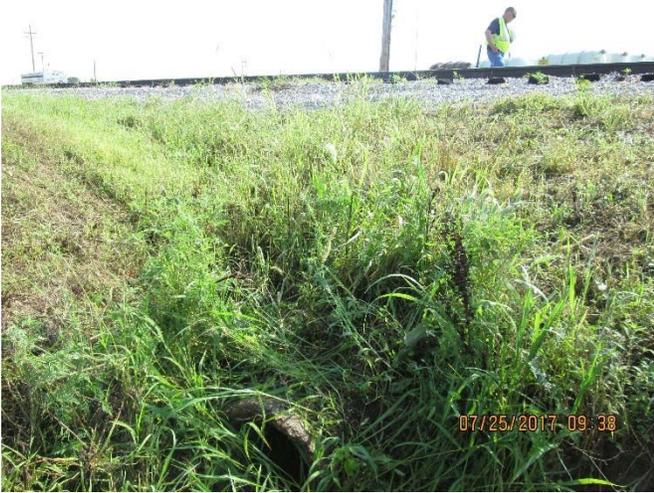
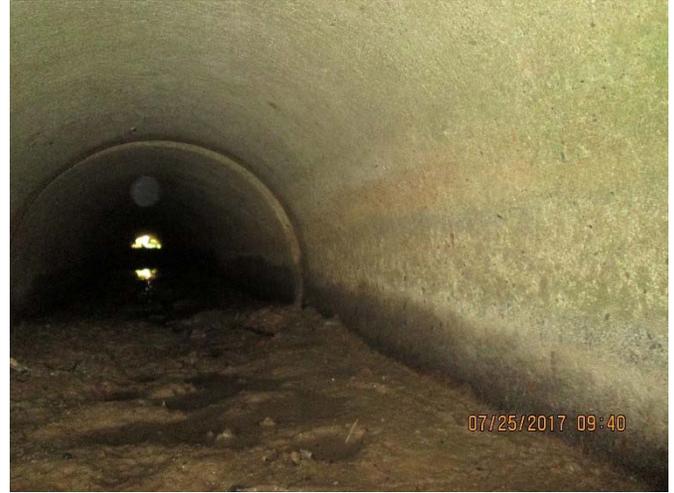
**Track #AT, one 24" RCP culvert, inside the LA fence, approximately 100 yards south of the rail stops near Patrol Road #1**, at approximate GPS coordinates 37.11712° N, 88.82047° W. Washing has occurred on the east side of the track near the radiological zone at the corner of C-745-A1. The culvert is approximately 50% silted and, with the exception of one three foot segment dislodged (on the east side), the concrete segments are uniform and in acceptable condition. Recommend repairing the erosion on the east side, removing the sediment, and repositioning/reconnecting the displaced section to the existing culvert. See photographs 6984, 6989, and 6999.

6984 Concrete Culvert (24"), Track #AT, West Side

6989 Concrete Culvert (24"), Track #AT, Interior View, West Side Looking to the East

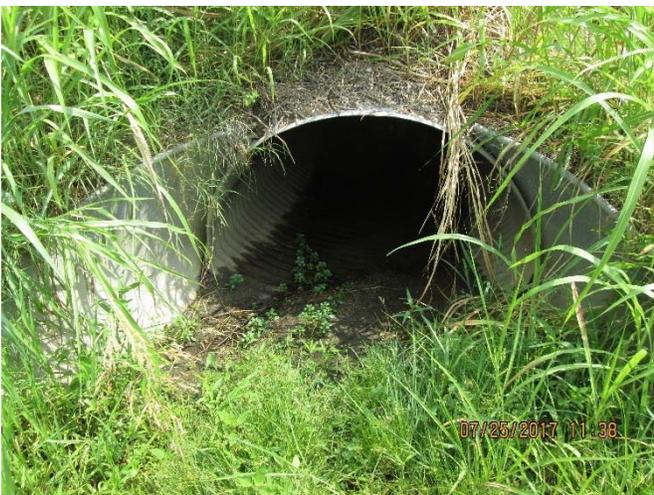
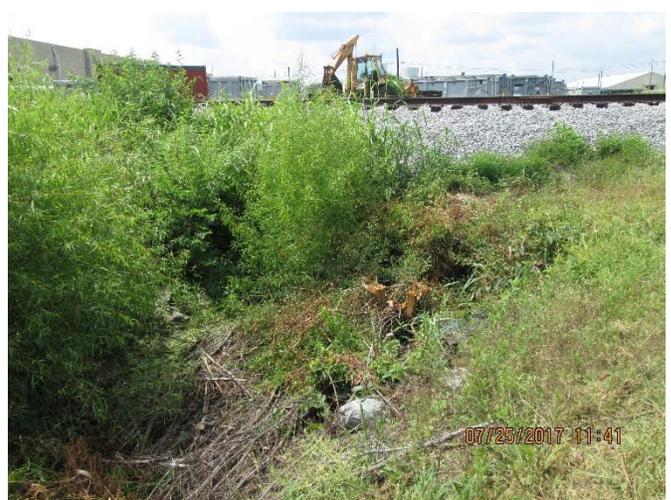
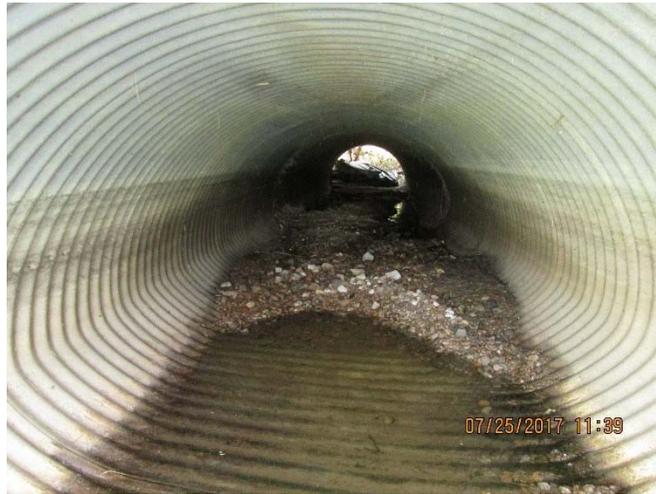
**Track #6, one 60" CMP culvert inside the LA fence, approximately 260 feet east of 10<sup>th</sup> Street and 60 feet west of the 6-7 switch, at approximate GPS coordinates 37.119971° N, 88.809576° W.** This culvert appears to be in good condition, however, it has a plastic bag (or some other type plastic material) creating a 40% obstruction in the north end along with a moderate amount of ballast material. Recommend removing the plastic obstruction and ballast material from the north end of the culvert. See photographs 7151, 7160, and 7153.

7151 Corrugated Metal Pipe Culvert, (60"), Track #6, South Side of Culvert

7160 Corrugated Metal Pipe Culvert, (60"), Track #6, North Side of Culvert

7153 Corrugated Metal Pipe Culvert, (60"), Track #6, Interior as Seen from South Side Looking North

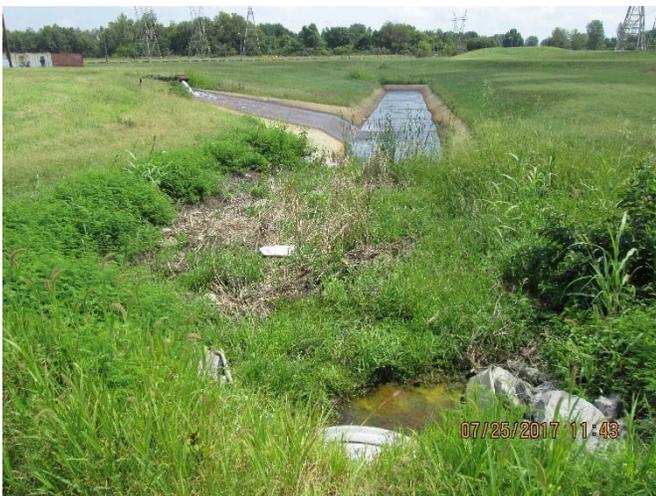
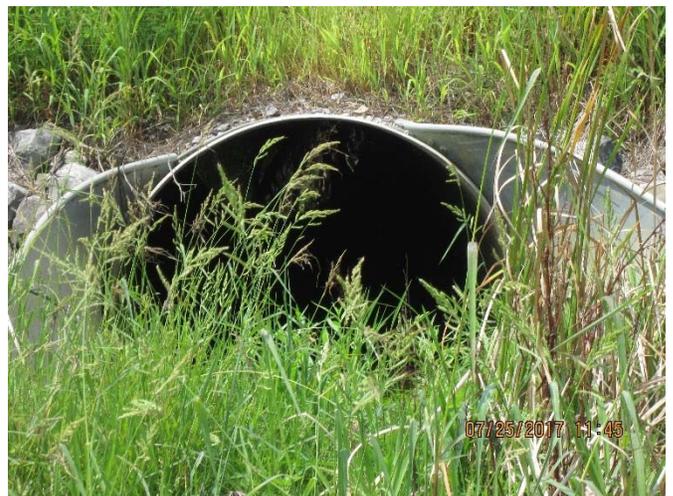
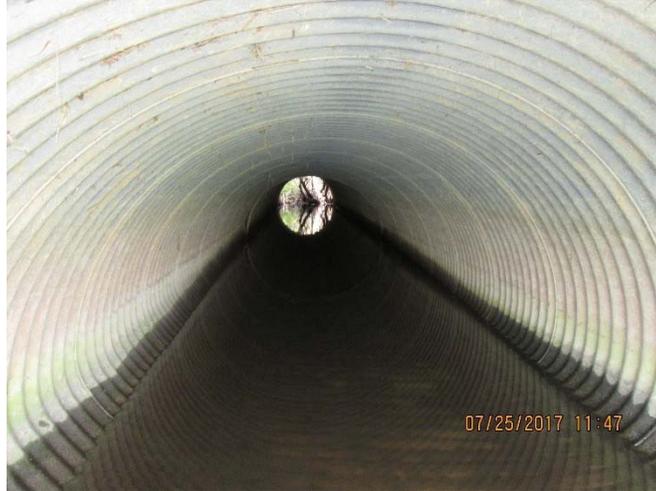
**Track #6, one 60" CMP culvert inside the LA fence, approximately 300 feet east of 10<sup>th</sup> Street and 210 feet west of the 6-6 switch, at approximate GPS coordinates 37.120086° N, 88.809377° W.** This section of track is inactive. The culvert is just northeast of the Location 19 culvert and drains the North South Diversion Ditch into the C-760-A Surge Basin. This culvert is in acceptable material condition but partially plugged by heavy growth of vegetation. Recommend removing the vegetation. See photographs 7165, 7167, and 7172.

7165 Metal Culvert (60"), Track #6, Near C-760-A, Looking North

7167 Metal Culvert (60"), Track #6, Near C-760-A, Looking South

*7172 Metal Culvert (60"), Track #6, Near C-760-A, Interior Looking South*
