## **POST-CLOSURE CARE AND MONITORING PLAN**

### **LOS ALAMOS COUNTY AIRPORT LANDFILL COVER REPLACEMENT**

Revision 01

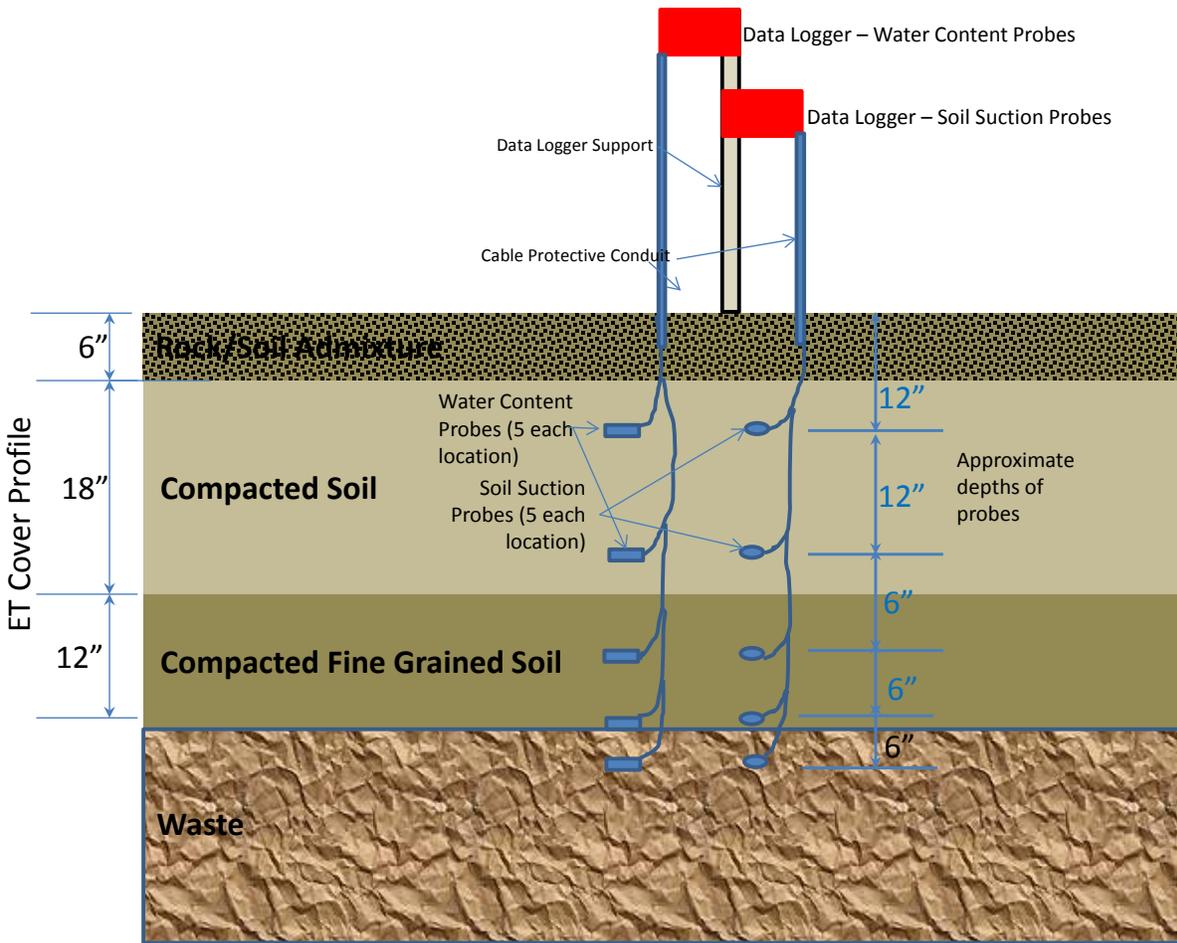
Figure 1. Water Balance Monitoring Typical Equipment

shall be two locations within the cover system to be monitored (Figure 2). The two locations are to be used to provide duplication in case of instrumentation or software errors. Each location shall have five water content probes and 5 soil suction probes installed within the profile to measure the respective parameters on a daily basis (Figure 1). Each set of probes shall be connected to an on-site data logger that will compile the data to be downloaded by the Inspection Engineer on a quarterly basis. The summary and analysis of the data shall be submitted with each quarterly inspection report.

Proposed Monitoring Equipment at each location (2 locations) includes:

- 5 each – GS3 water content probes by Decagon Devices Inc.
- 5 each – MPS-6 water potential probes by Decagon Devices, Inc.
- 2 each – EM50 data loggers by Decagon Devices Inc.

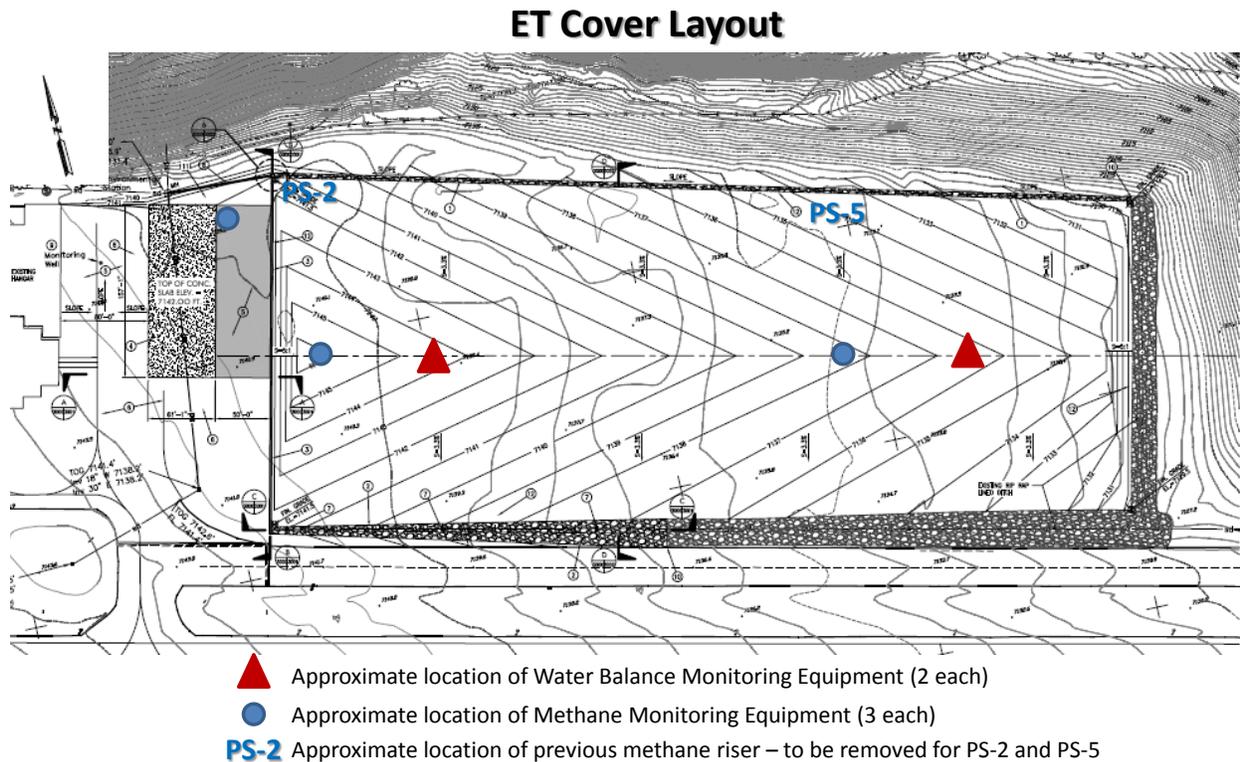
Figure 2. Methane and Water Balance Monitoring Locations

Methane monitoring shall be performed at three locations (Figures 2 and 3). The monitoring equipment shall be installed within three months after the completion of the cover construction. The monitoring shall include the installation of the three passive vent locations. Each location shall include a vertical riser installed into the underlying waste that rises above ground level where measurements can be made (Figure 3).

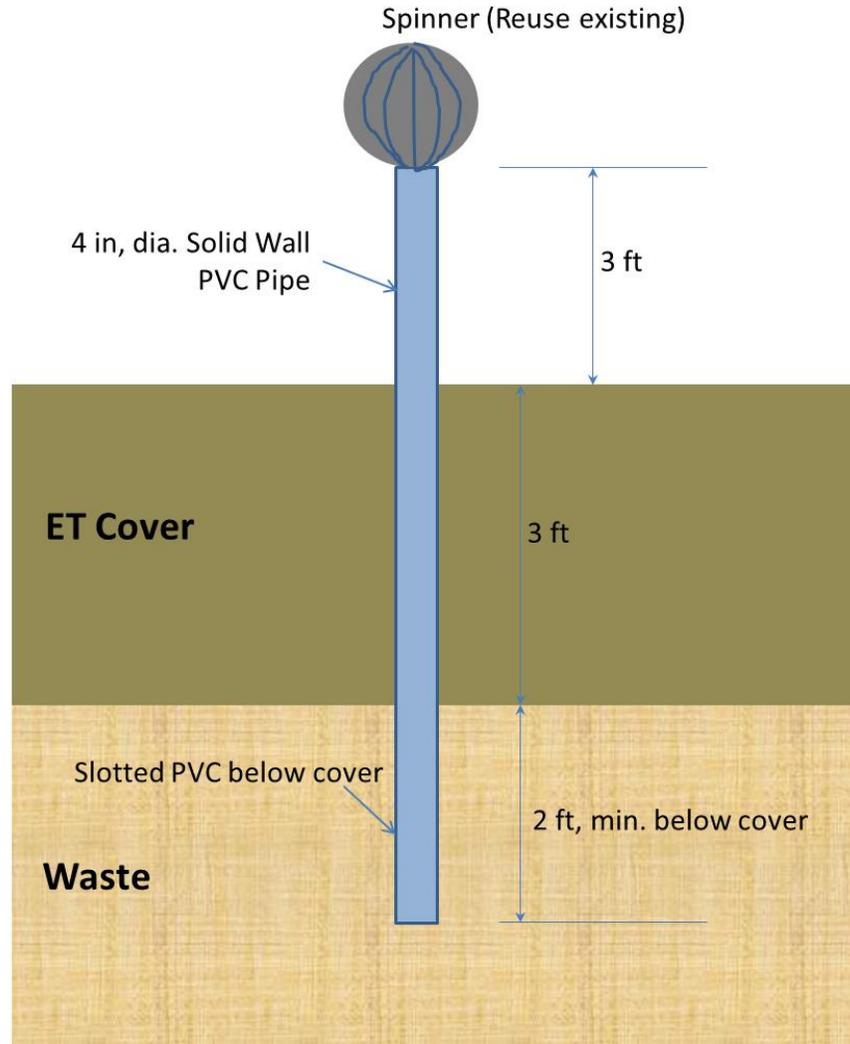
**Figure 3. Methane Monitoring Vent**
